CITY OF TRACY

CITYWIDE PUBLIC FACILITIES MASTER PLAN UPDATE

December 2023

II. FACILITY CONDITION ASSESSMENTS

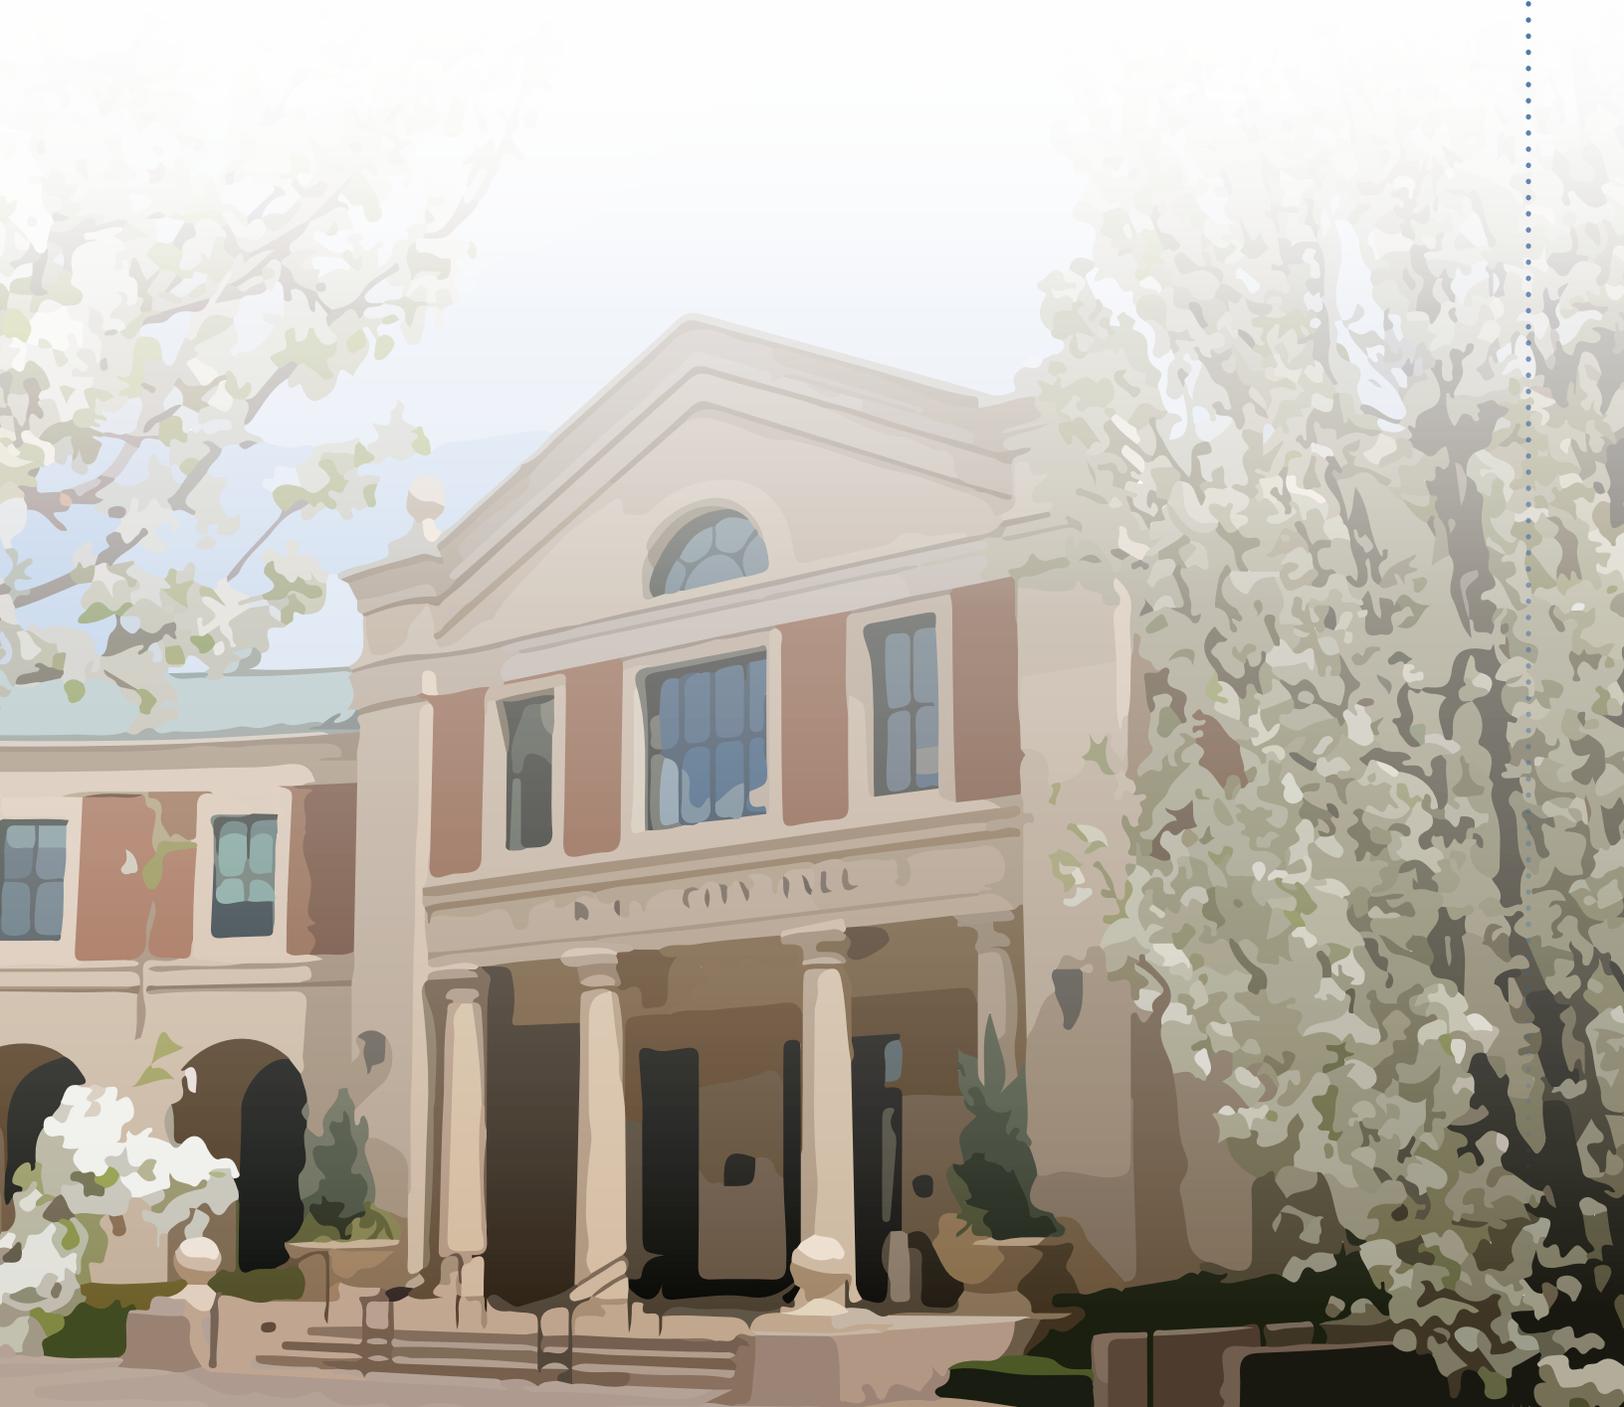
Condition Summary - City Hall

Overall Rating 4.1

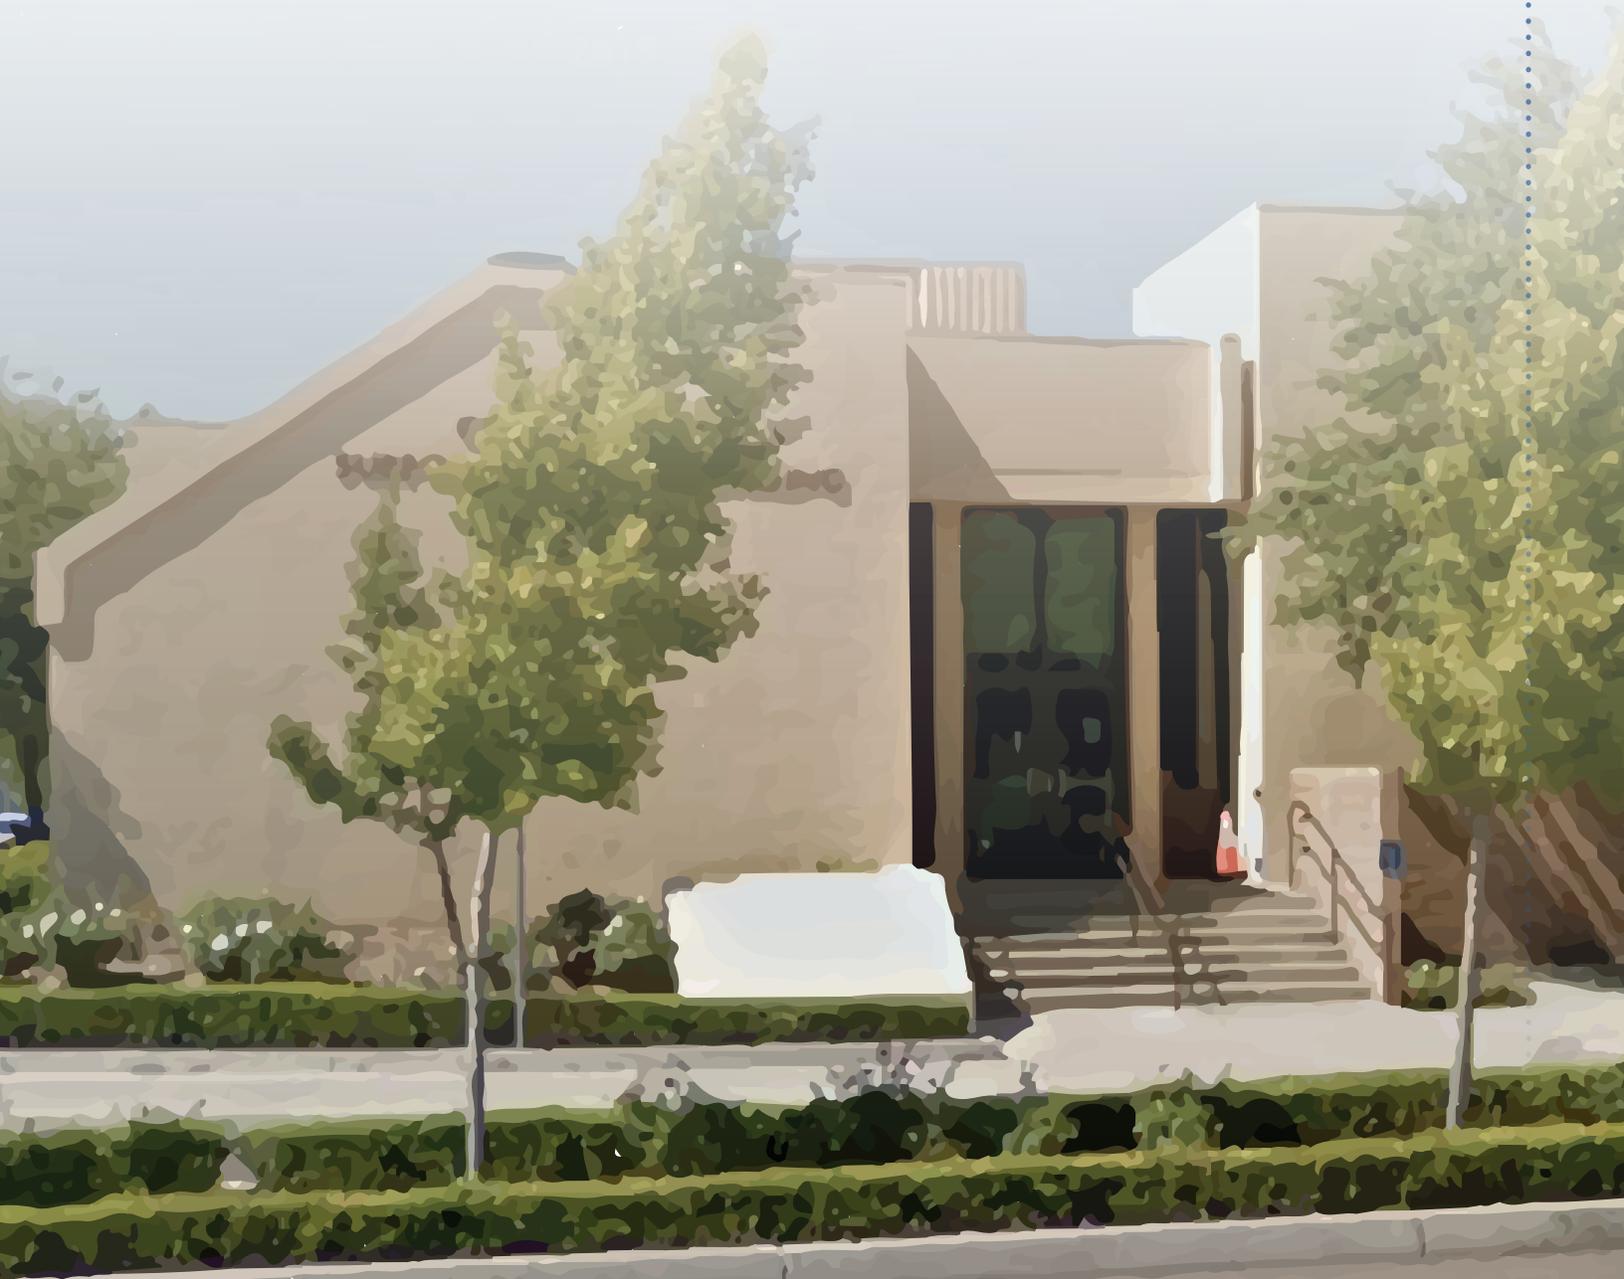
Condition Summary - Support Services Building

Overall Rating 3.6

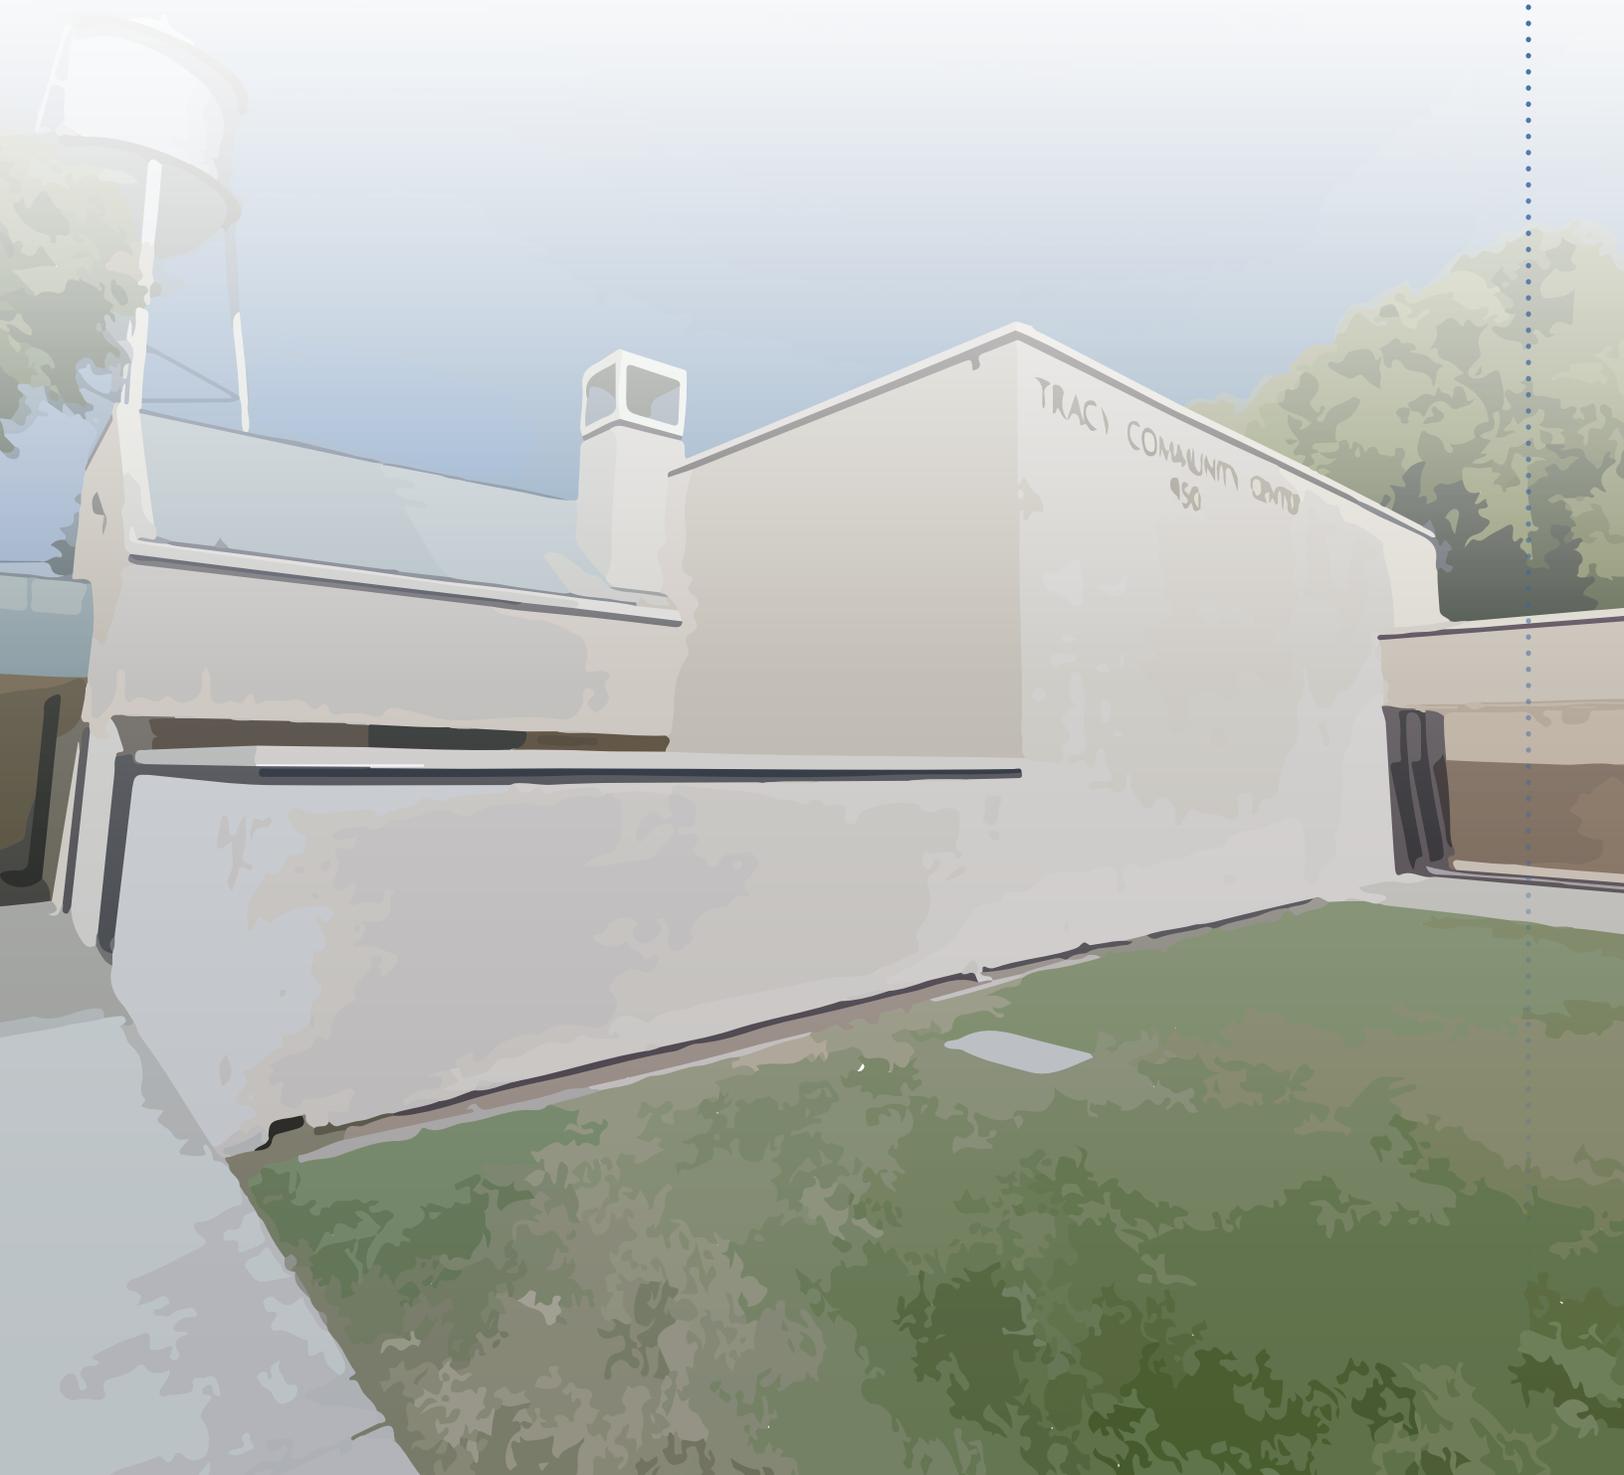
Condition Summary - Community Center

Overall Rating 3.5

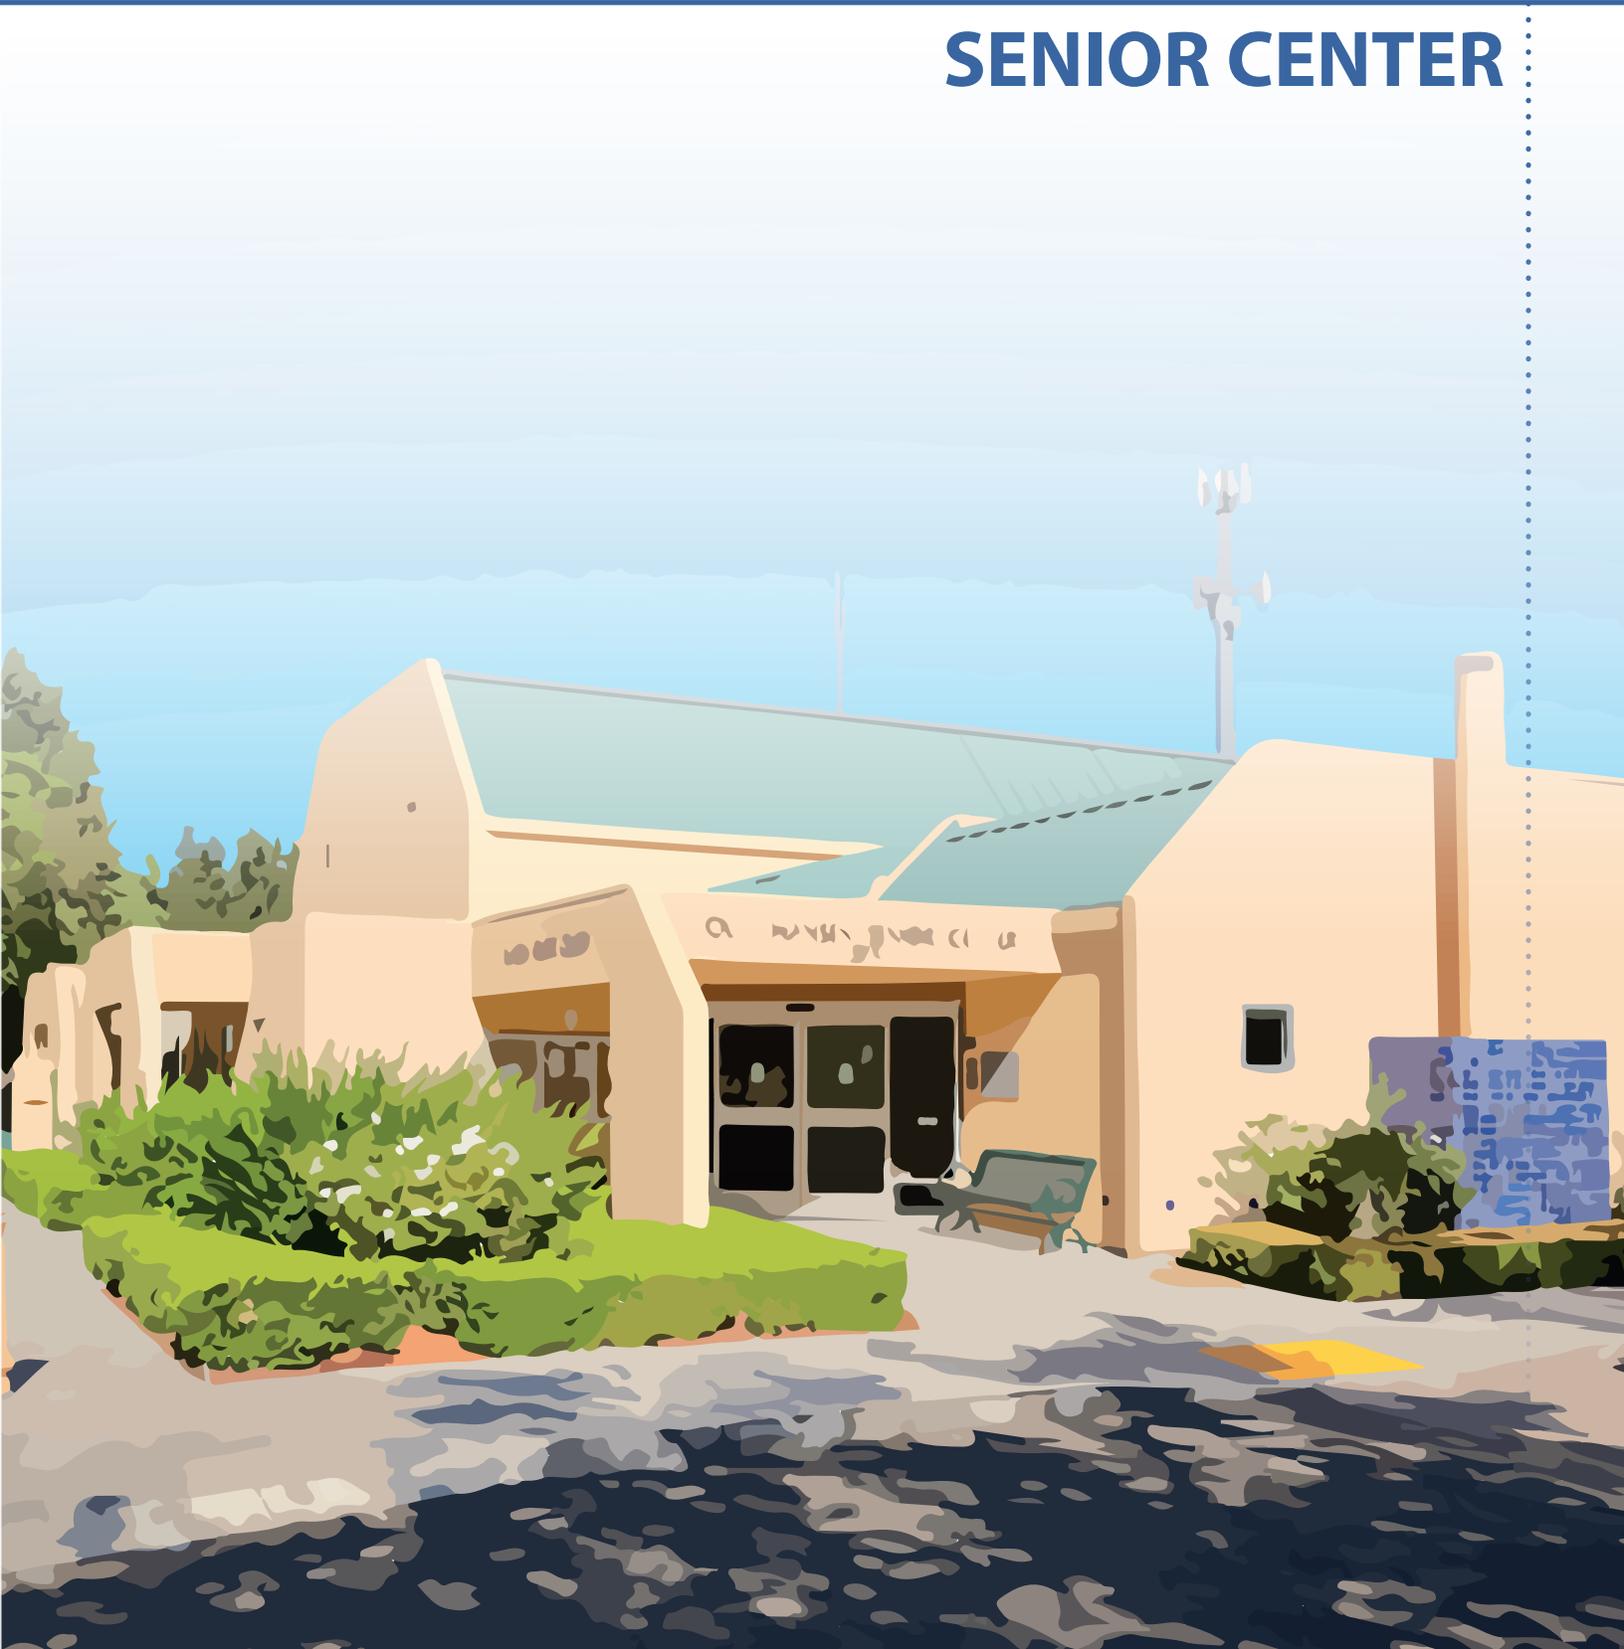
Condition Summary - Senior Center

Overall Rating 4.0

<p>Site 4.0</p> <p>Landscaping at the Senior Center gives the facility and grounds a well-maintained and cared for appearance. There is fire service access adjacent to the facility with access to street lighting for maintenance. Sidewalks surround the facility with minimal pavement cracking. Bricks laid at the exterior patio require extensive cleaning in high traffic areas. Site gates and latch mechanisms work well.</p>	<p>Interior 4.5</p> <p>The lobby has been recently remodeled with new flooring, paint, furniture, and other elements. Lighting fixtures are largely LED throughout. Some rooms contain movable partitions to allow for a separation of one larger room into smaller rooms. Kitchen equipment and finishes are in good condition with much remaining service life. Acoustic ceiling tiles and flooring have recently been replaced and add to the facility's appearance.</p>
<p>Exterior Envelope 3.6</p> <p>Painted stucco covering the majority of the facility's exterior is in good condition with minimal cracking or chipping. However, some cracking is present where painted stucco meets the foundation. Some exterior metal doors are scratched and/or dented. The rooftop-mounted hose works well for keeping the roof surface maintained and cleaned annually and should be considered for other city facilities. New flashings and gutters have been recently installed.</p>	<p>MEP Systems 4.1</p> <p>Electrical equipment is located in an exterior electrical room with direct access from the site. Electrical panels contain additional service life and switchboard is rated at 400 Amps. Fire alarm panel and controls are in good condition and located inside the facility. Maintenance reports changing the facility's RTU3 style air filter is a cumbersome process. A past electrical wiring issue has not resurfaced.</p>

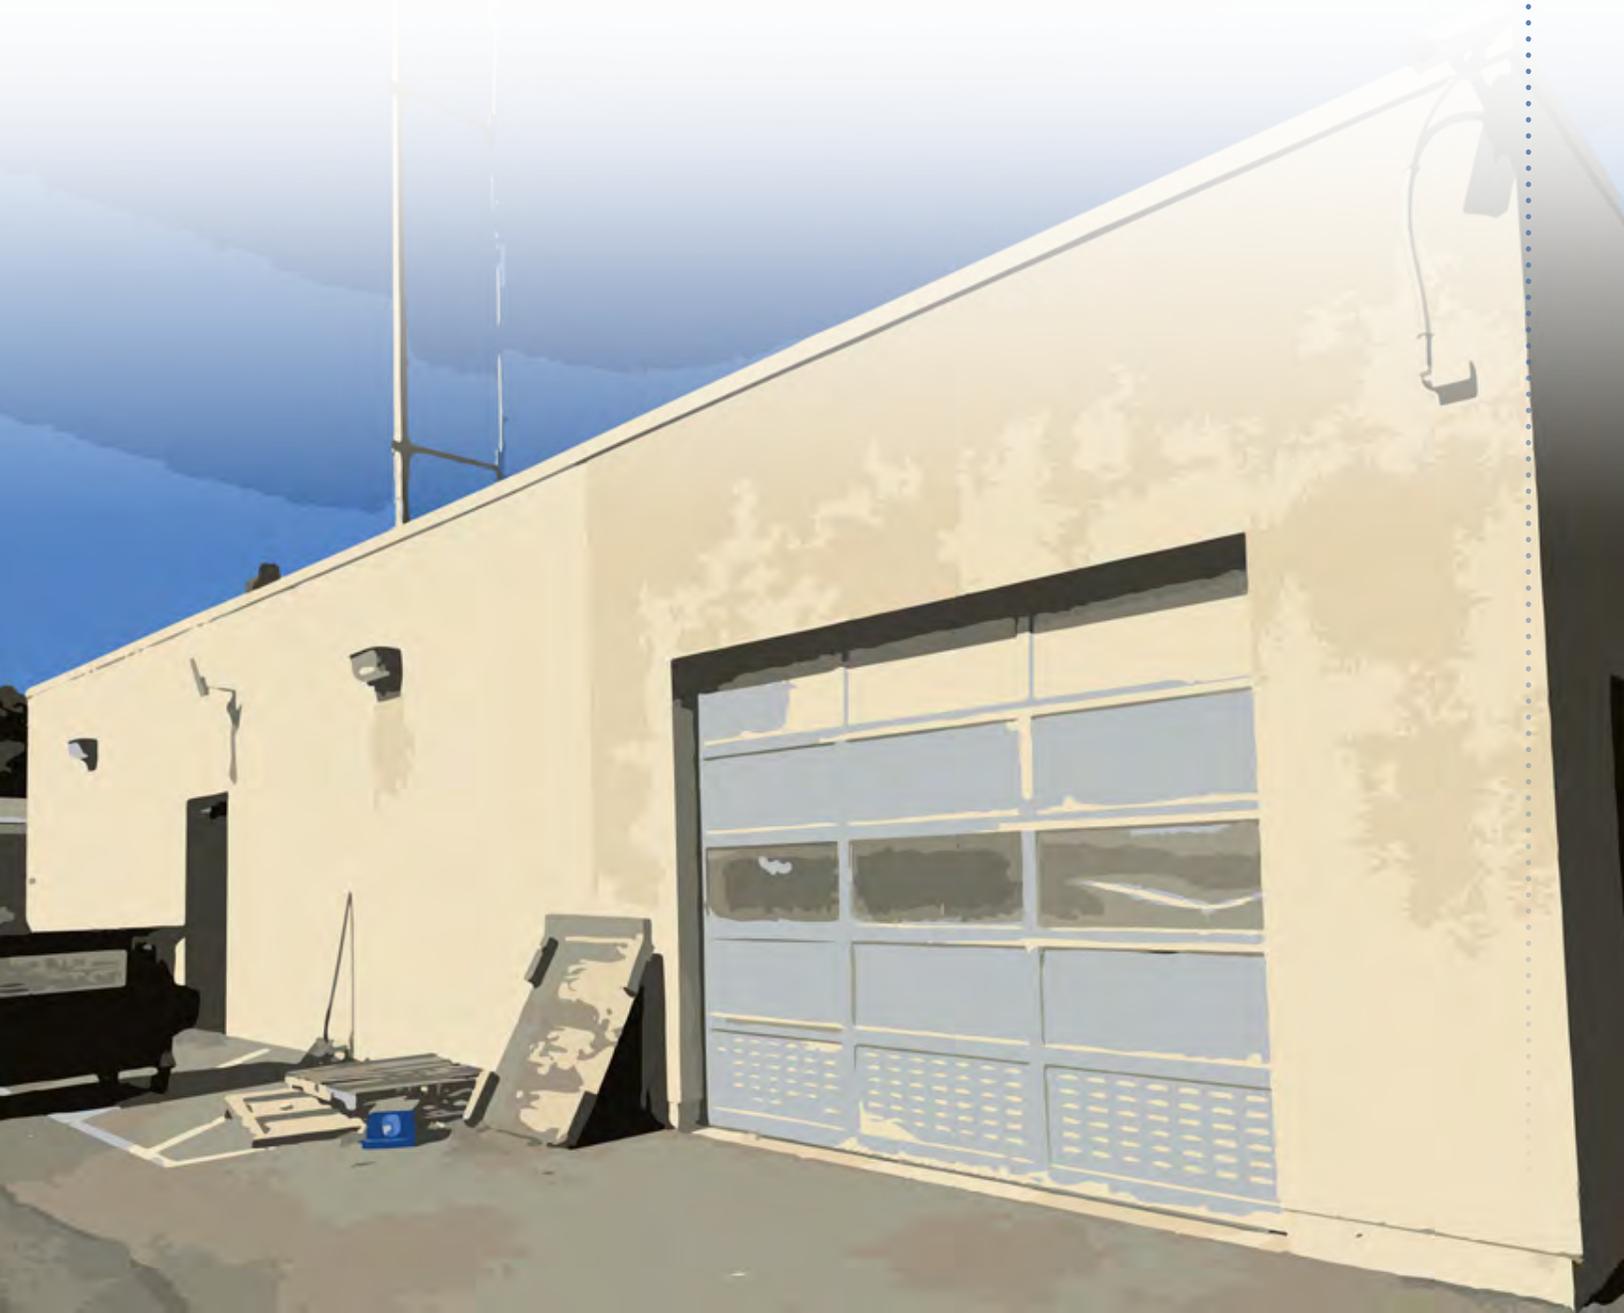
Condition Summary - Police Annex

Overall Rating 3.4

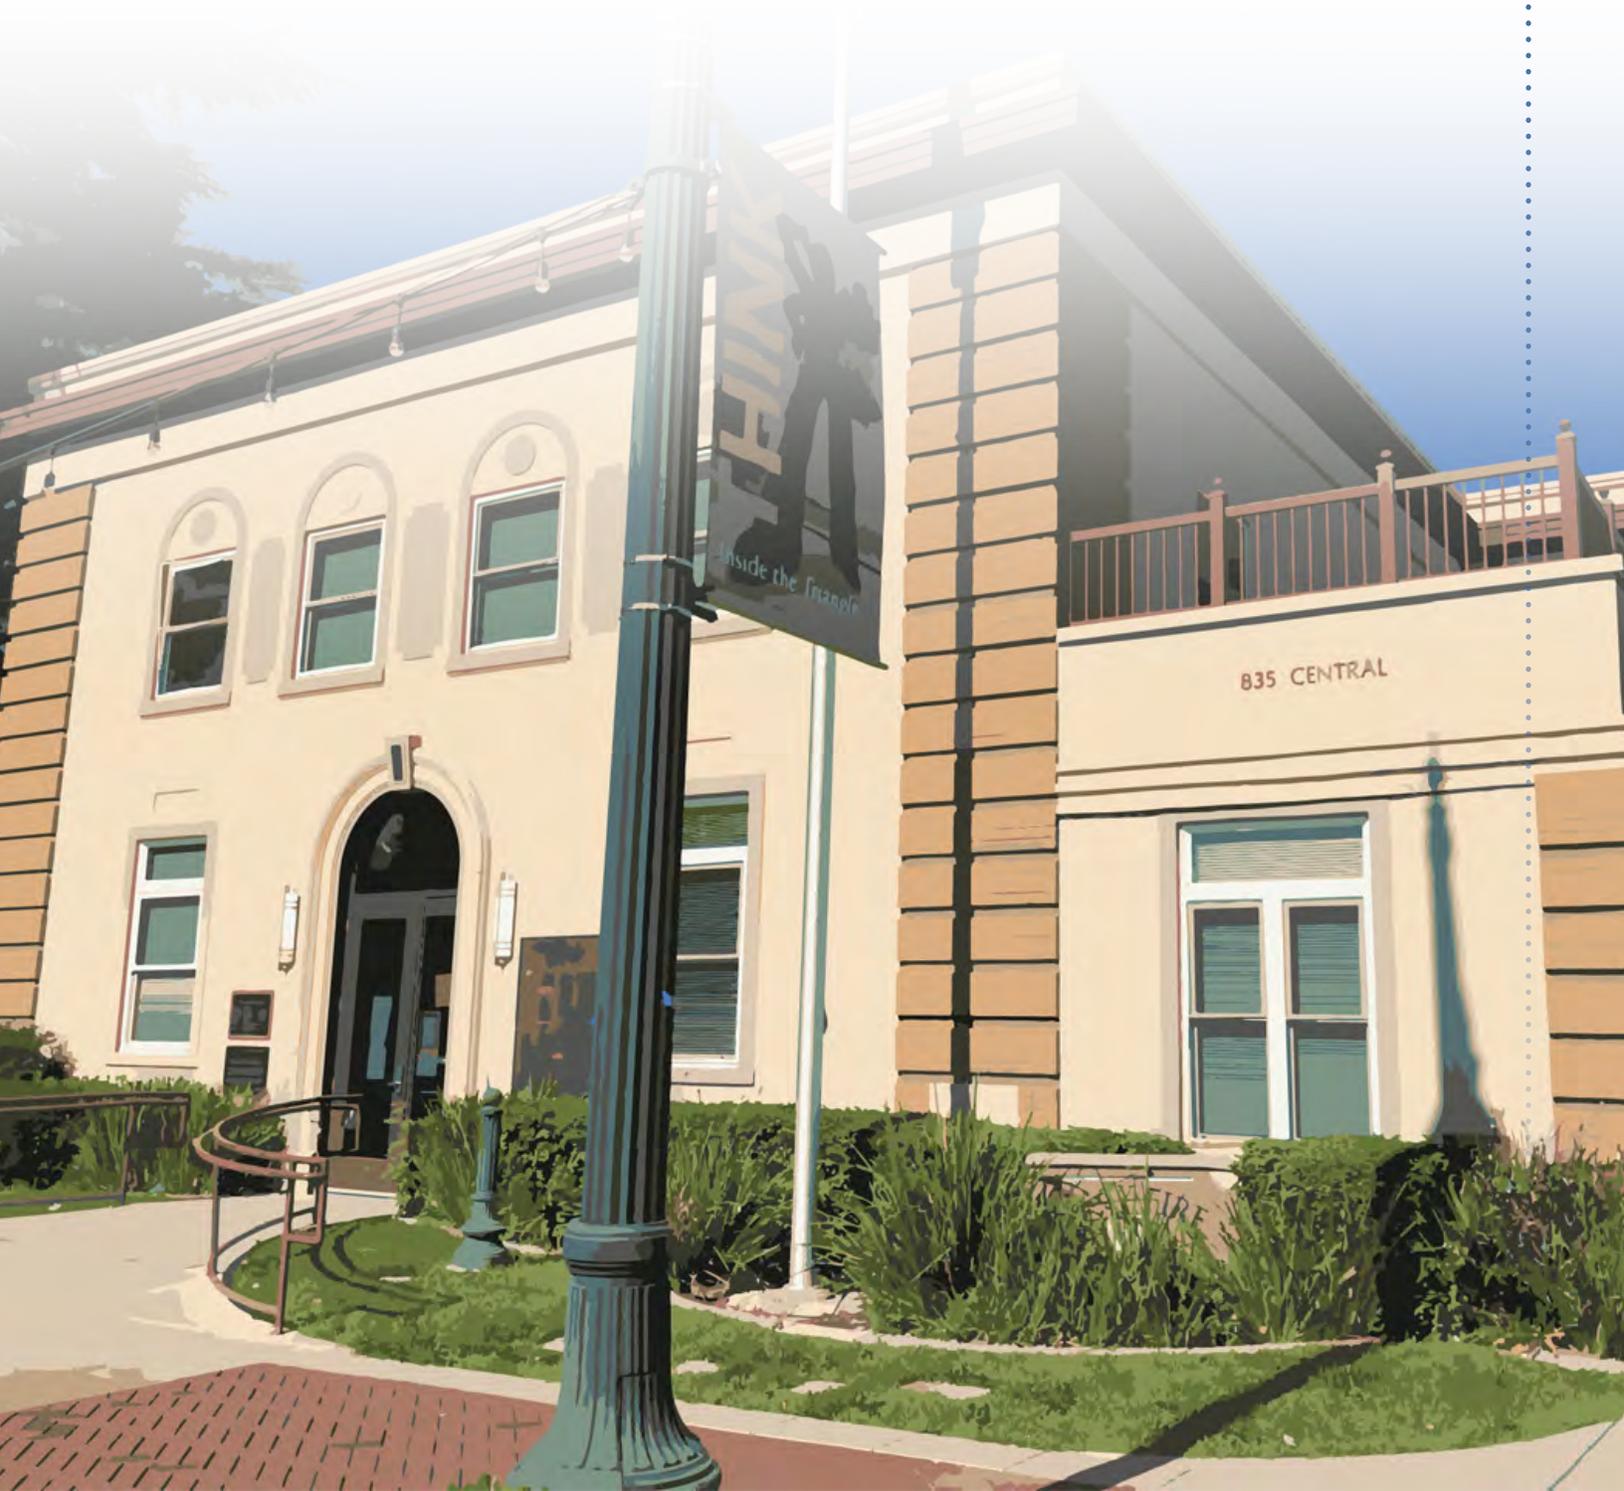
Condition Summary - Fire Administration

Overall Rating 3.8

Site 3.9

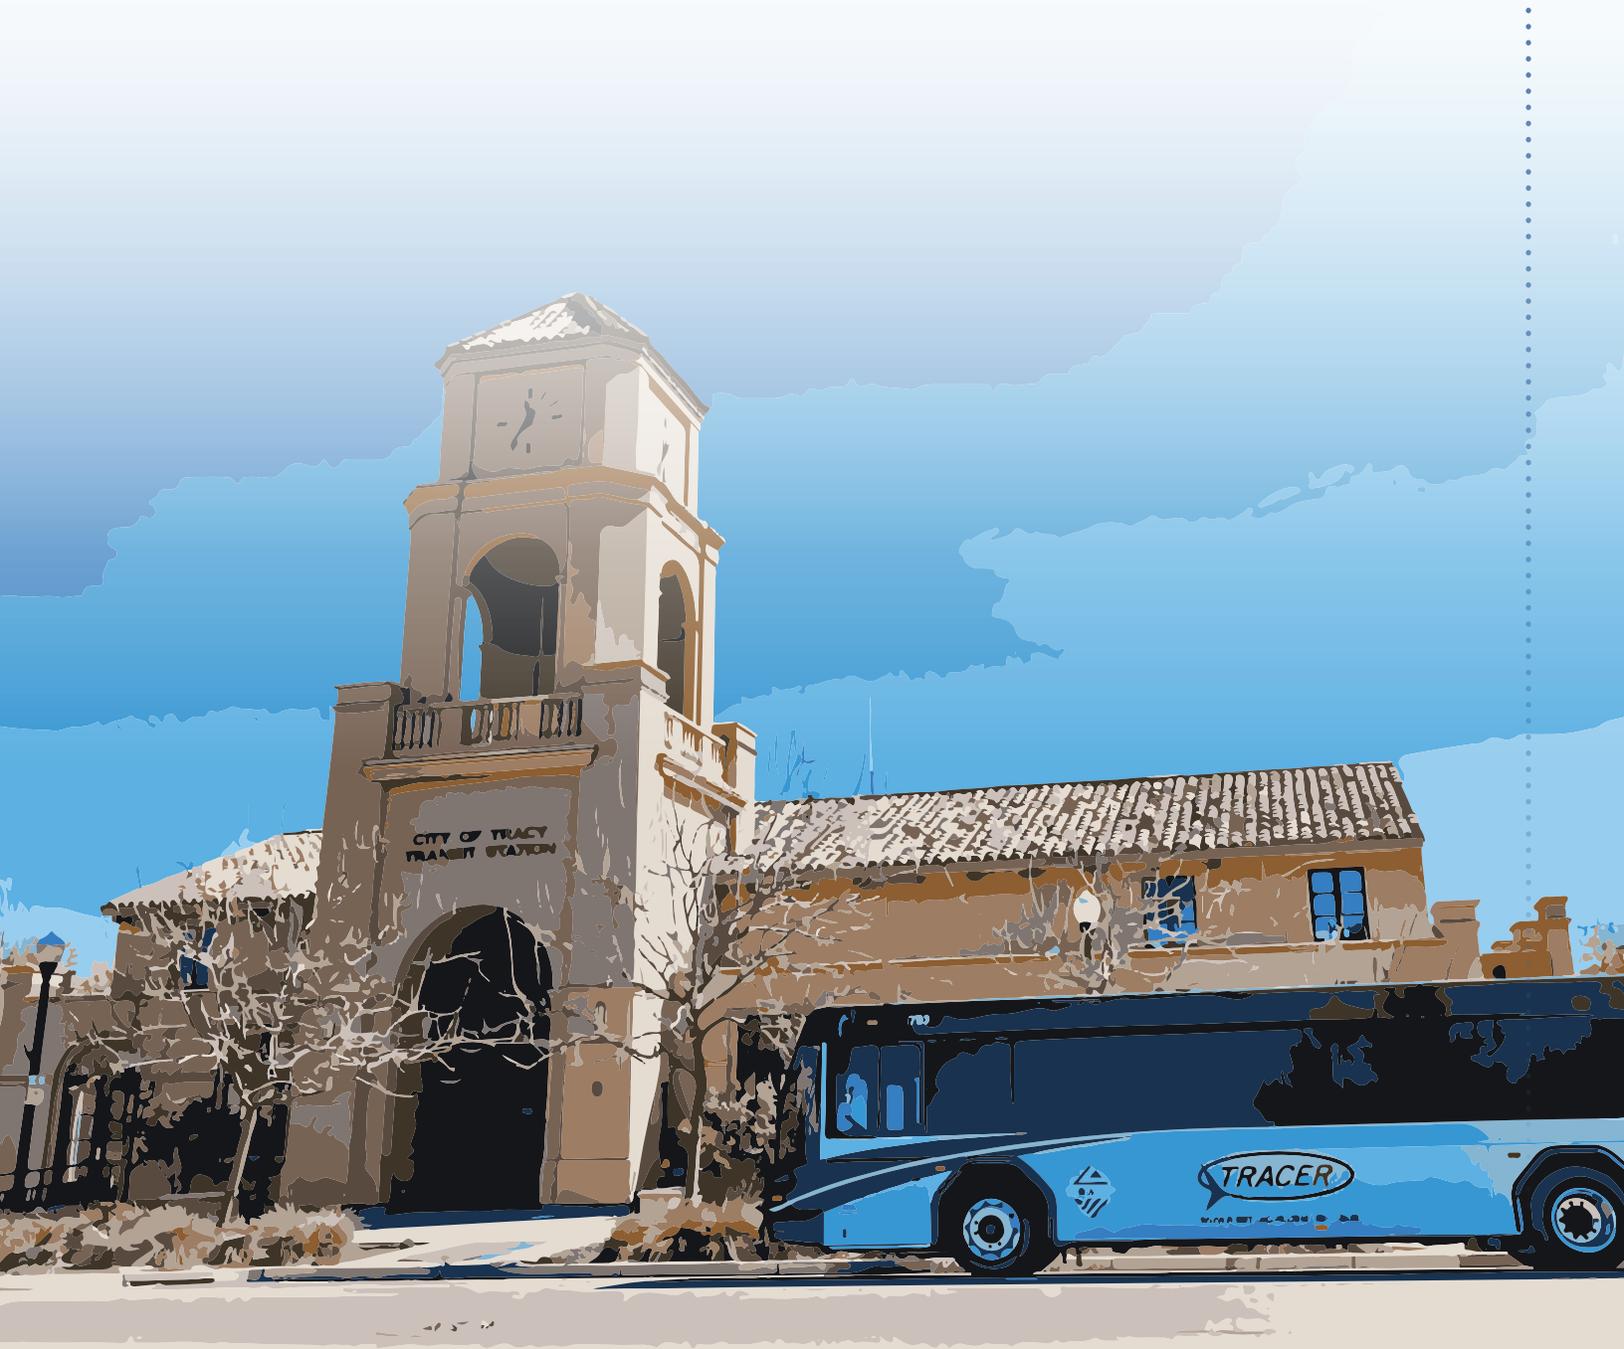
Condition Summary - Tracy Transit Station (New)

Overall Rating 3.8

Site 3.9 **Interior** 3.8

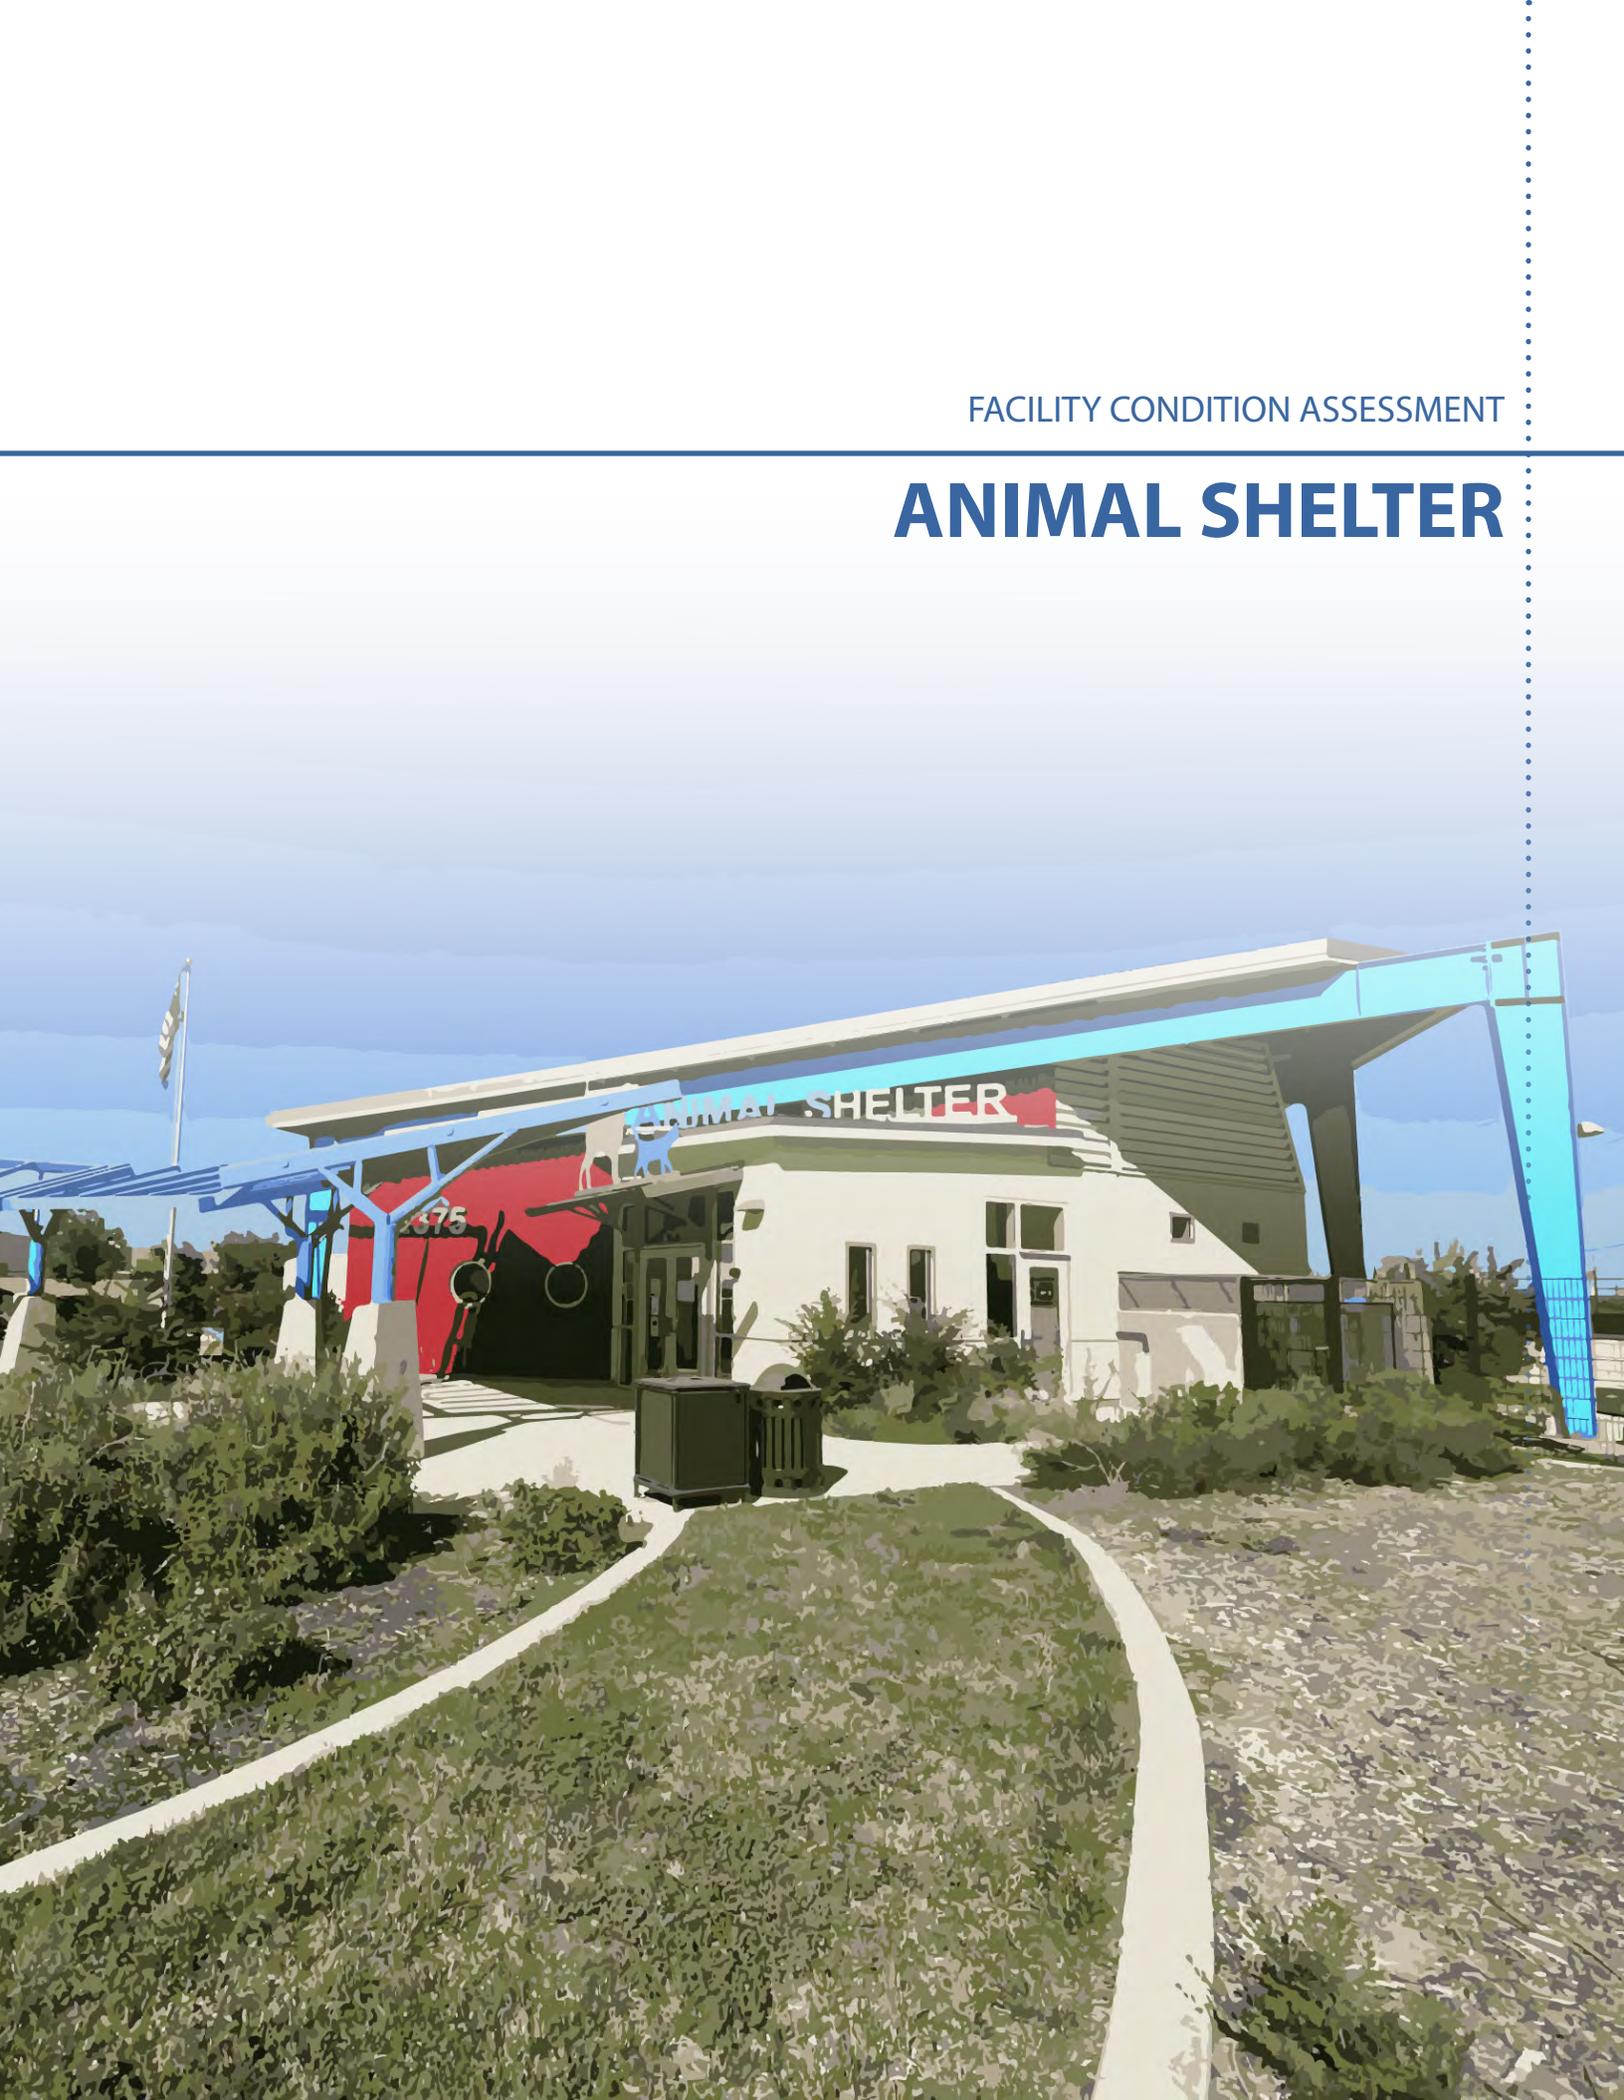
Condition Summary - Animal Shelter

Overall Rating 4.1

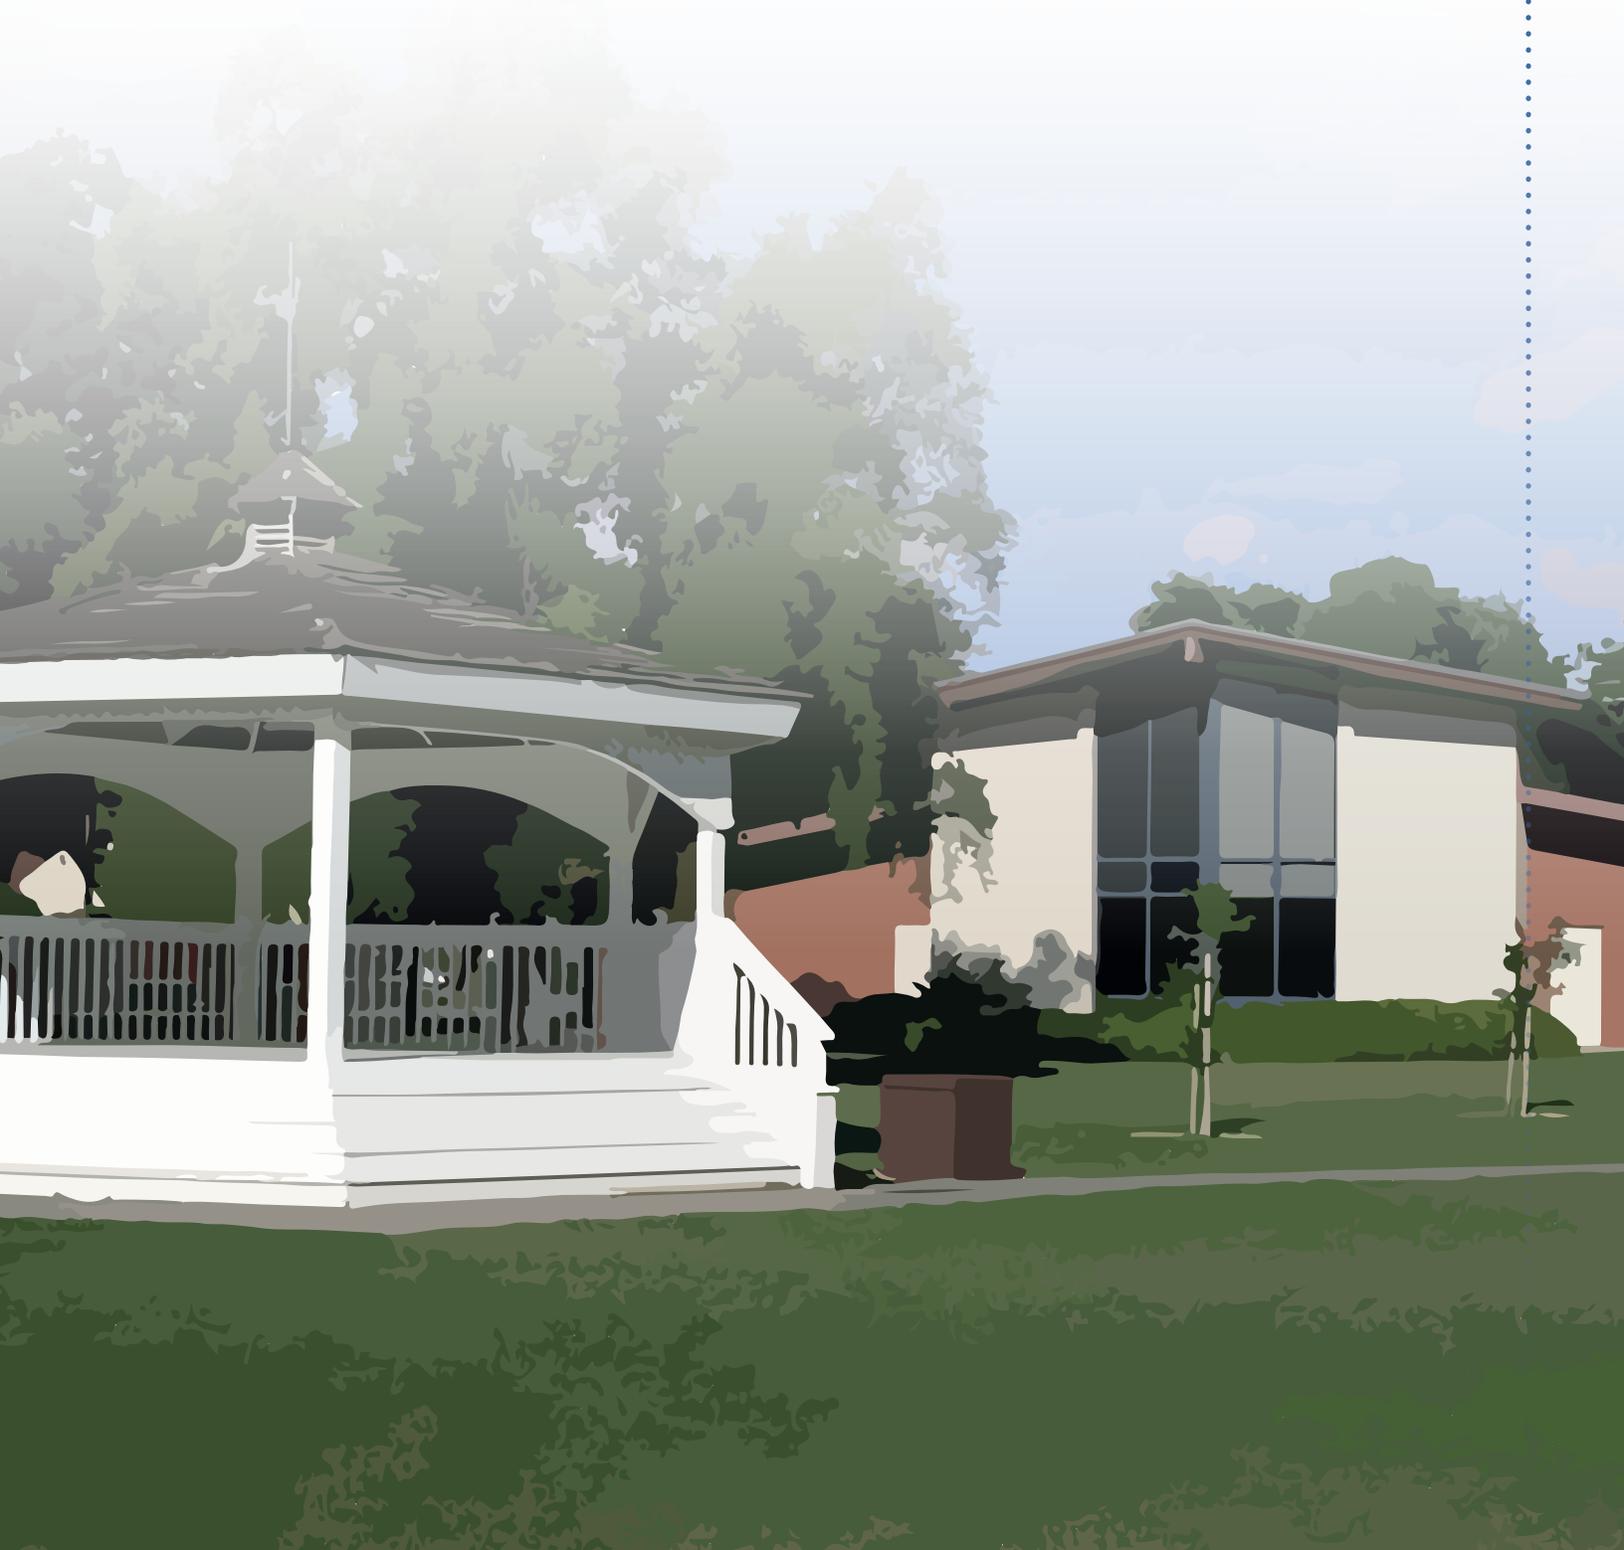
Condition Summary - Tracy Library

Overall Rating 3.5
