CITY OF TRACY

CITYWIDE PUBLIC FACILITIES MASTER PLAN UPDATE

December 2023

II. FACILITY CONDITION ASSESSMENTS

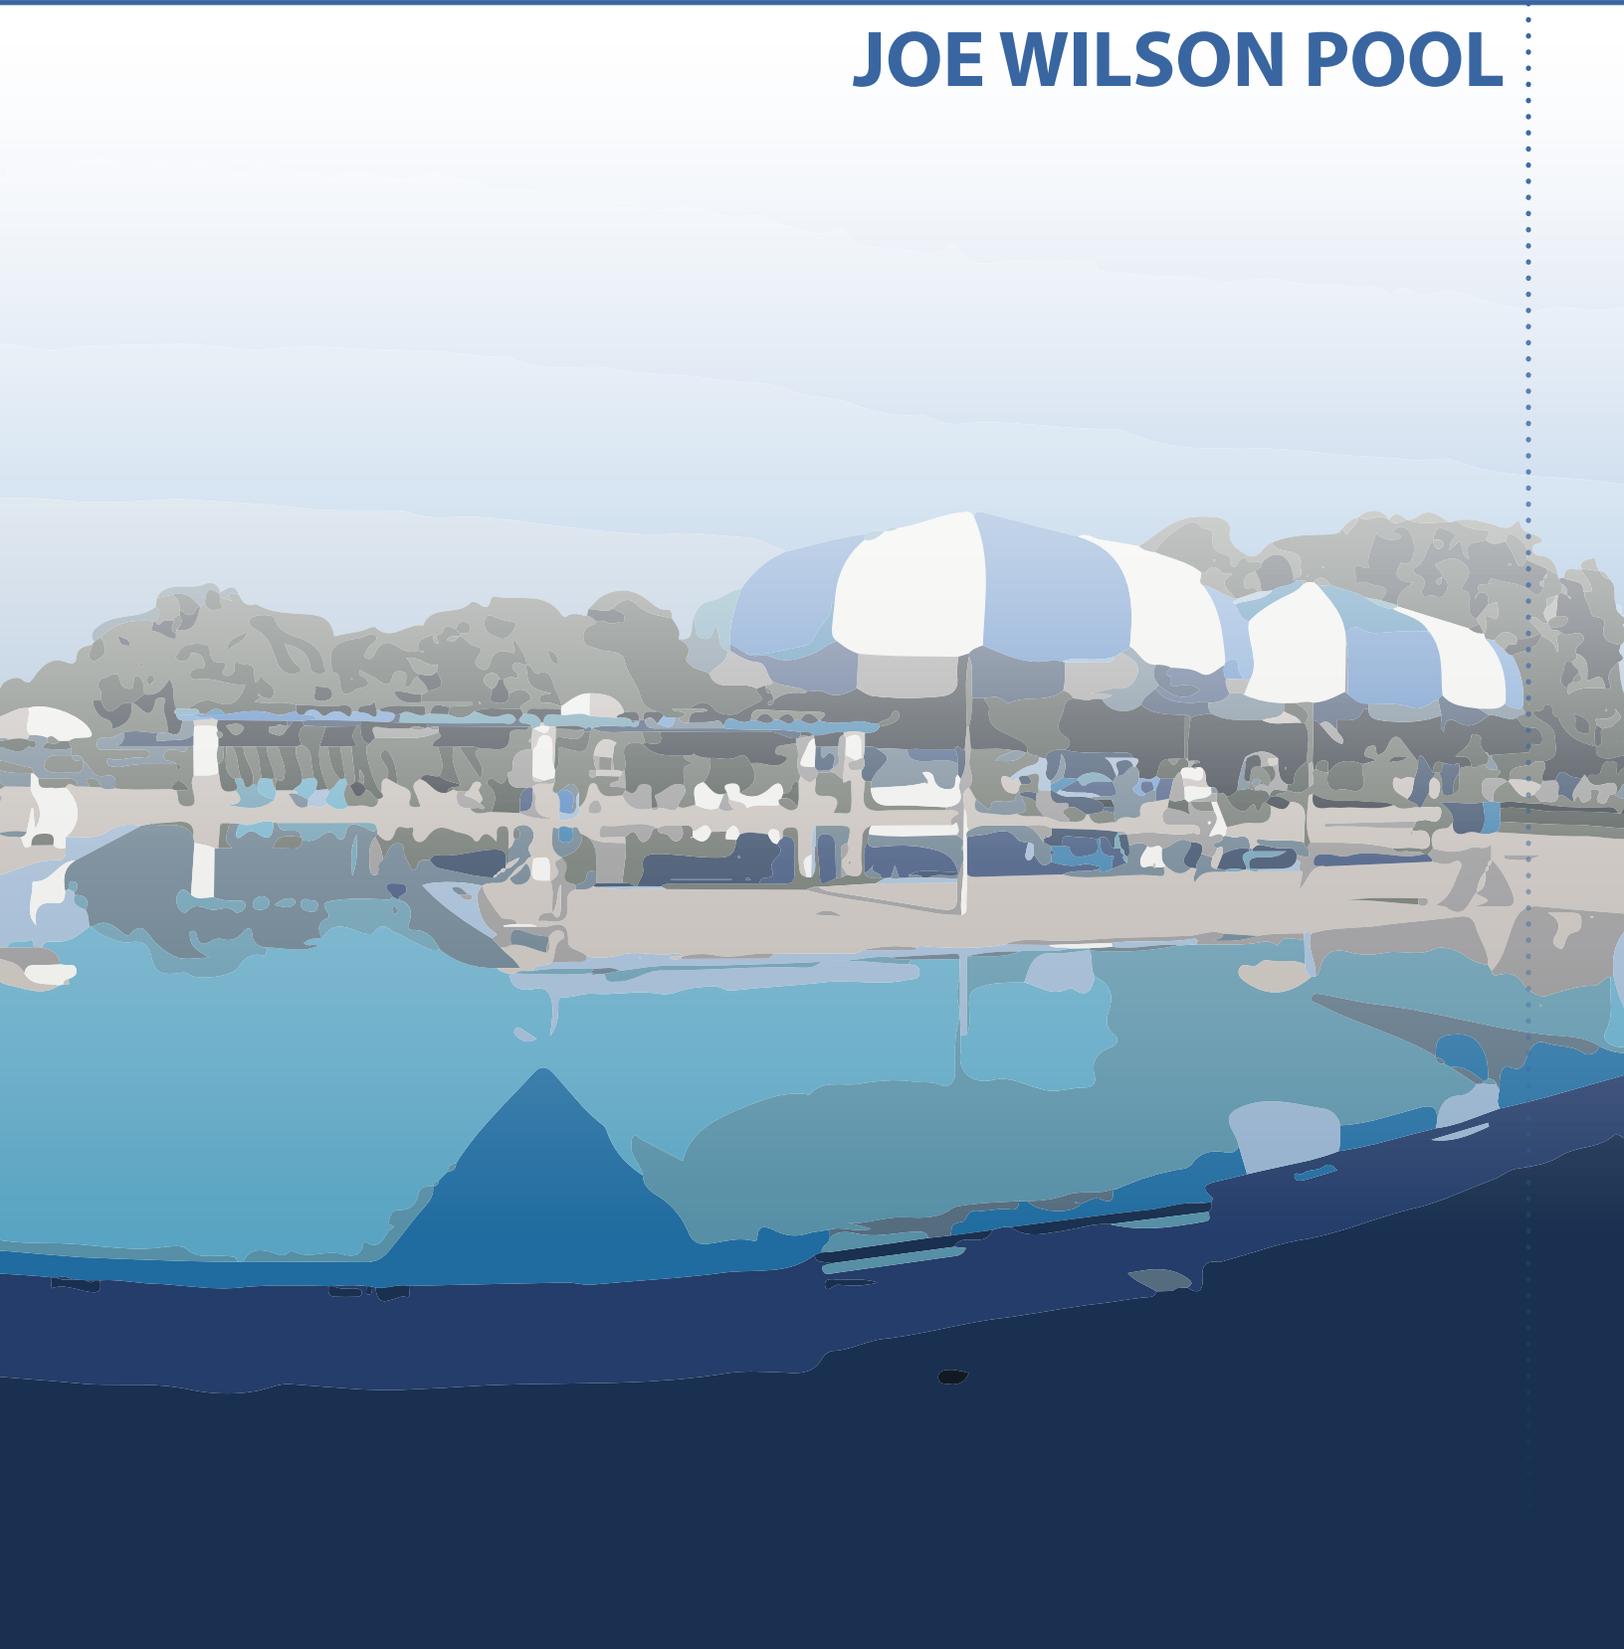
Condition Summary - Joe Wilson Pool

Overall Rating 4.2

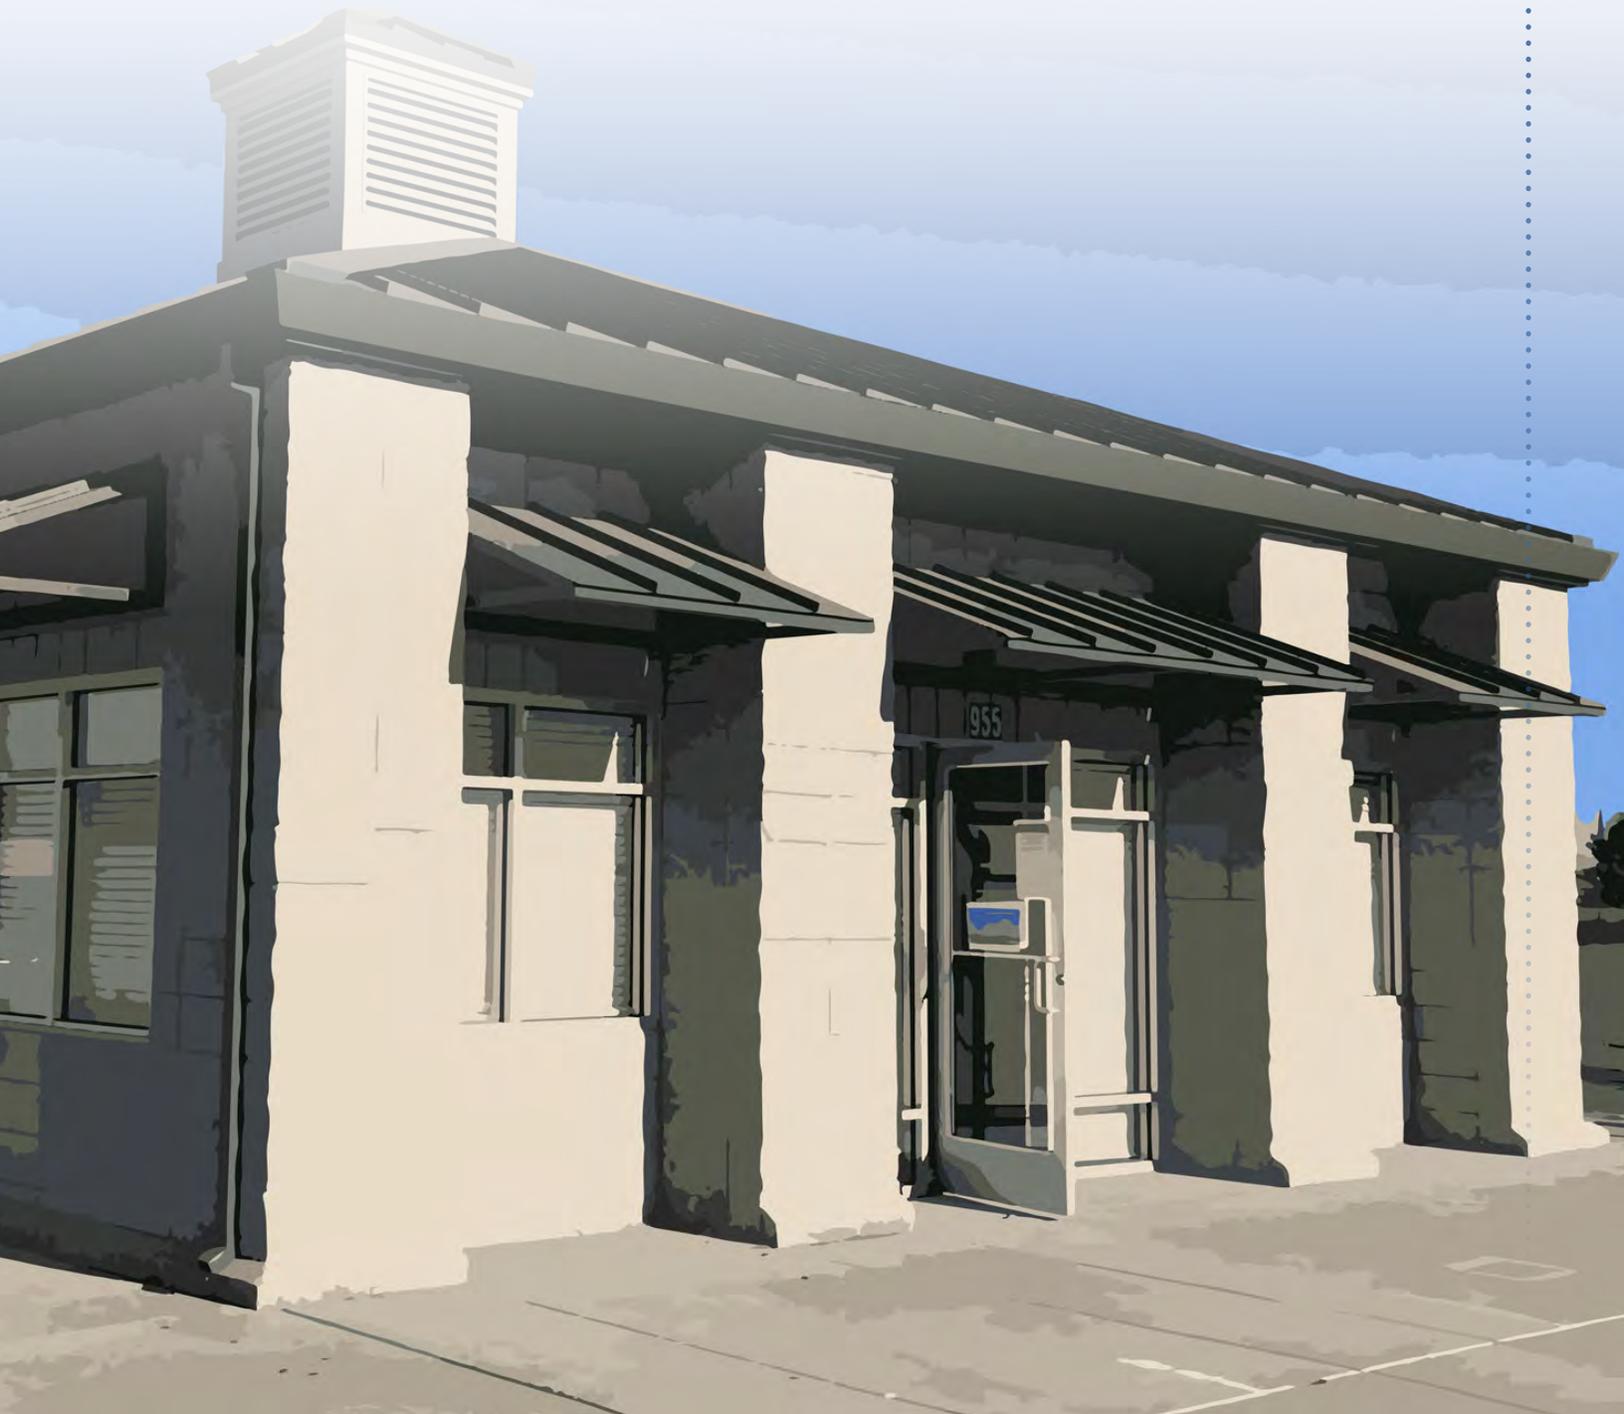
Condition Summary - Sport Complex Meeting Room

Overall Rating 3.3

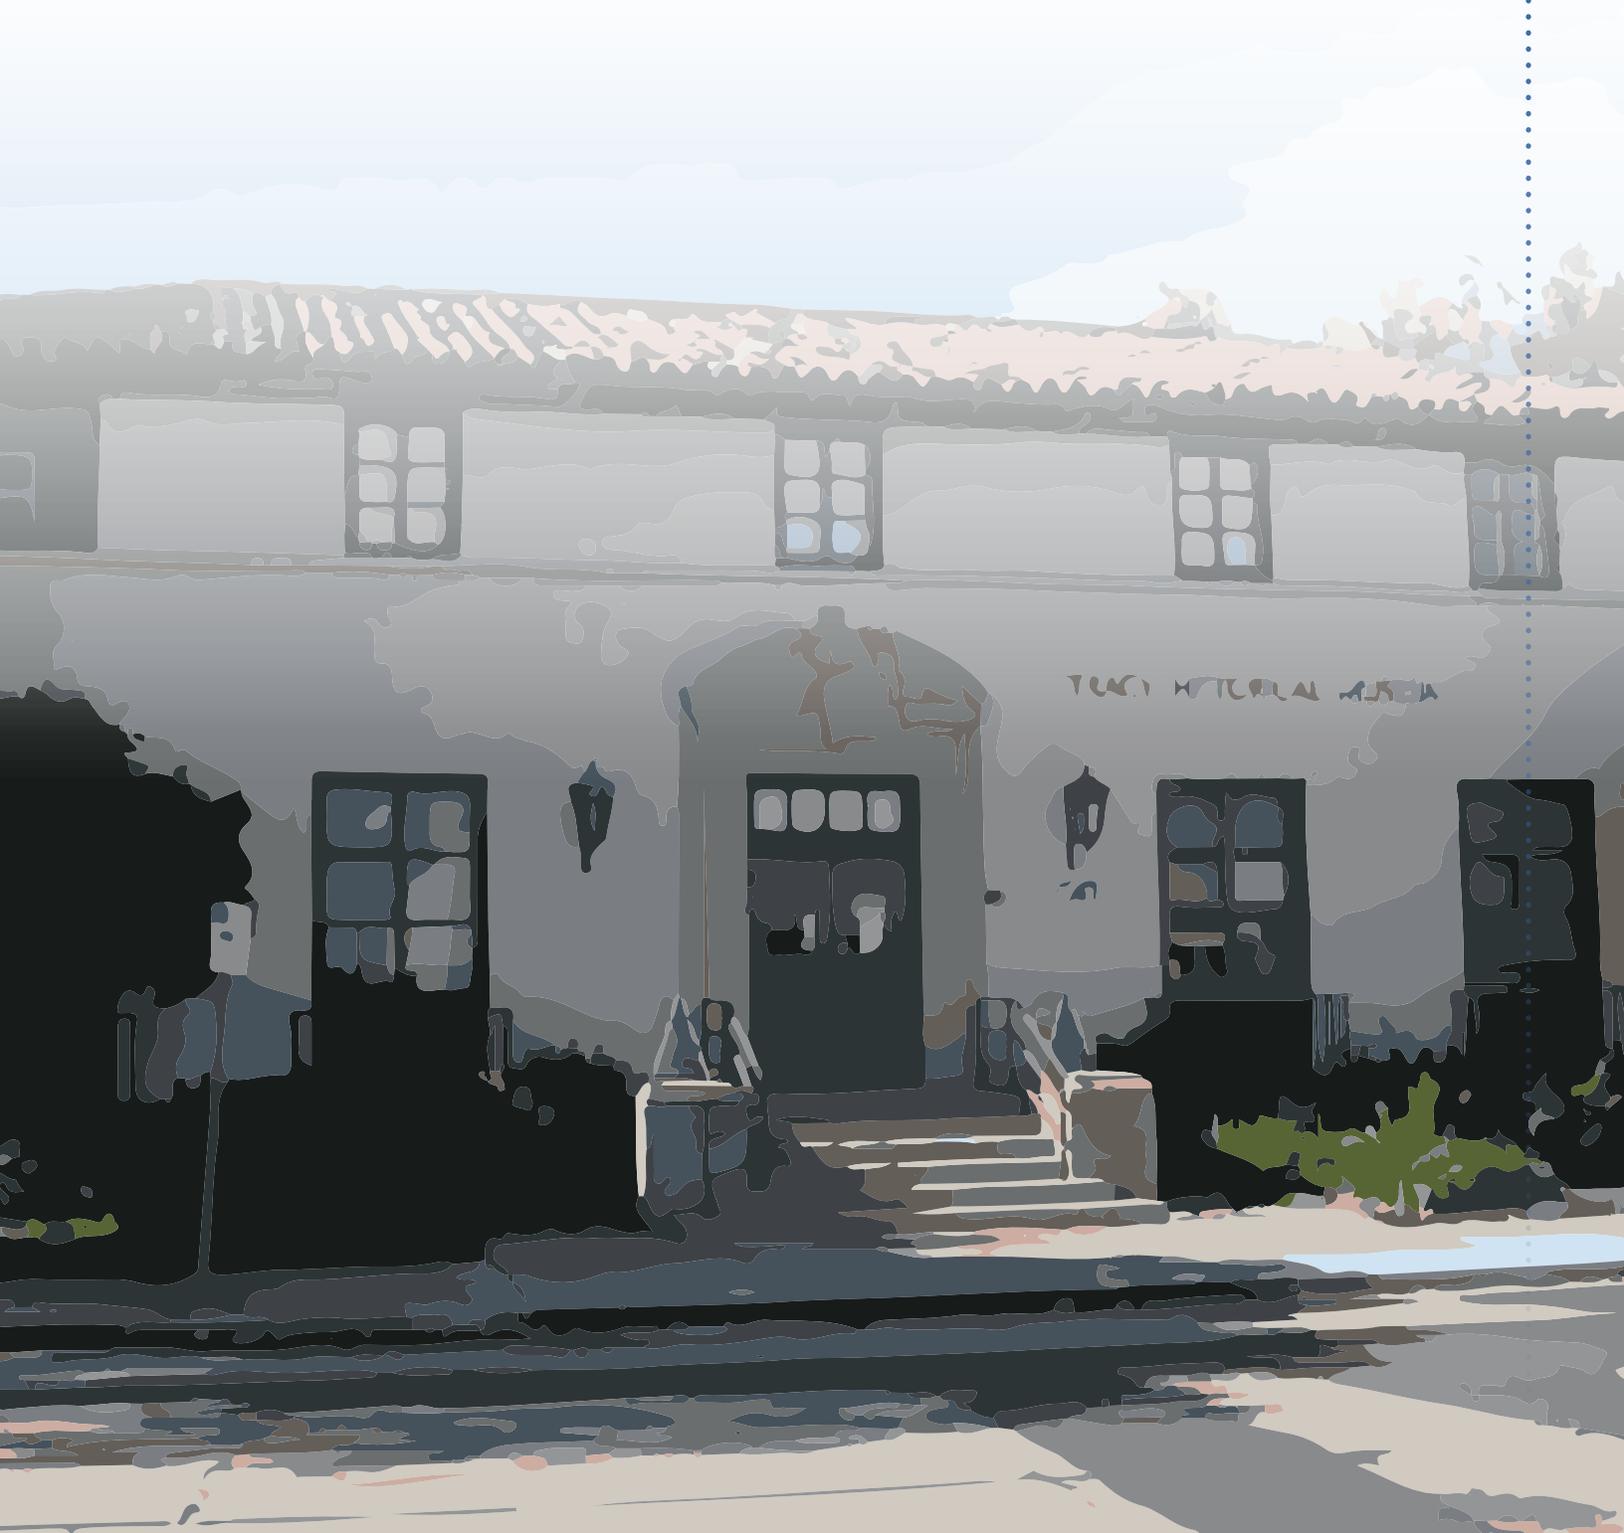
Condition Summary - Tracy Historical Museum

Overall Rating 3.2

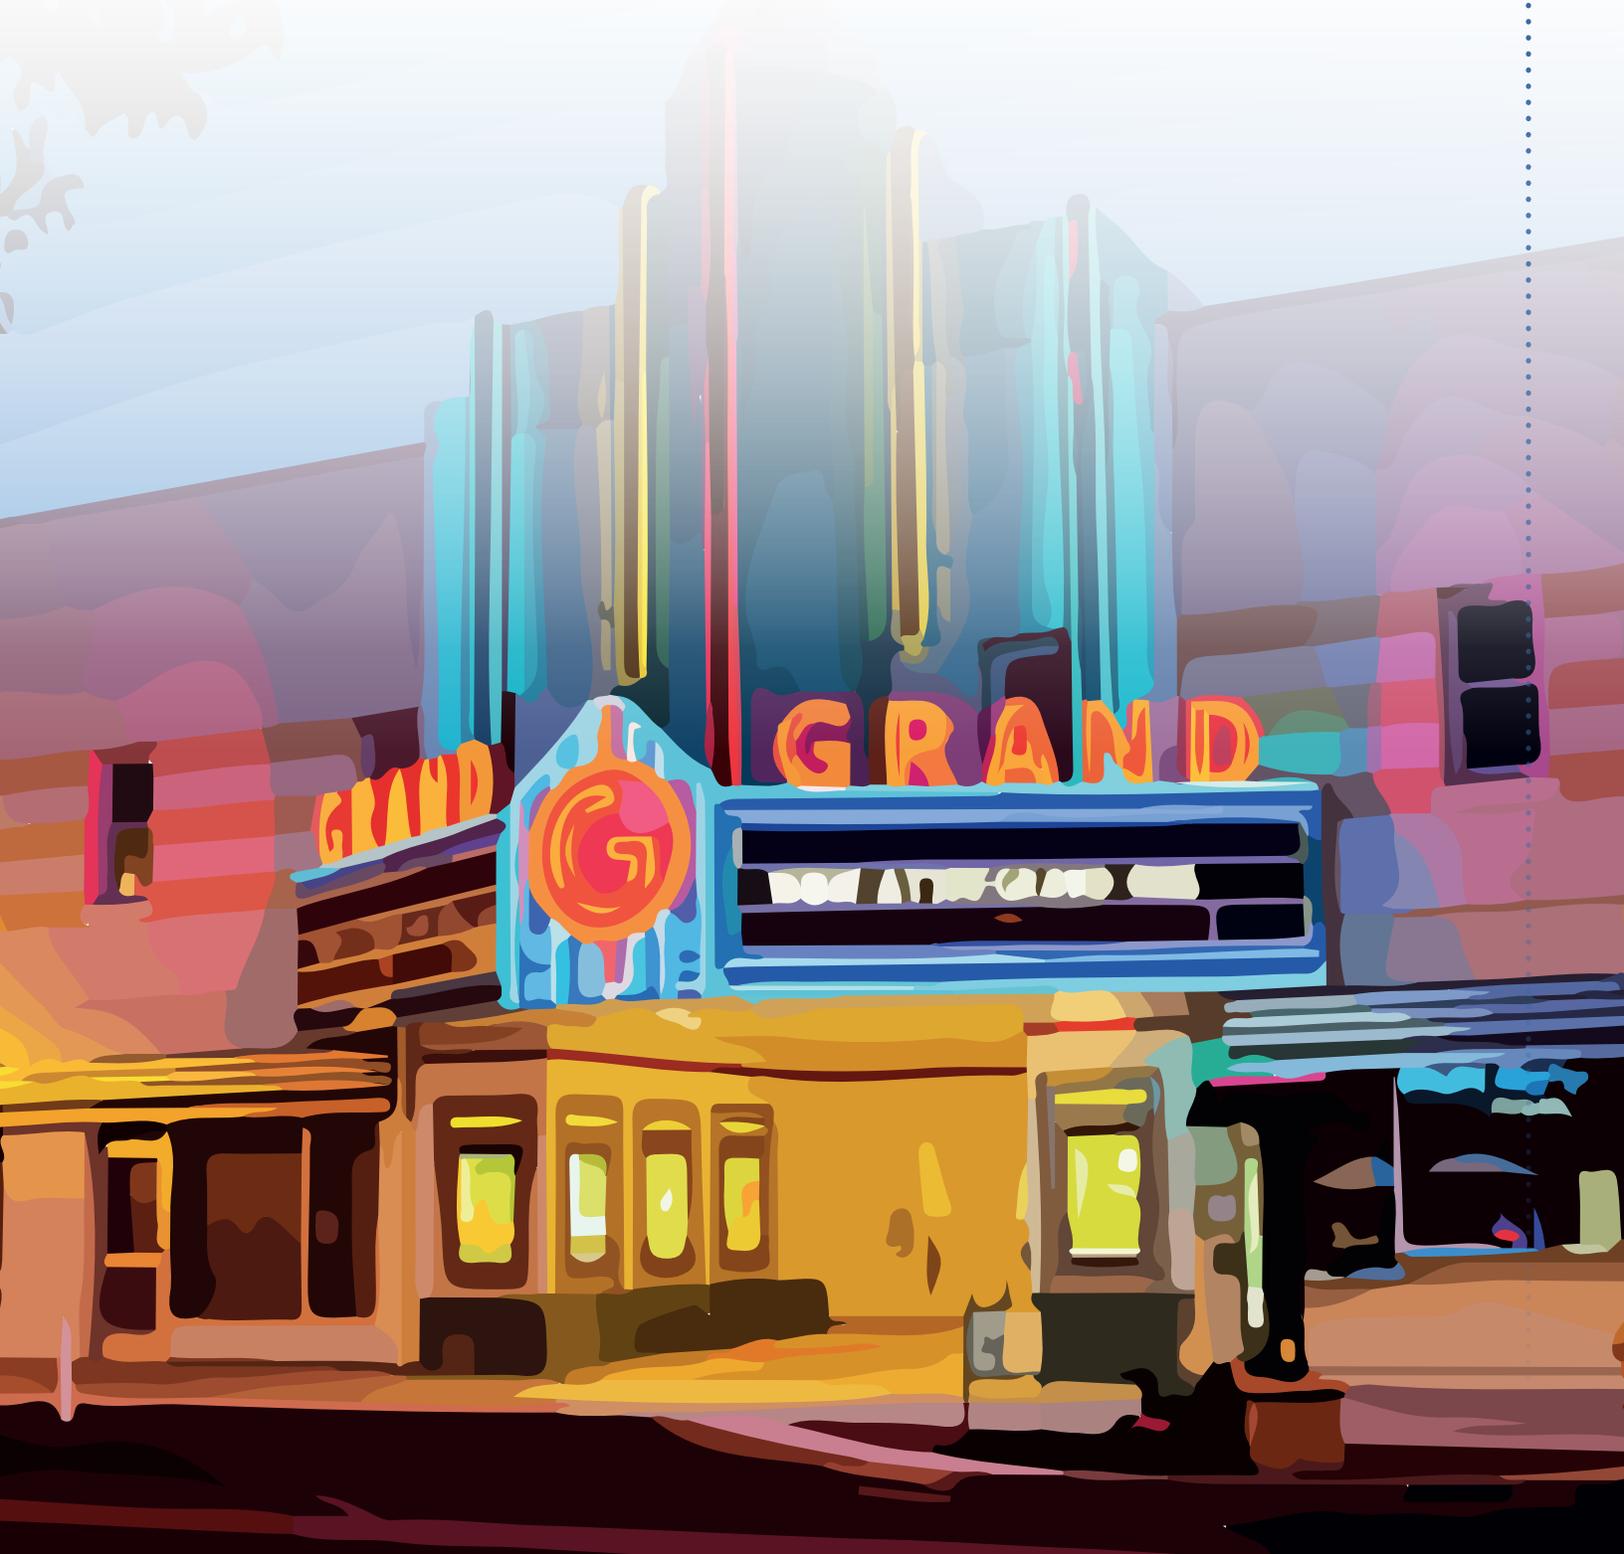
Condition Summary - Grand Theatre

Overall Rating 3.7

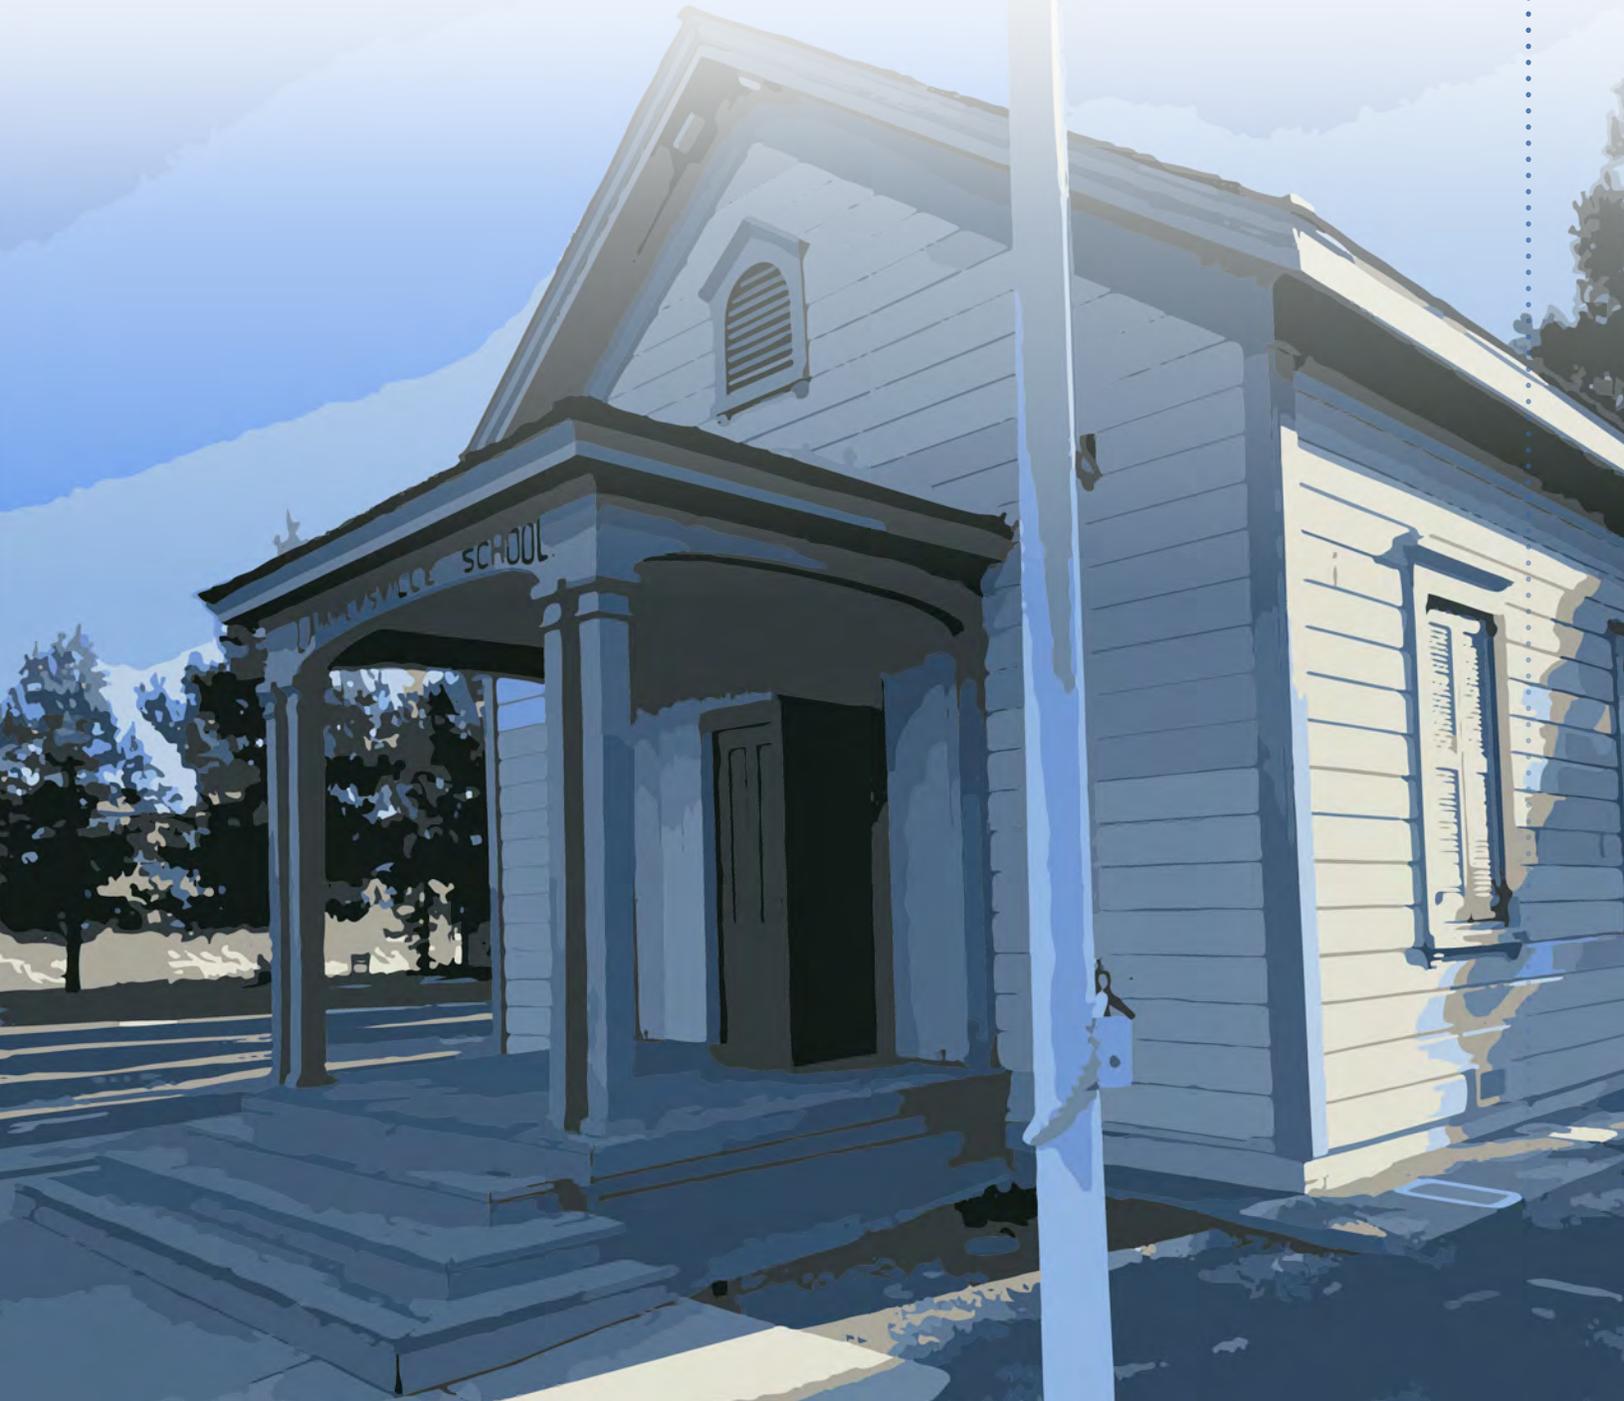
Condition Summary - Lammersville School

Overall Rating 3.1

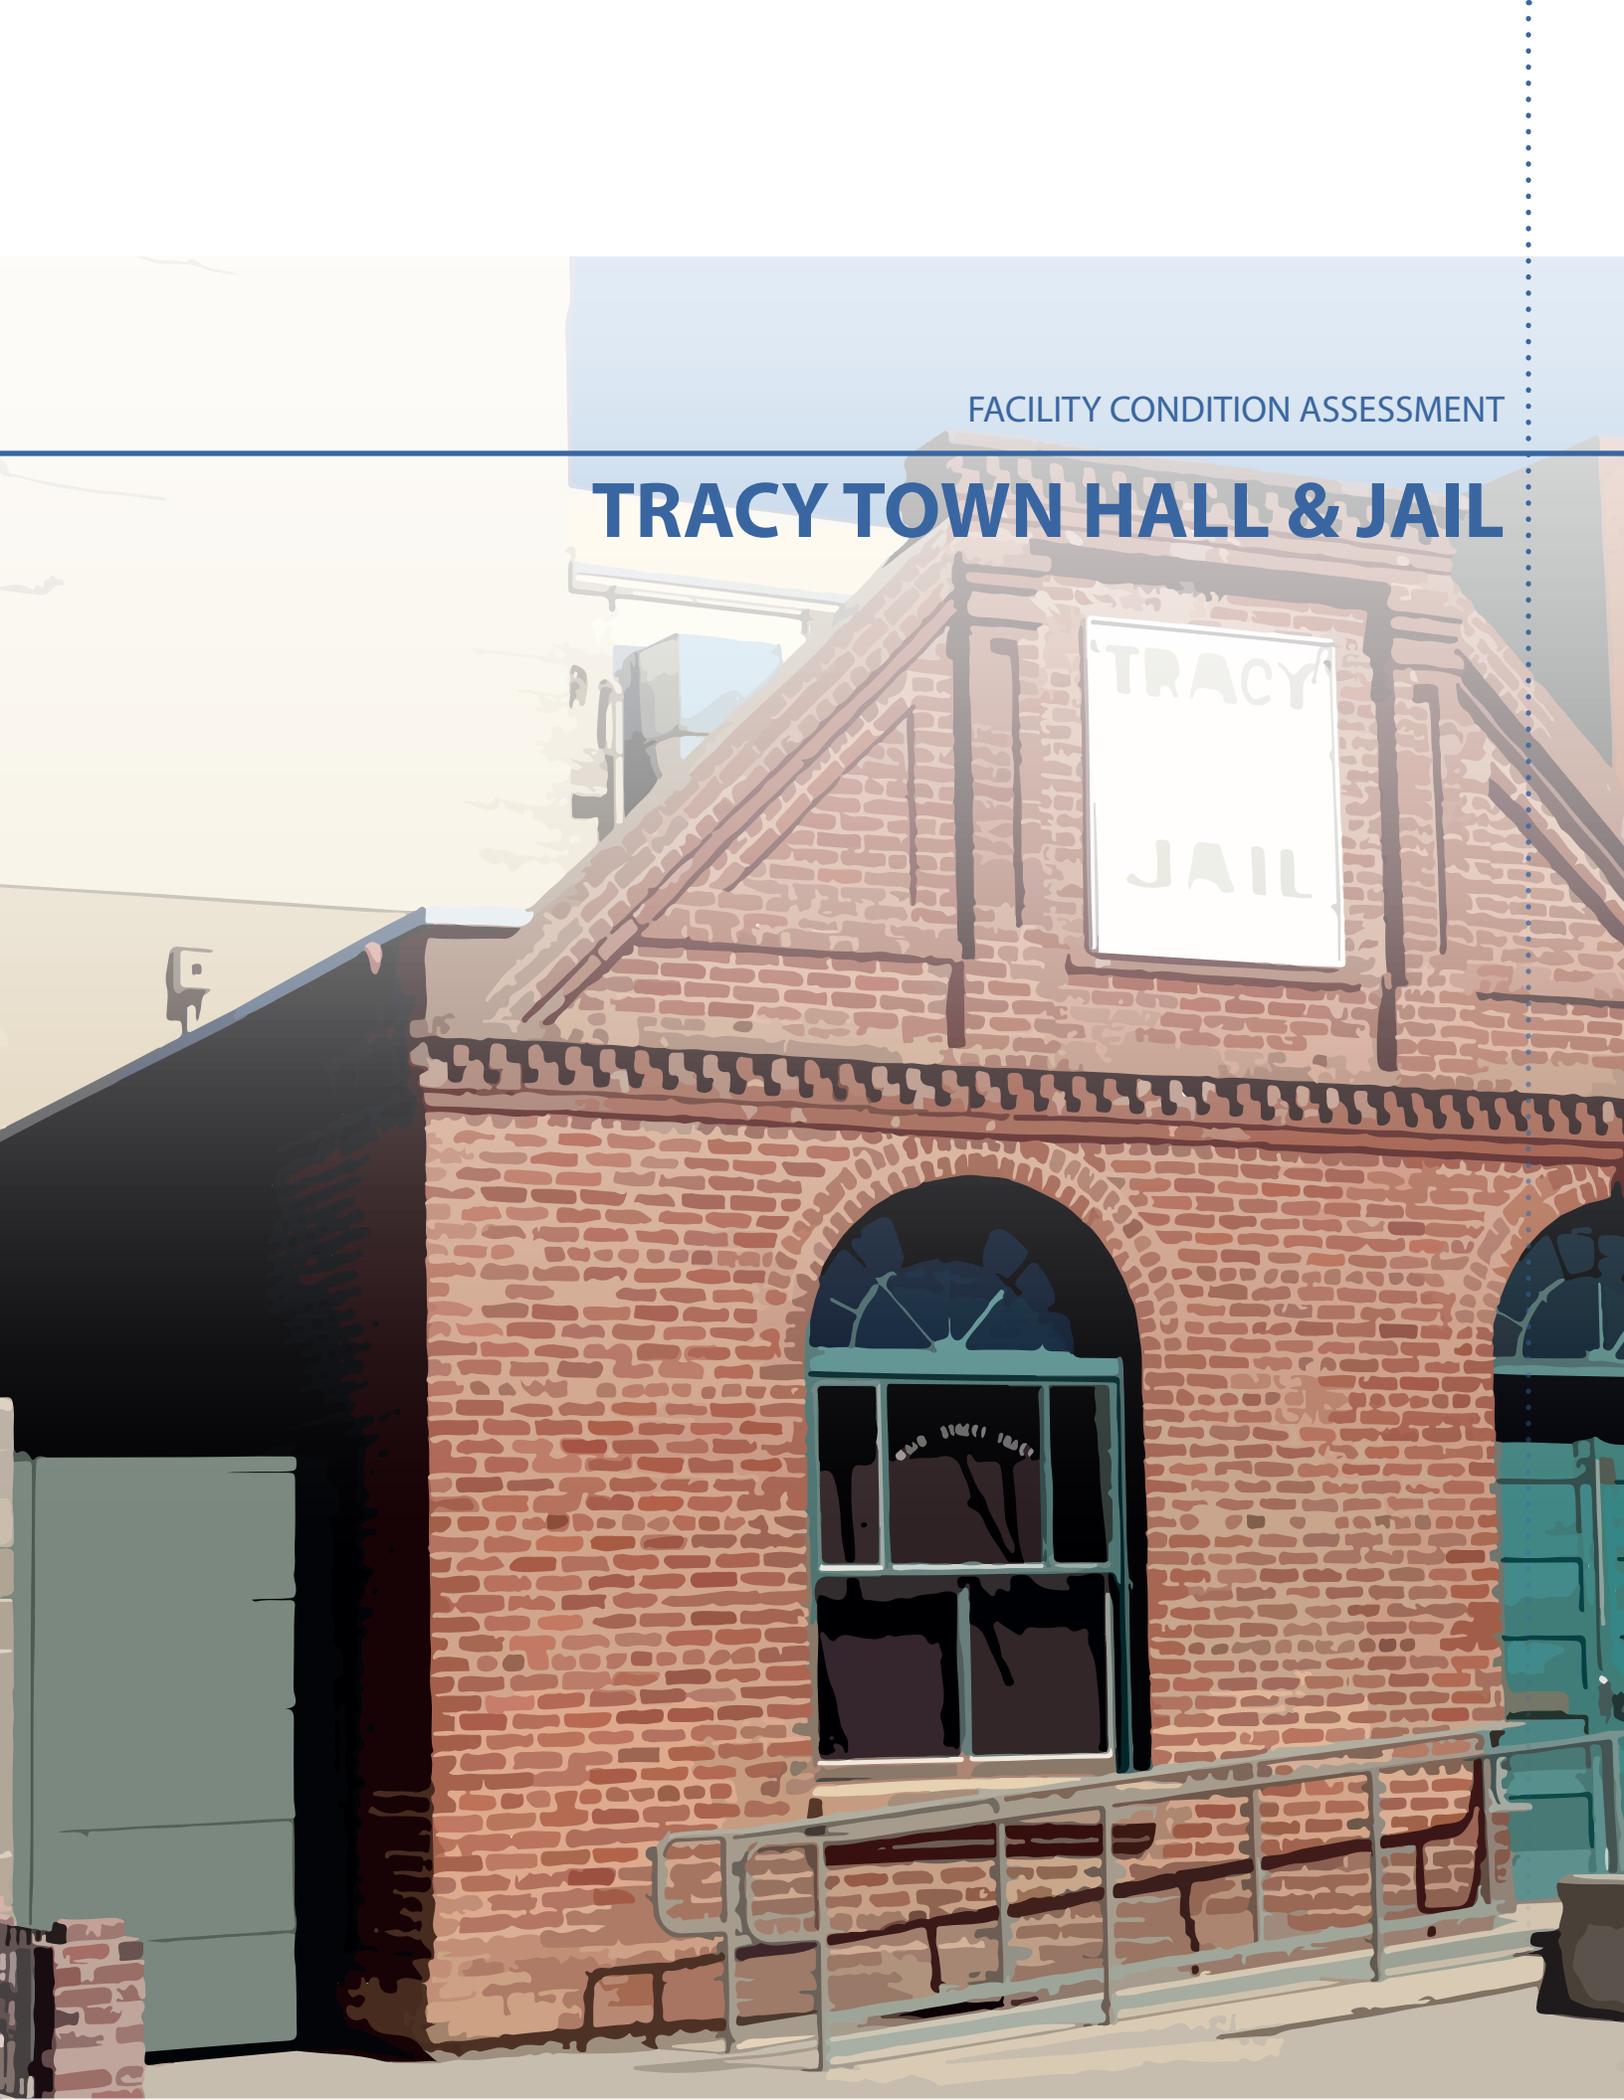
Condition Summary - Tracy Town Hall & Jail

Overall Rating 3.1

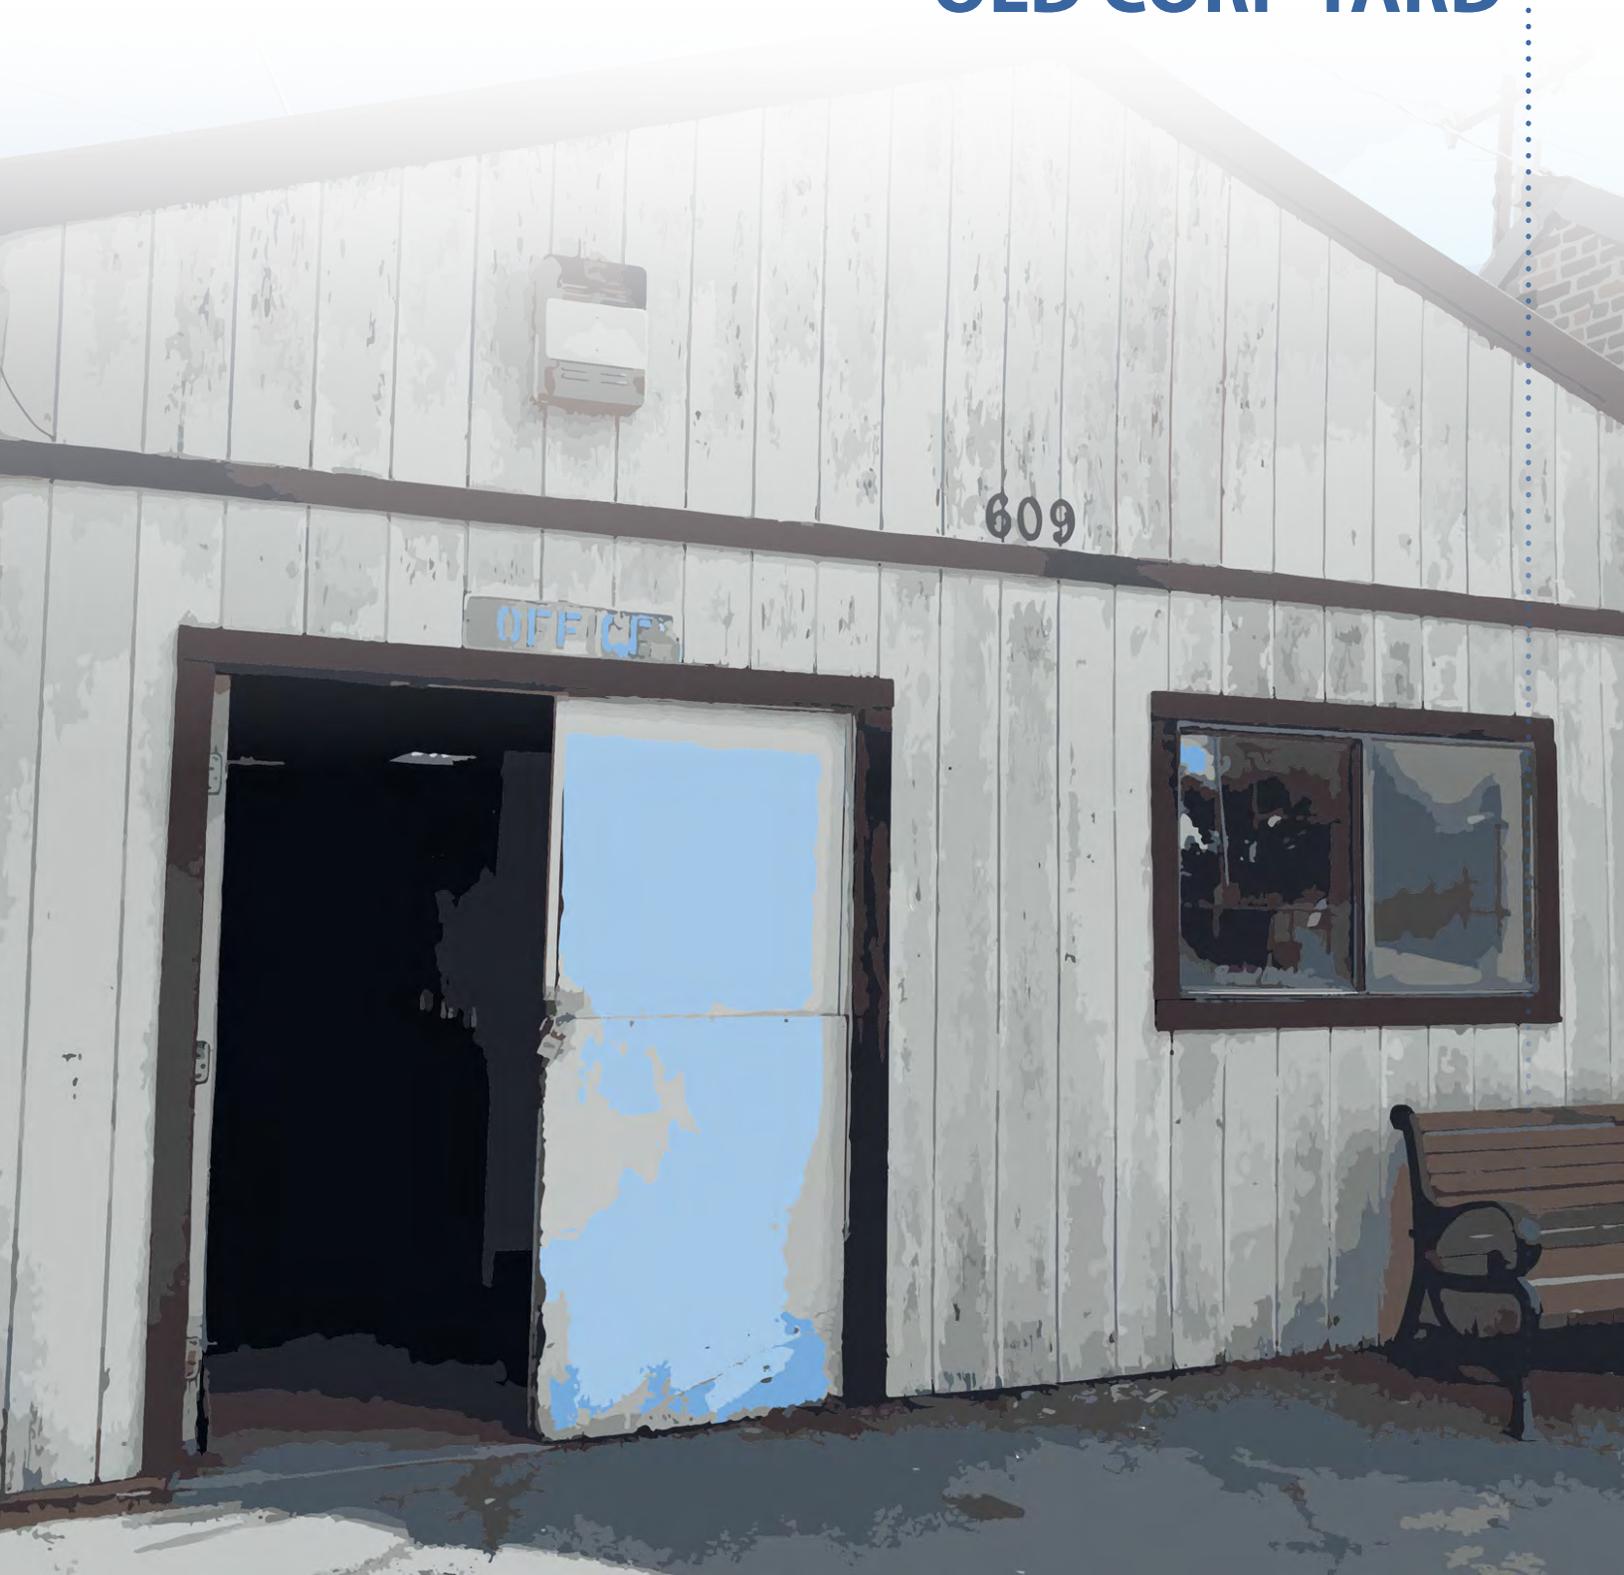
Condition Summary - Old Corp Yard

Overall Rating 2.5

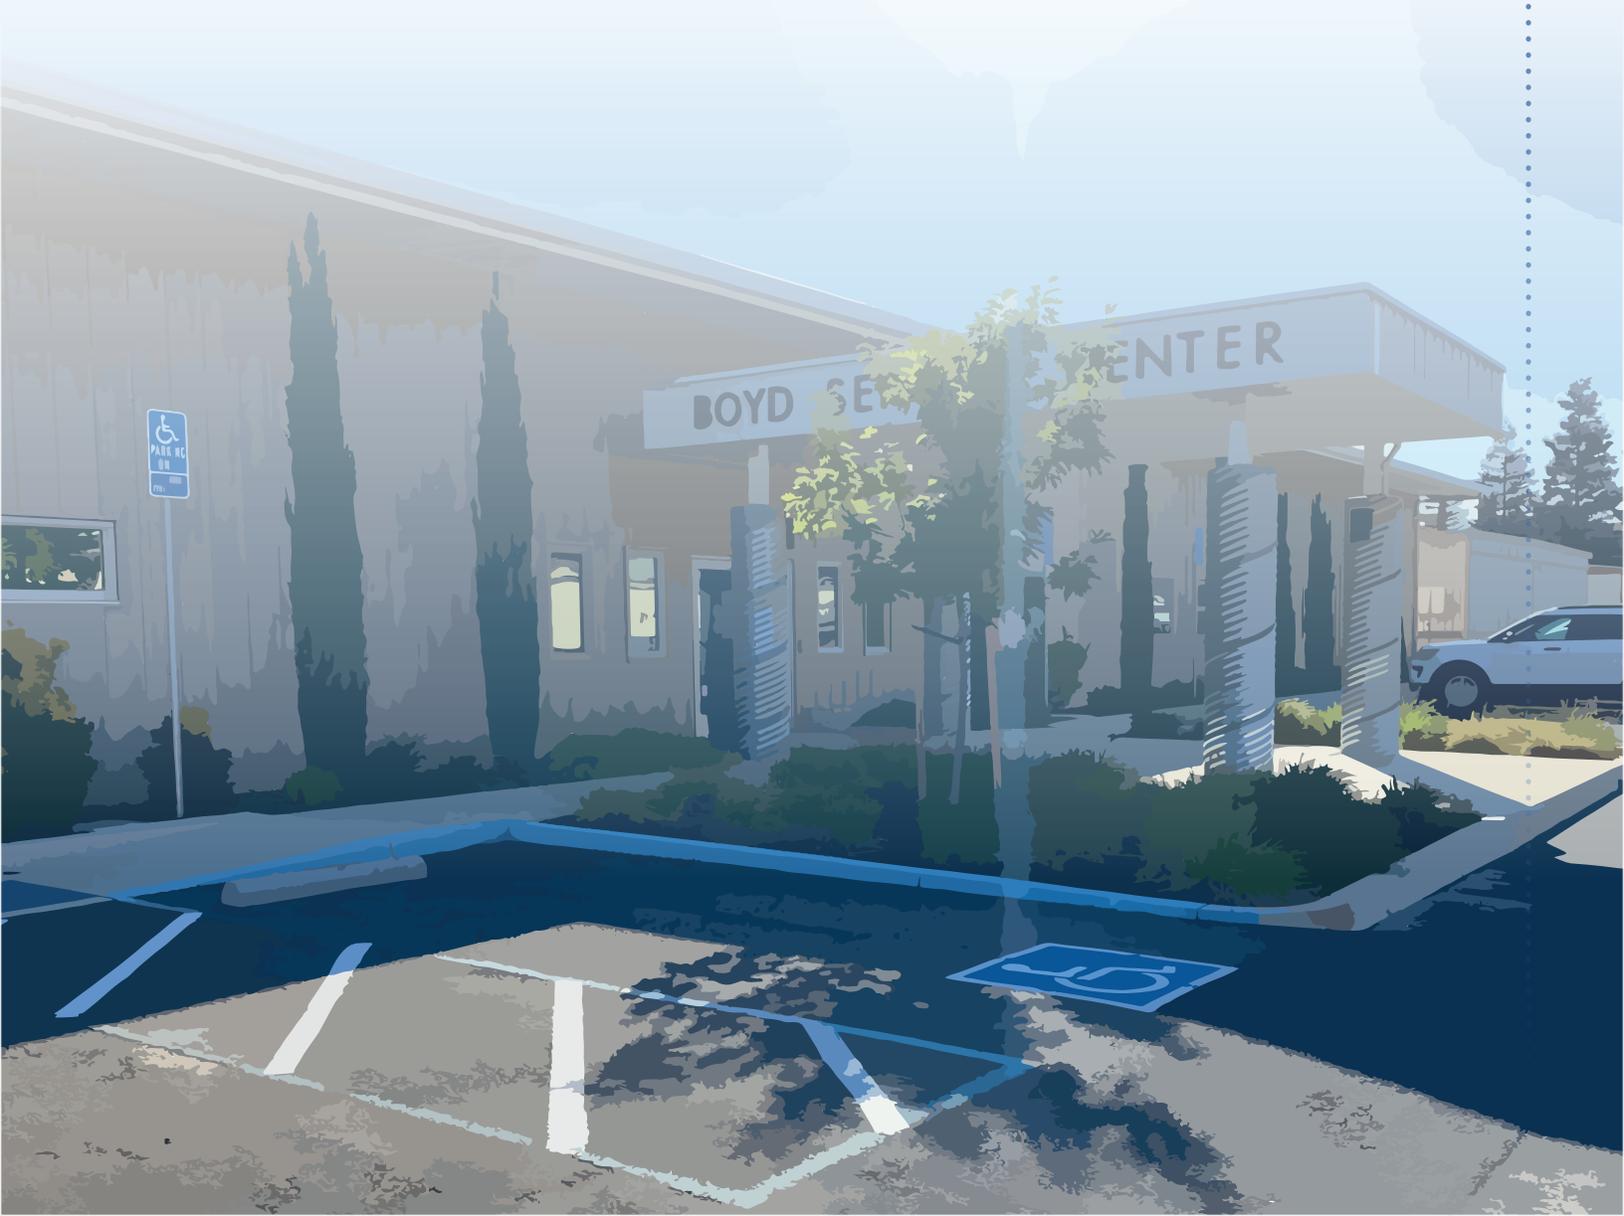
Condition Summary - Boyd Service Center

Overall Rating 3.5

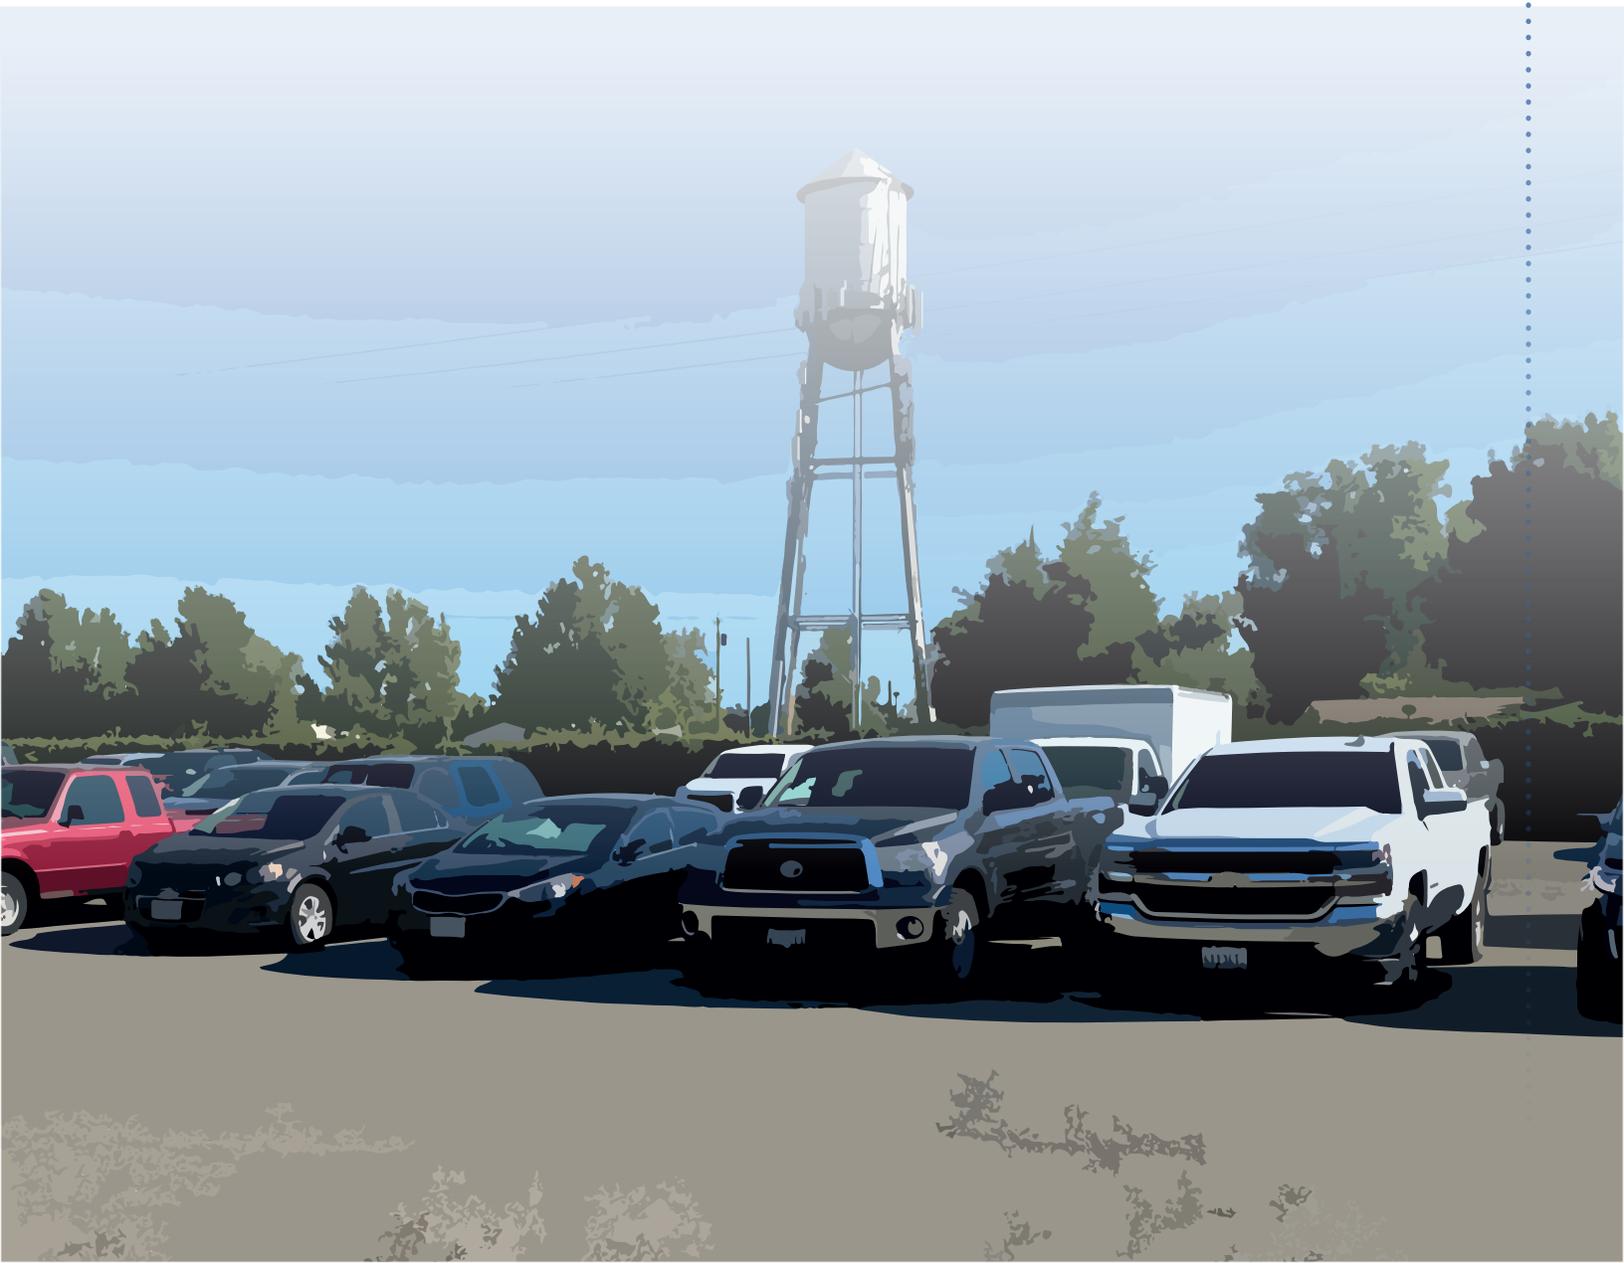
Condition Summary - Boyd Service Center

3.9
