CITY OF TRACY

CITYWIDE PUBLIC FACILITIES MASTER PLAN UPDATE

December 2023

II. FACILITY CONDITION ASSESSMENTS

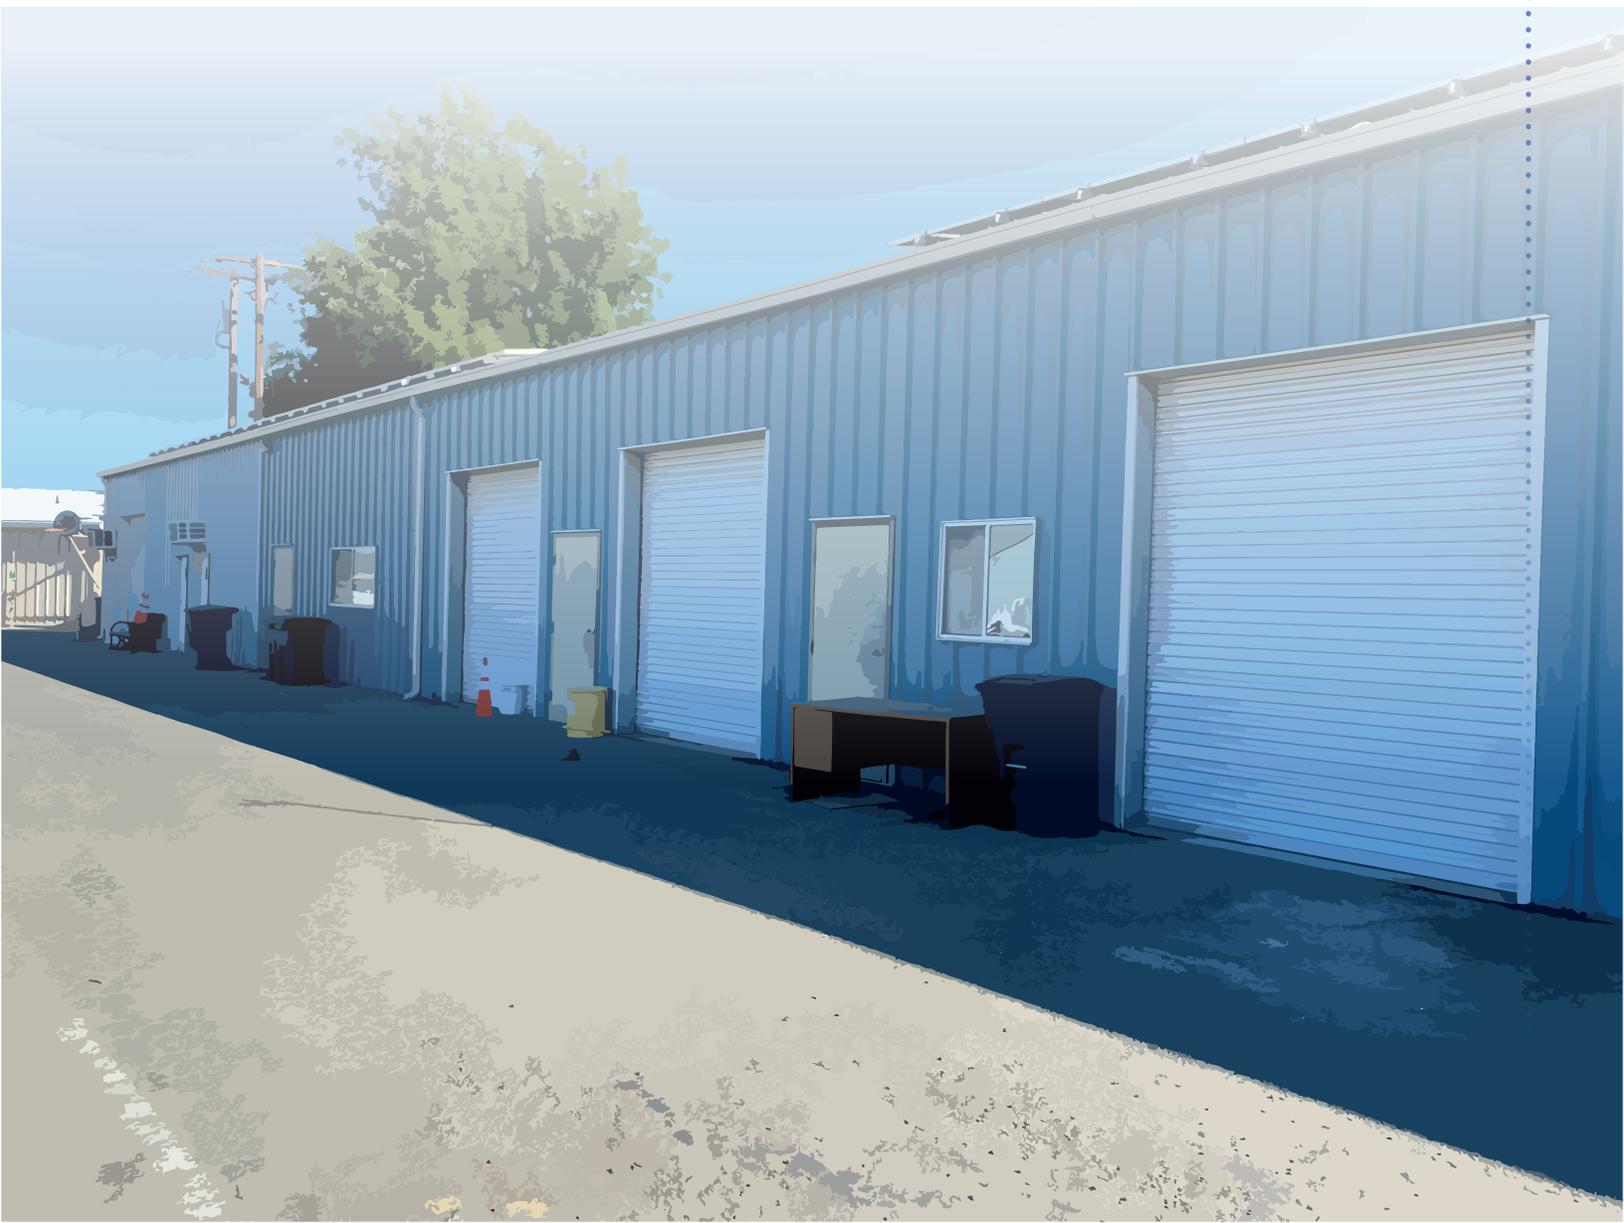
Condition Summary - Boyd Service Center

2.9

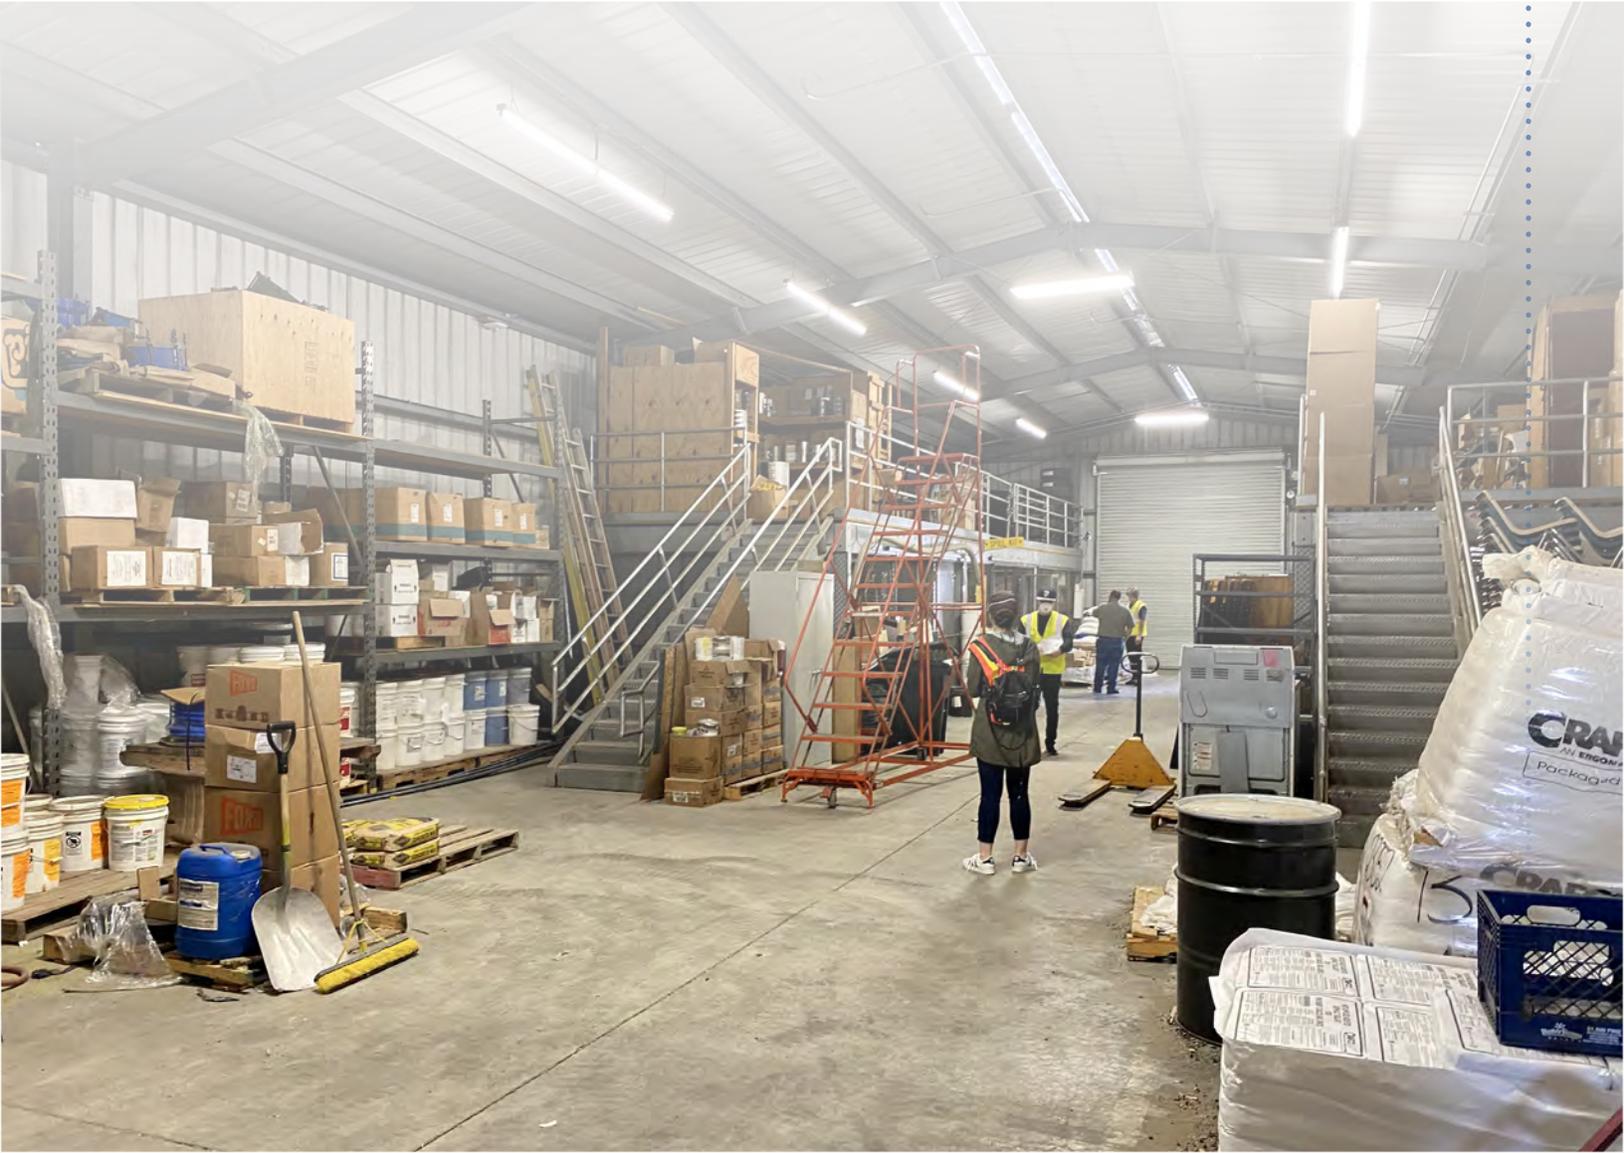
Condition Summary - Boyd Service Center

3.5

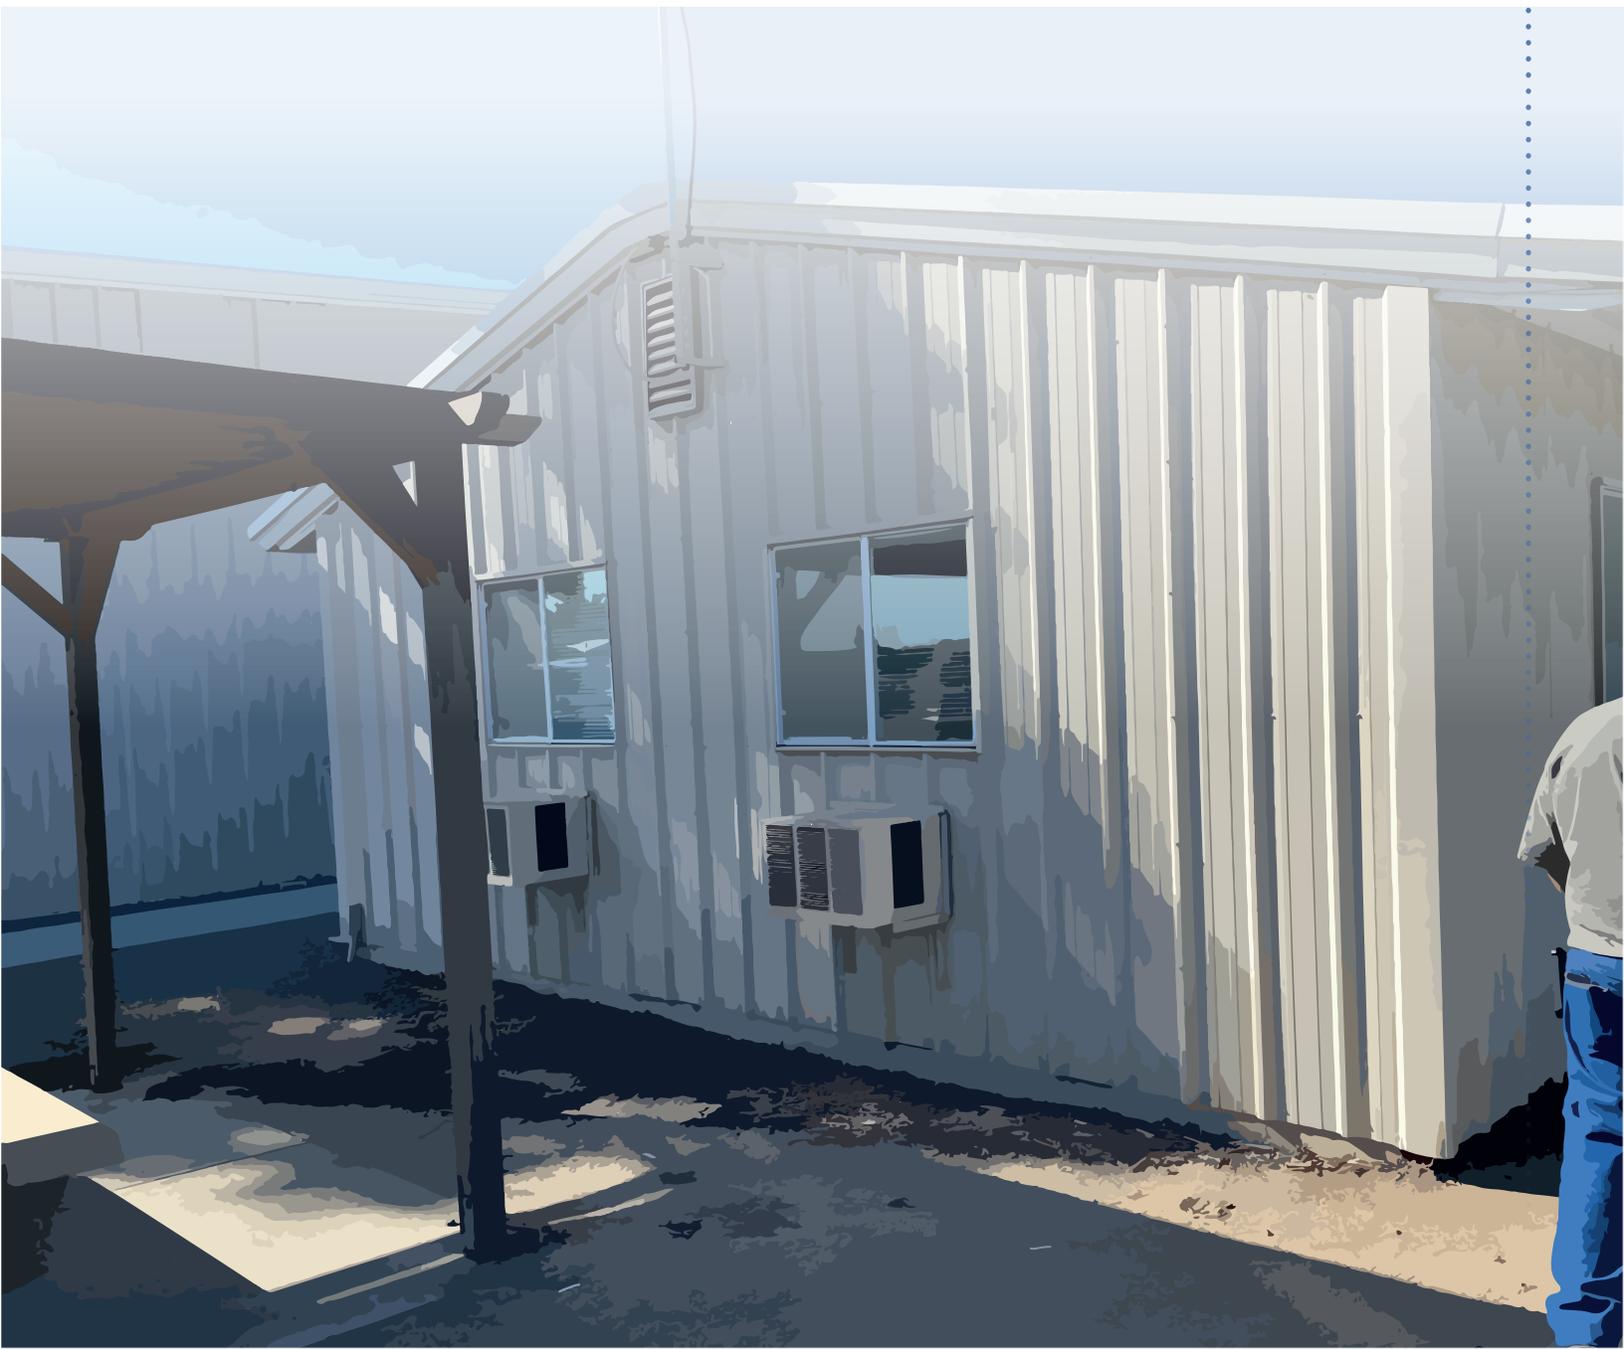
Condition Summary - Boyd Service Center

Overall Rating 3.5
