CITY OF TRACY

CITYWIDE PUBLIC FACILITIES MASTER PLAN UPDATE

December 2023

II. FACILITY CONDITION ASSESSMENTS

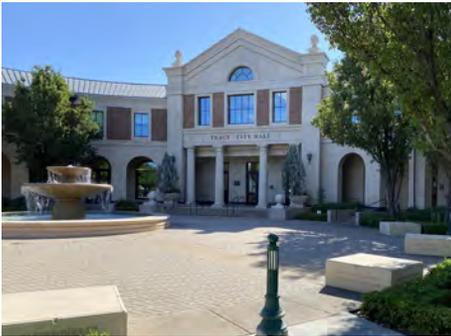
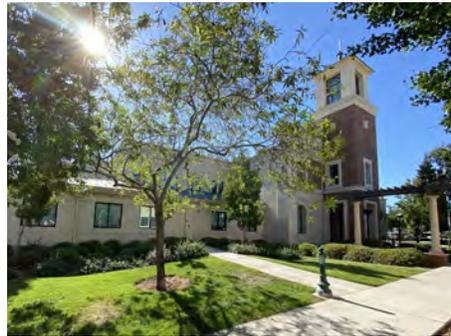
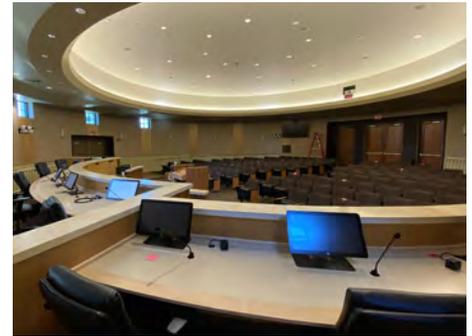
The structure is in good visible condition and shows signs of normal wear and tear. Minimal cracking was present at building base near foundation.

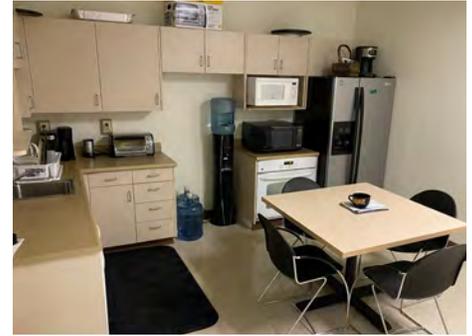
Interior

Wood door frames contain light splitting in areas and wooden window sills contain various levels of condition with some dry and deteriorating. Square carpet tiles and rolled carpet both hide stains well due to their dark color but don't give the interior a welcoming appearance and contain fraying and stains upon close inspection. Restroom floor tile is in fair condition with surface wear and staining present. Restroom surfaces generally contain out-of-date materials. A large scuff is present in floor length mirror in male restroom. Linoleum tile flooring in main building and trailer is in fair condition with much scratching and some chipping at seam areas. Rectangular acoustic ceiling tiles in main lobby and workspace area contain minimal signs of staining. Acoustic ceiling system grid of Support Services Trailer appears out of plumb in areas with tiles not placed properly and components protruding at odd angles. Gate separating reception from staff area is in poor condition with chipping at edges and discoloration at top due to frequent operation. Some staining is present at lighting lenses at Support Services Trailer.

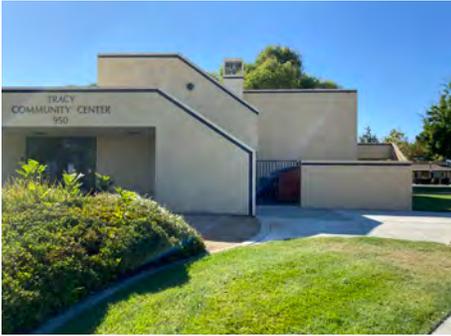
The exterior of building at electrical room is damaged at the door and exterior wall. TPO roof surface is in fair condition with no major signs of deterioration or surface uprising, but is stained with worn surfaces especially at areas of maintenance use and water ponding. Peaked metal roof portions are faded from sun damage and starting to rust at where lower edges of roofing panels meet flashing. Double entrance doors at lobby are in generally good condition with light scratching at paint. Roof access ladder is mounted securely to wall in table and chair storage area. Some rooftop elements including

exhaust fans contain rust. Roof drains are cracked. Windows are single pane and in good to fair condition with tinting that is not yet peeling but windows require cleaning. Exterior stucco is deteriorating at base of roof area and ground level and dirty areas under upper roof parapet.

Exterior Envelope: It is recommended to repair damage portions of wall and door, clean TPO roof surface at areas of maintenance use and water ponding, replace faded and rusting portions of peaked metal roof, clean rusted roof elements, repair roof drains, replace single paned windows, and repair exterior stucco at base of roof area and ground level.

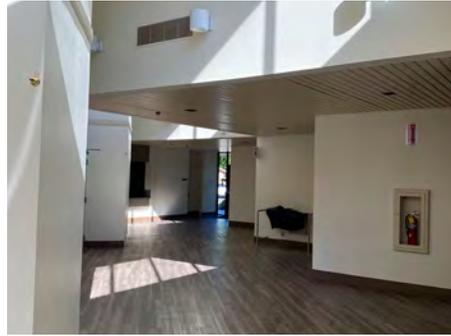
The main Community Hall is in good condition with recently renovated elements including flooring. Ceiling acoustic tile surfaces are in visually good condition. Flooring tiles are missing at entrances to some storage areas nears the main hall with exposed flooring adhesive present. Wall paint is scuffed and peeling in these storage areas. In general, storage area for chairs and tables is unfinished with damaged flooring, wall and ceiling elements. Concrete flooring in conference areas is in fair condition with moderate scuffing and cracking but shines nicely with no significant deterioration. Scratches on other wall surfaces are present. Acoustic ceiling tile is outdated and discolored in the main hall space. Kitchen equipment has served the facility well with signs of wear such a deteriorated stove top burners. Stained grout is present at ceramic tile flooring in kitchen. Metal ceiling system at lobby is in good condition with minimal signs of wear which include paint chipping at edges. Lobby baseboards are torn in a few places. Components of snack serving window and room are unfinished at interior. Restroom tile flooring is stained in high use areas.

Interior: Recommended actions include adding missing floor tiles at entrances to some storage areas, repainting walls in storage areas, generally renovating these areas to produce a more finished appearance, and fixing scratches on other wall surfaces. Additionally, recommendations include replacing acoustic ceiling tile, replacing stove top burners, cleaning grout at ceramic tile flooring in kitchen, repairing lobby baseboards, finishing components of snack serving window and room, and cleaning restroom tile flooring.

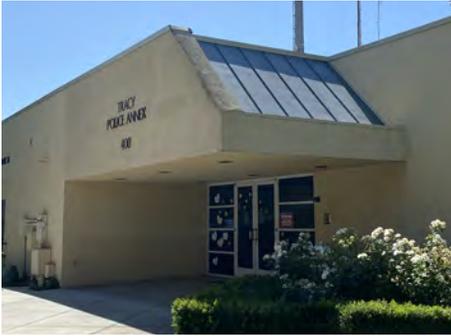
Painted concrete masonry exterior is faded and chipping in areas, especially where items are mounted on the exterior. Stucco is chipped and deteriorated in some areas. Mounted light fixtures contain discolored lenses and finish due to weathering and age. Exterior door sills contain no protection in many instances. Garage door opening to rear parking area is damaged with scratches and dents. Building signage is beginning to deteriorate and approaching its useful service life.

Exterior Envelope: It is recommended to repaint concrete masonry exterior, replace mounted light fixtures, provide protection for exterior door sills, replace garage door, and replace building signage.

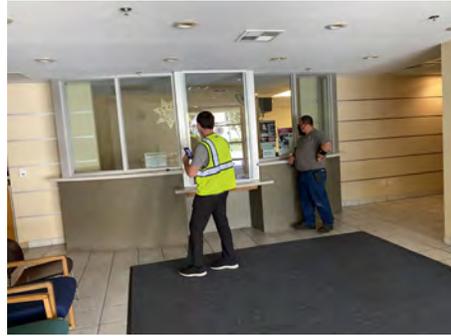
Lobby

investigation. Ceiling tiles are stained throughout the facility especially in conference areas. Wood doors have wear and are 20-min fire rated. Some door hinges have been replaced. Channel 26 room is somewhat crowded but in good condition overall. Carpeting is stained at the entrance to this area. Vinyl flooring in areas including kitchenette/break areas is scratched, bubbling, loose, or missing. At least one lighting fixture is hanging haphazardly below the ceiling system in kitchenette. Visible aspects of roof system are discolored and faded. Some restroom flooring tiles are cracked with stained grout. Lighting at public lobby near service center is severely lacking with standard incandescent bulbs in discolored and undersized recessed mounts. The roof was not accessible at the time of site visit.

Interior: Recommended actions include repairing and repainting metal doors in city jail space, adding lighting in same space, cleaning ceiling stains, and replacing ceiling tiles. In addition, carpeting should be cleaned, vinyl flooring should be replaced, lighting fixtures must be rehung, and lighting should be added in the public lobby with appropriate color and sizing.

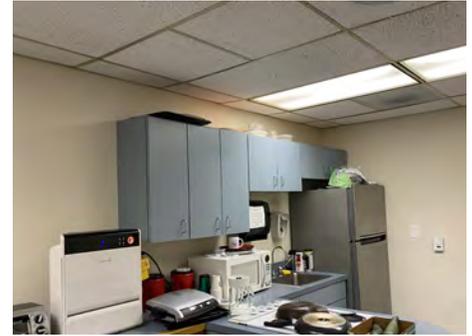
Break Room

Kitchenettes throughout the Police Annex are non-compliant due to lack of counter knee space and other items. Restroom accessories are non-compliant in some instances. Clear floor space in certain areas of the building is limited due to storage of items.

ADA Compliance: Recommendations include rebuilding kitchenettes to provide adequate knee space, relocating restroom accessories to be compliant, and clearing floor space to increase accessibility compliance.

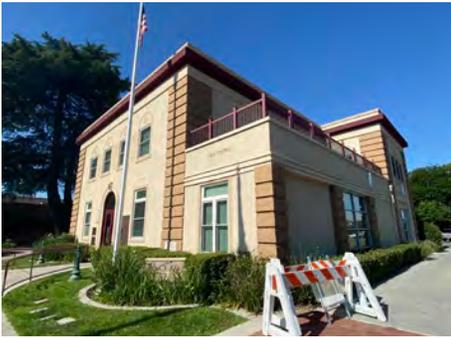
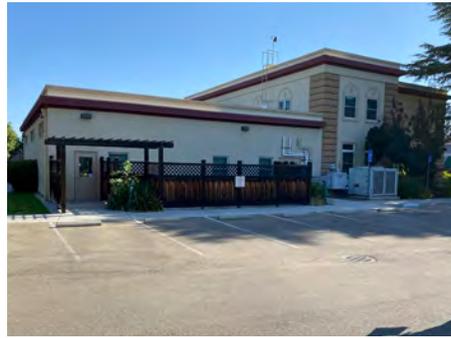
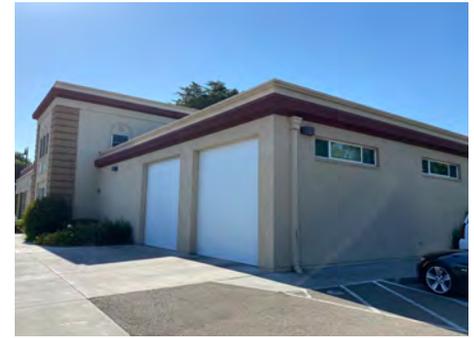
Condition Summary - Fire Administration

Overall Rating 3.8

Site elements are plenty and include parking, landscaping, site lighting similar to that used at the Civic Center and a flag pole. Sidewalks along central avenue include poured concrete and geometrically arranged masonry which adds to the facility's visual appearance. Railings near main public entrance contain worn and faded paint due to use and sun. Historical Tracy fireman statue is well-kept. Surrounding bench area would benefit from cleaning. Vegetation is healthy throughout. Sidewalk near main parking area is lightly discolored in areas. Parking lot paving contains stains but surface is not yet deteriorating at a quick rate. Parking lot striping is faded. Site signage is in good condition but dirty at exposed top surfaces. Wood fence near rear of building is weathered but in fairly good condition.

Painted stucco exterior siding contains much cracking, mostly near ground surface but all throughout stucco surface including areas of cracking to roof parapet. Paint of various architectural components gives the facility a premium appearance but paint is starting to fade from exterior surfaces at most areas. Mounted gutters are in good condition with minimal denting and lack chipped paint. Mounted light fixtures contain faded housing and are adding to staining at stucco siding. Metal door at rear of building to parking lot is stained with faded paint and accessibility signage. Porch at second story overlooking Central Avenue requires cleaning at floor surface due to dirt and debris buildup. Skylight lenses are slightly dirty but tinting is holding up well. Garage door surfaces show no signs of deterioration. TPO roof surface is in good condition but stained and discolored in areas

Cracking in stucco surfaces throughout exterior of facility suggests that shifting of the structure may be happening at a more frequent rate than is standard. Additional cracking is present at interior at interior CMU construction and at door frames of MEP room which alludes to stucco cracking being in the concrete wall structure rather than just stucco deterioration. Cracking is also present painted walls in garage area, especially around window. Large fire protection piping is appropriately braced to walls and ceiling structure. Cracking is present at concrete flooring of MEP area.

Carpeting and vinyl flooring surfaces of living area contain minimal signs of wear with light scuffs at kitchen floor. Can lighting is detaching at painted ceiling in living area. Paint is chipped at corners of walls in living area. Vinyl tile flooring is well-polished throughout main facility areas but staining is present at seams under drinking fountain and in a few other areas including near baseboards. Break room flooring contains excessive wear compared with the remainder of the facility's vinyl flooring. Painted wood baseboards are dirty and heavily scuffed. Rectangular acoustic ceiling tiles contain grid components that are out of plumb in areas. Restroom tile flooring and other surfaces are in good condition and holding up well to use. Lighting types vary throughout the facility but are generally a type of recessed rectangular fixture. These fixtures are in fair to good condition with some lenses loose or discolored. A large stain is present on a singular acoustic ceiling tile near office spaces by public entrance and reception. Some wear is present at wooden gate

Weathering protection for piping to exterior boiler is missing at corner bend near rear entrance. Insulation for some piping components in MEP room is stained at multiple areas. Water piping is located over electrical equipment which violates the building code. Elevator components contain very minimal visual signs of wear, and interior cab components appear freshly installed. A rear garage area houses most of the facility's electrical components including main electrical switchboards, power maintaining system. The facility contains two State water heaters installed in 2005, likely with a moderate amount of remaining useful service life (3-5 years). Air handler and ductwork is in good condition.

Clear floor space is lacking in some areas due to stored items. Handrails for interior stairs were added to be made compliant. Elements of break areas in living space and main facility are non-compliant.

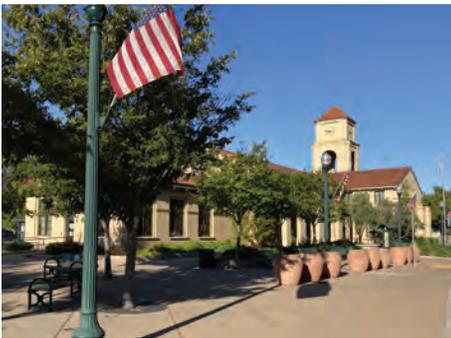
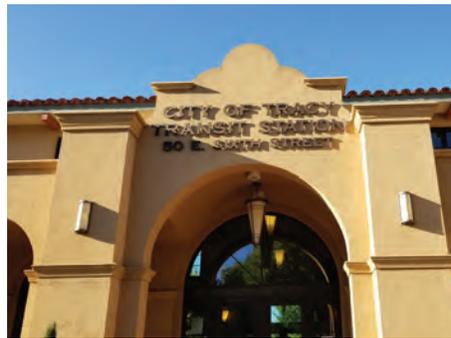
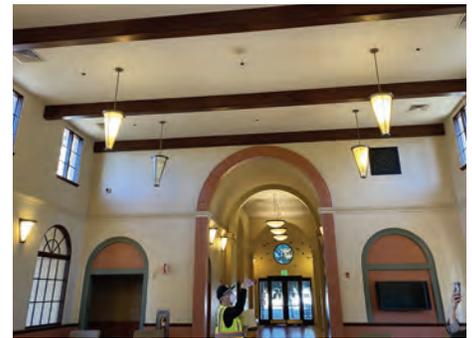
Site signage and supports are in good condition. Parking pavement is cracked in many places with faded striping at both accessible and standard spaces. Concrete tile at site adds to the appearance but is cracked and dirty in high traffic areas. Landscaping serves the facility fairly but would benefit from improvement. Vandalism is present at landscaping planters and site elements. Paint is chipping from site garbage receptacles.

Exterior window frames contain chipping paint in multiple areas. Water marks are present below window sills at the exterior of the facility. Minor cracking has been observed at exterior wall structure. Clay tile flooring adjacent to exterior entrances is generally in good condition but dirty. Clay roof tiles are in good condition overall but some contain chipping. Exterior doors and hardware are past useful service life with lots of scuffs and scratches present. Roof drains at access platform require replacement.

Minimal cracking is present at interior tile flooring in lobby. No structural cracking was observed at walls. Roof structure is in sound condition as observed visually. Minimal cracking is present at exterior finishes. Roof structure contains cracking at parapets.

Floor tile is cracked in places at the facility's interior including at the lobby. Other flooring elements are worn beyond standard service life including vinyl flooring in storage areas and carpeting in office areas. Velvet transition strips make audible cracking noise when walking over and may not be secure in places. Acoustic ceiling tile is in fair condition overall but multiple water marks were observed in office areas, hinting at the presence of plumbing system leakage. Leaks are present on ceiling system above the all-gender restroom in the office area. A movable partition exists between rooms 103 and 104. Restroom finishes are slightly outdated but otherwise holding up well.

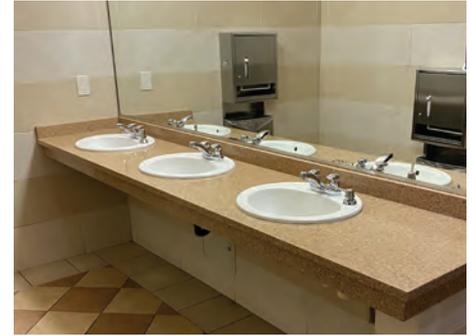
Bathroom

Evidence of plumbing system leaks are shown by damaged ceiling tiles and toilets are showing leakage at bases. Water piping is present over electrical equipment in Room 109, a code violation. HVAC system requires upgrade and renovation to meet needs. Mechanical equipment is largely located on a platform near the clock tower. Roof mounted A/C units serve the conference room area. An 800 Amp main switchboard serves the facility well and located in the same area with fire alarm and Internet server equipment.

MEP Systems: Improvements should include repairing plumbing system leaks within ceiling system, relocating water piping in Room 109 and renovating the HVAC system to meet needs.

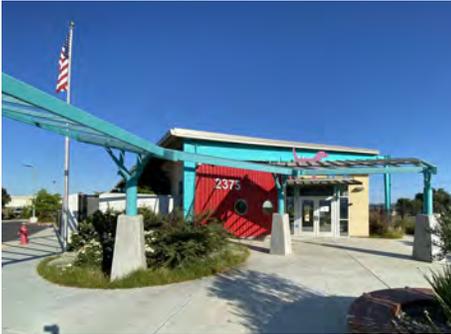
Exterior

The exterior of the Animal Shelter is in good condition overall. Multiple components are used for exterior façade elements and are holding up well. Some discoloration on exterior wall surfaces is present. Light cracking is present at top of exterior concrete security wall.

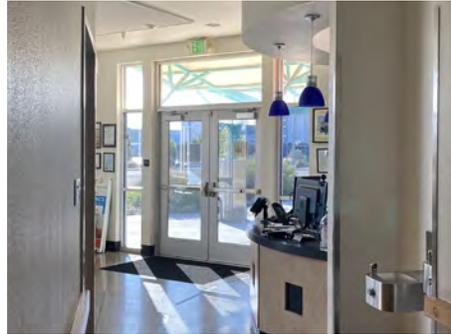
Lobby

Single door in lobby sometimes sticks and will not remain open or closed. Double doors in lobby area don't shut properly and requires significant effort to close and lock. The ground latch in this location requires maintenance and servicing. Stone flooring in lobby is in good condition. Concrete flooring is cracking in places in animal housing area. Terrazzo flooring around reception desk has slight wear. Guillotine doors break often at animal housing area and require frequent maintenance to pulley operation system. Flooring in laundry area is dirty and worn with rusting around laundry drainage. Grooming area flooring requires cleaning and holding area flooring is scratched. Window seats have come loose in multiple areas. Floor drainage in animal cleaning areas is in good condition. Attic contains no roof access. Sink wood is worn in "CAT ISO" area.

Interior: Interior spaces would benefit from repairing lobby single door to remain open and closed, replacing locking system on double doors in lobby, servicing the ground latch in lobby, and repairing cracks in concrete flooring in animal housing area. Additionally, it is recommended to replace guillotine doors, replace flooring in the laundry area, clean holding area flooring, tighten window seals, provide roof access for attic, and replace sink counter carpentry in "CAT ISO" area.

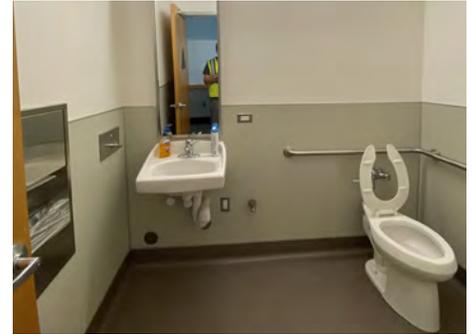
Bathroom

Light cracking is present at soffit of women's restroom. Equipment attachment and supports for laundry machines are not being utilized. Ductwork and cabling above ceiling appears to be appropriately braced.

Various elements of animal intake and housing operations aren't ADA compliant. Restrooms contain minor fixtures violations.

Structure: It is recommended to repair cracking at soffit of women's restroom and utilize non-structural seismic hold downs for laundry machines.

ADA Compliance: It is recommended to reconfigure various elements of animal intake and housing operations areas to be made compliant. Minor changes to restroom fixtures are required.

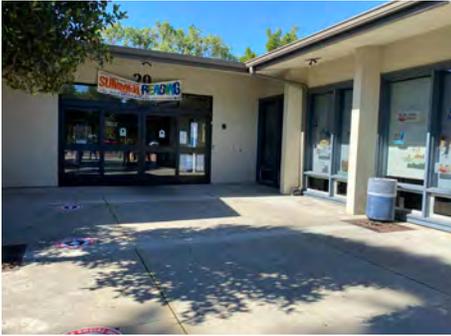
Exterior Envelope: It is recommended to clean masonry surface, repair light cracking at roof connections to eaves, properly attach gutter, and add a downspout at the rear of the building.

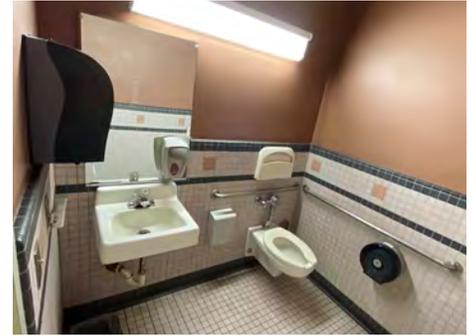
Bathroom

Interior: Improvements should include cleaning some ceiling tiles, cleaning carpeted flooring throughout the building, replacing restroom tile flooring, replacing restroom sinks and repairing the leakage under restroom sinks.

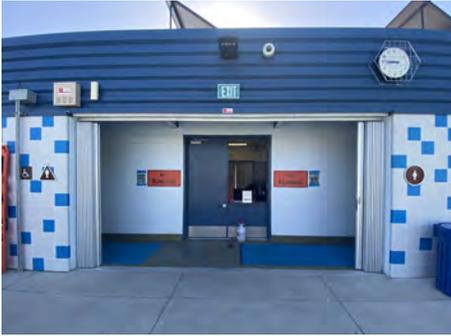
Exterior tile wall finish is slightly stained at tile in areas but grout is holding up well and only discolored at areas where other items are mounted on the wall. Roof drainage includes gutters that are exposed only at the exterior fascia and are clogged with leaves in areas. Metal fascia at top of exterior walls is discolored with a finish and paint that is beginning to deteriorate at joints and flat surfaces. Exterior entrance to locker room doors are folding and aluminum and show no signs of wear. Signage is in good condition and serves the facility well, but requires substantial cleaning. Exterior windows are present at a small number of areas including the food service window at the kitchen.

Exterior Envelope: It is recommended to clean out gutters and to paint metal fascia and re-grout some exterior tile.

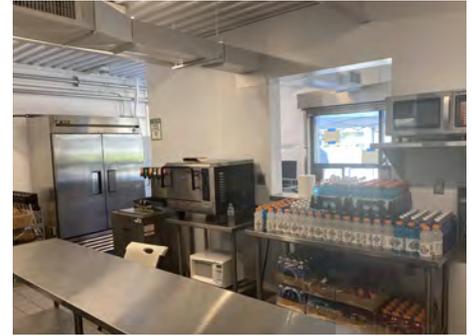
Interior lighting is in good condition and largely LED tube lighting throughout. Brown tile flooring in kitchen area has stained grout in the center of the kitchen and in areas under heavy-use appliances. Ceiling kitchen is exposed corrugated metal with a clean painted finish. Kitchen appliances are largely stainless steel and contain significant remaining useful service life. Smooth wall finished in kitchen appears freshly painted with no cracking or staining. Locker room walls are finished in similar painted concrete blocks as pump room but are more stained and discolored at both block surfaces and grout. Ceiling systems in this location are similar to the kitchen but discolored and stained in areas likely due to moisture buildup from shower steam. Restrooms are finished in stainless steel and serve the facility well under heavy use. Epoxied flooring in restrooms and locker rooms is in good condition with minimal surface wear. Tile wainscot is similarly maintained with minimal staining. Roll up metal doors in lock room areas are well-maintained with no obvious visual signs of deterioration. Shower walls and flooring are finished in tile that appears to be holding up well. Minimal staining is present at shower floor tile and grout which is to be expected. The interior of locker rooms and showers has an area under the roof that is fully exposed to the outdoors, which greatly increases ventilation with no effect on privacy.

Interior: Recommendations include replacing tiling at kitchen flooring, repainting concrete blocks and grout in locker room walls and updating lighting system at reception.

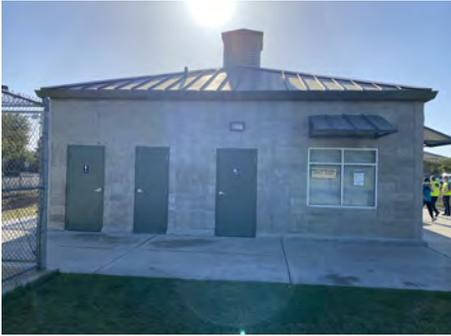
<p>Site 3.1</p> <p>Parking asphalt for the Tracy Sports Complex is stained and beginning to deteriorate. Striping and other pavement markings are faded and lacking in areas. Curb paint is in poor condition at curb bases and mostly scraped off from curbing. Small grass patch areas directly adjacent to the facility are dry in spots and also contain areas of no vegetation. Sidewalk adjacent to parking lot at street side has some significant cracking in areas. Black painted surface at short gate adjacent to the facility is discolored with rusting visible especially at the base and is also significantly damaged.</p>	<p>Structure 2.6</p> <p>Minimal cracking was visible at some CMU blocks at the interior. Some moderate cracking is present at the base of foundation around building which suggests a shifting structure.</p>
<p>Exterior Envelope 3.3</p> <p>Roof surface is in good condition but requires cleaning due to dirt and grime buildup. Awning have similar dirt buildup especially at areas near roof eaves. Concrete block siding is in fair condition with spotted chipping and cracking at all sides. Staining is also present at exterior siding. Aluminum entrance doors are in good condition with much remaining service life but lock sets are dirty and contain fading green paint and rusted hinges. Exterior-mounted lighting fixtures contain discolored housings and overly yellowed lenses. Aluminum window frames are discolored and worn. Gutter paint finish is fading but no major denting or attachment issues were observed besides cracked material leading gutter ends into grand drains. Sealants at door thresholds at main restrooms and generally around the building are cracked and deteriorating. Awning surfaces are worn on the undersides.</p>	<p>Interior 3.8</p> <p>Interior vinyl tile flooring is nearing the end of its useful service life with lots of scuffing and discoloration throughout. Interior doors have worn surfaces. Ceiling system is in poor condition with acoustic tiles that are plumb and not yet discolored with signs of staining in utility closet. Light fixture housings are slightly discolored and stained in places. Interior CMU walls are discolored and would benefit from a repainting. Baseboard is not properly attached in places.</p>

Site: Recommendations include repairing parking asphalt, repainting the striping, pavement markings and curb paint, re-seeding the grass, repairing the sidewalk adjacent to the parking lot, and repairing the black painted surface at short gate.

Exterior Envelope: It is recommended to clean the roof surface, fix small cracks and paint chipping, clean exterior siding, replace lock sets of aluminum entrance doors, and replace exterior-mounted lighting fixtures. Other recommended actions include resealing sealants at door thresholds at main restrooms and replacing awning surfaces.

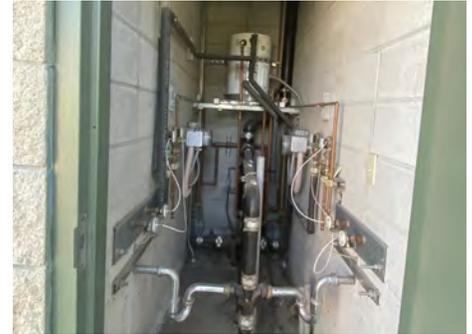
<p>MEP Systems 3.7</p> <p>Plumbing for restrooms and the remainder of the facility is accessed via a small exterior room and is in good condition. Housing for exterior A/C unit is smashed and is rusting through areas of chipping paint. Electrical switchboards serving the facility contain appropriate capacity for the fields' significant amount of sports lighting.</p>
	<p>ADA Compliance Needs Compliance</p> <p>Main restroom fixtures are largely non-compliant including toilet flush button. However, ADA compliant restrooms are located with exterior access at the rear of the facility adjacent to the fields. Accessibility signage at parking lot asphalt surface is worn beyond recognition.</p>

MEP Systems: It is recommended to replace the housing for exterior A/C unit.

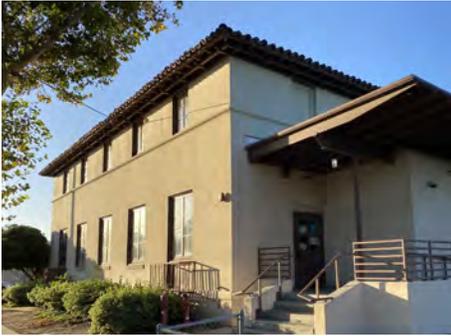
Painted concrete exterior envelope is generally in fair condition with surface discoloration in areas and light cracking present. Paint chipping is present in window frames. Exterior lighting fixtures are outdated and dirty due to cobwebs and other debris. Stucco at exterior and stair siding requires intensive cleaning and in some cases new paint. Roof parapet is not flush in places and some clay roof tiles are loose, chipped or missing. The underside of the roof overhand requires new paint. Roof surface itself requires intensive cleaning and new sealant in areas. Skylight windows are single pane and serviceable from roof and contain rusted frames. Drainage elements are rusted and clogging evidence and ponding water are both present around drains. Entrance door at rear near parking lot requires replacement. Main entrance doors require replacement or new paint. Decorative window balconies are rusted in places and require new paint at minimum. Single pane windows are

Exterior Envelope: It is recommended to clean and paint exterior surface where discoloration and cracking is present. It is also recommended to repaint window frames and repair damage at roof.

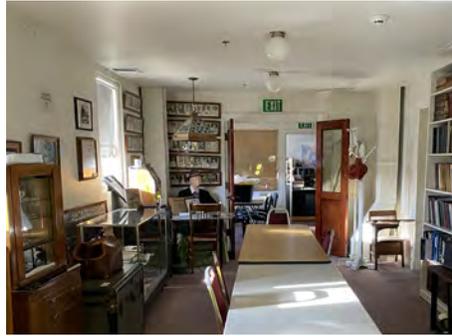
Interior

Stains and discoloration on suspended ceiling tiles suggest leakage from the second floor. Tiling throughout museum is in good condition with signs of wear and discoloration. Wood flooring throughout main level of interior is scuffed, scratched and contains misaligned floorboards in places. Tile flooring near Holly Sugar display requires cleaning. Carpeting at second floor is in good condition but transition strips and tile grout around these areas require replacement. Elevator is in serviceable condition with remaining service life but sills require intensive cleaning. Finished in restrooms are in good condition.

Interior: Improvements should include replacing stained ceiling tiles and repairing and cleaning wood flooring.

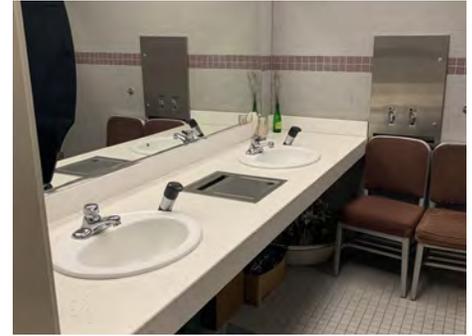
Bathroom

HVAC systems are in good condition. Leaking from restroom upstairs restroom should be repaired. Rooftop HVAC equipment is nearing the end of its useful service life and would benefit from replacement. Water lines going to AC units are rusted. Fire water access is provided on-site but access valves require painting and new signage due to rust and paint deterioration. Exit signage is required to be illuminated.

MEP Systems: Recommended actions include fixing leakage from second floor restroom.

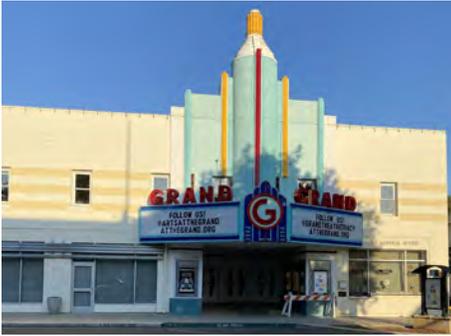
The downtown area site serves the facility well. Some cracking is present at exterior site curbing and cracks at pavement exist throughout. Sidewalk surrounding the facility is finished in large tiles that are in good condition with minimal signs of staining or wear. The alleyway used for deliveries and production access contains surface paving in poor condition.

Skylights are in poor condition due to failed seals and gaskets, but replacement is planned in a current capital improvement project. As part of the roof and skylights replacement project, interior soffit components will be investigated and repaired as required. Exterior paint is faded at downtown facing ones. Exterior signage is in fair condition but would benefit from modernization. Aluminum framed windows are present at the exterior. Exterior overhang near corner entrance has minimal signs of cracking. Exterior siding is constructed out of various materials due to the facility's long standing construction history and incorporation of surrounding buildings. Exterior lighting is generally lacking and outdated especially in places such as the roof parapet. Large metal door with access to and from the alley area is rusted and damaged at base. Rusted track fixings and components are present along with deteriorated rubber at the frame and track guides. Repair of exterior wall cracks and exterior painting is included as a current CIP item.

Site: Recommendations include repairing cracking at exterior site curbing, and re-surfacing alleyway.

Exterior Envelope: It is recommended to modernize exterior signage, add exterior lighting, and replace the large metal door at the alley area including track components.

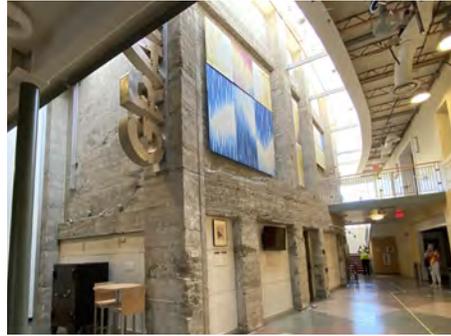
Interior acoustic ceiling tiles are lightly stained with grids askew in some office areas. Lobby concrete flooring is in especially good condition with sealant providing a nice sheen. Carpeting in various areas of the building is lightly worn with service life remaining. Lighting fixtures vary considerably throughout the building's interior. Some are historic fixtures original to the building's construction and largely in restored condition. Paint throughout the interior varies in color and finish but serves the facility well. Some staining present at finish of second floor balcony visible from ground floor lobby. Wood flooring in the Dance Studio has a gloss finish applied annually and the central area of flooring is textured. Cracks are present at mirror panels at Dance Studio walls near areas where support bars are attached. Red velvet seats at the Historic Grand View Theatre are worn in multiple areas including seat cushions, seat backs and arm rests. Yellow paint on stair treads to orchestra pit area is fading. Some sound deadening material at the stage area is coming loose from wall attachment points. Carpeting in theater area is lightly worn. Flooring at Black Box theater is scuffed and contains a dull finish. Restroom VCT tile flooring is discolored and warped. Some staining on ceiling is present near ADA shower in restroom area. Temporary repairs to ceiling system in Gallery Workroom are visible and involve taped ceiling tiles. Grout in tile flooring in art

store is stained in high traffic areas. Tile Restroom Floor at 2nd story contains stained grout. A significant crack exists from the Art Gallery to the Dance Studio in decorative flooring, and the same anomaly occurs at the main lobby near the foyer.

Handrails throughout the lobby are non-compliant due to very minor dimensional violations. Truncated domes at the entrance to the facility are present at the downtown area leading to other areas of downtown. Some work areas are non-compliant due to storage spaces covering open floor space area.

Interior: Recommended actions include realigning ceiling tiles, replacing worn seats at the theater, reapplying sound deadening material at the stage area, maintaining the Studio Theater accordingly, replacing VCT tile in restroom, replacing ceiling tiles in Gallery Workroom and cleaning grout in tile flooring in the art store and restroom floor at the 2nd story.

ADA Compliance: Recommendations include making minor dimensional fixes to handrails throughout the lobby and clearing floor spaces in work areas.

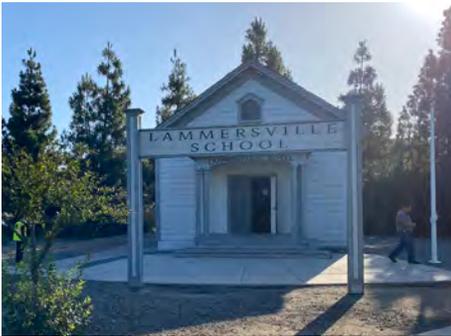
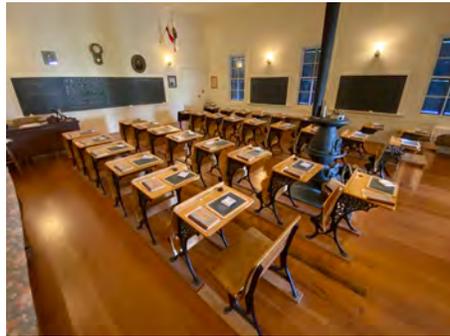
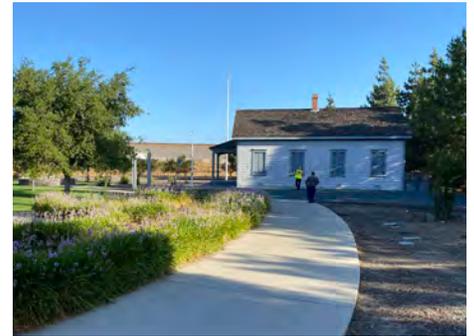
<p>Site 2.6</p> <p>No parking to the Lammersville School is provided. Canopy posts at exterior sign contain rot at bases on both sides and paint is flaking from signage. Ground cover directly adjacent to the building consists of dirt and dry tan bark and would benefit from some renovation. Sidewalks contain minimal cracking.</p>	<p>Interior 3.5</p> <p>Wood flooring at entrance (high traffic area) is scuffed and discolored. Historical elements showing the history of Lammersville School are largely present. The ceiling is finished in plaster and painted white. All lighting is wall mounted. Single pane vertically-sliding windows are found throughout.</p>
<p>Exterior Envelope 2.3</p> <p>Wooden floorboards at porch and ramp are cracked and deteriorating in places. Evidence of wood rot is present at some areas along with excessive paint chipping on wooden boards and building wood siding. Wood paneling is missing at door frame base. The building requires complete repainting. Roof shingles are in poor condition and showing various levels of separation from roof surface and membrane. Gutters and downspouts are not provided.</p>	<p>MEP Systems 3.7</p> <p>There is no restroom in the building. Electrical needs are met in the current use scenario.</p>

<p>Structure 3.1</p> <p>Slight cracking at concrete surrounding foundation is present. Wood rot concerns exist. No other visible structural issues were observed.</p>	<p>ADA Compliance Needs Compliance</p> <p>The facility is largely non-compliant due to lack of handrails at stairs and furniture that restricts path of travel. Mounting heights for interior accessories require adjustment. Wood ramp at rear of building appears to be ADA compliant but handrails require minor modification.</p>

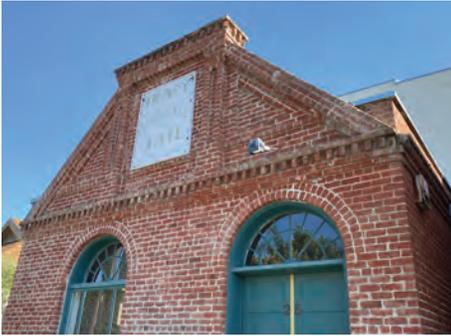
- Exterior Envelope** 2.5
- The exterior masonry facade is in adequate condition for its age but shows signs of fading, crumbling and other deterioration. Along the bottom of the front, and concentrated on the right of the door is quite discolored and would benefit from cleaning and repainting. Tracy Town Hall and Jail sign is severely faded and rusting through in places. Most of the window frames need to be repaired or repainted. Exterior mounted alarm box is rusted.

Exterior Envelope: It is recommended to apply historical preservation measures to the exterior and renovate the sign. Replace window frames where required and paint others. It is also recommended to repair cracks on window sill.

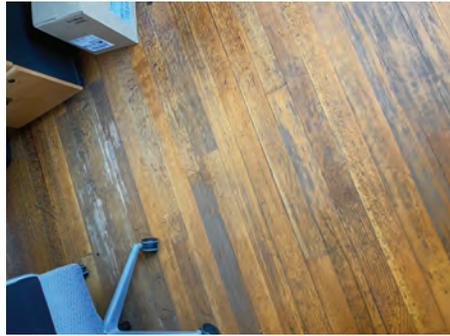
Interior Flooring

- Interior** 3.3
- Hardwood floor finishes are worn throughout the building especially in high traffic areas. Wall and ceiling paint finishes are in good condition. Ceiling crack is present near the corner by the passageway to restroom. Furniture is in fair condition with light scratching on some surfaces. Finishes within restroom would benefit from modernization in general. Cabinets within the restroom do not have proper doors.

Interior: Improvements should include refinishing hardwood floors, repairing crack in ceiling, modernizing the whole restroom, and refinishing the storage room walls.

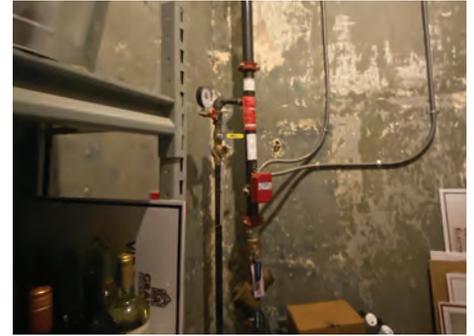
- MEP Systems** 3.4
- Located within the storage room, piping of hydraulic system is in good condition. A window-mounted A/C unit serves the facility in summer months.

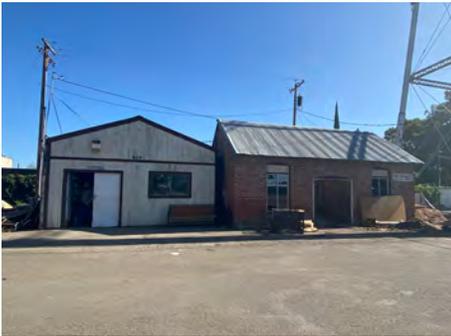
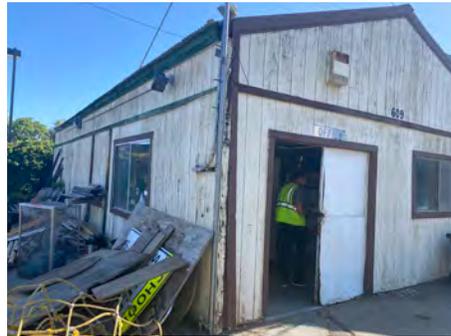
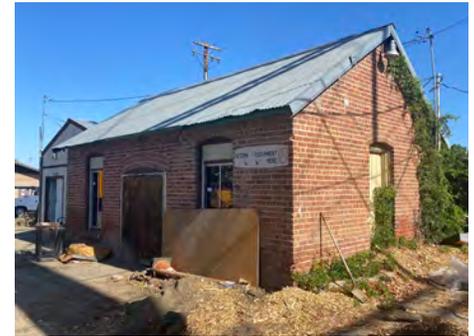
Condition Summary - Old Corp Yard

There are multiple buildings on the Old Corp Yard's site including an office building and a maintenance building. Various aspects of the site are in differing states of condition. Pavement requires resurfacing with a deteriorated surface and large cracking throughout. A fenced-in area sits adjacent to the two facilities and contains cellular communications equipment rented from the city by cellular companies. This area has rust on structural elements and deteriorated pavement. A new pump house facility is located on the opposite end of the Old Corporation Yard's site adjacent to 6th Street and S. Tracy Boulevard. This facility is in visibly excellent condition and was excluded from condition assessments.

The exterior of the maintenance building is historic masonry construction that is in fair condition for its age with slight chipping of bricks in places and grout that has cracked and deteriorated especially near the bottom of the structure. Entrance doors to the maintenance building are rotted wood and contain frames with paint chipping to the extreme. Windows are horizontally sliding and single pane and appear to be in fair condition and installed sometime after construction. The metal roof structure is slightly bent in places and contains no gutters although no leakage was reported. The exterior of the adjacent office building has painted wood siding that is chipping throughout. Exterior bolts and metal are rusting through paint coatings. Door hinges are rusted.

Exterior masonry at maintenance building shows visible signs of structural compromise including deteriorated grout and bricks. Aspects of the interior structure of the office building are exposed and beginning to rot in areas. A large crack is present in concrete flooring in the middle of the office building's interior.

The interior of the office facility contains rectangular ceiling tiles that are missing in areas and a grid system that is out of plumb. Some ceiling tiles are replaced with those that do not match the majority. Lighting is haphazardly arranged with differing methods of support. Concrete slab flooring serves the facility well but contains large chipping and cracks in areas.

Exterior-mounted conduit and electrical equipment boxes at office building are rusted and bent in areas. Some electrical equipment appears to be out of service. Exposed wiring and conduit at office interior appears well-supported but many unorganized wires are found throughout exposed portions of the ceiling system. Exterior mounted lighting fixtures contain discolored lenses and housings but appear to be well mounted.

The yard of the site doesn't contain ADA parking. The interior of the office facility does not contain clear floor space as there are many stored items in the center of pathways.

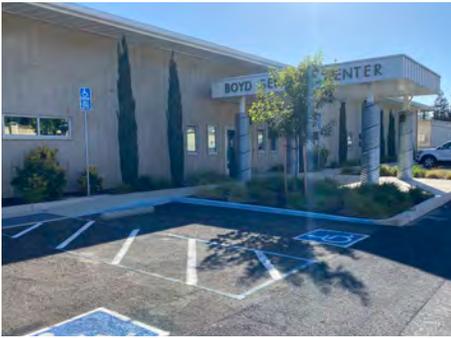
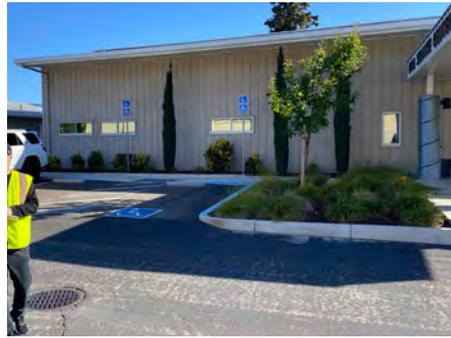
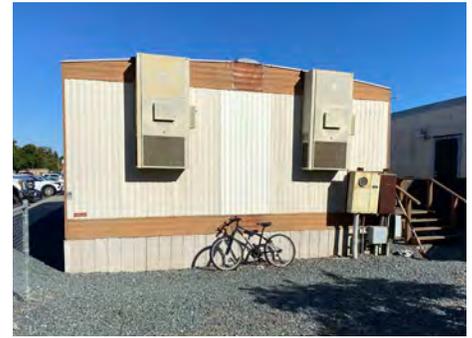
Asphalt paving for the administration parking area is cracked in places especially around central drainage. Parking lot painting and staining in this area has been recently redone. Curbing around sidewalk and landscape elements contains light cracking and discoloration. Landscaping around the administration building is minimal but healthy.

The exterior envelope of the Administration Building at the Boyd Service Center is painted metal with a metal roof and finished interior. The siding of the Administration Building is in good condition. Siding at other buildings is in varied condition with some containing visibly faded paint and rust.

Steel ship containers used for storage for City of Tracy departments contain surfaces in various states of condition with some major rusting and deterioration

Interior light fixtures and ceiling grid systems freely hung from the administration building ceiling may require additional non-structural seismic lateral and longitudinal support. Cracking exists at various concrete floors throughout facility buildings.

The interior of the administration building restroom facilities contain flooring, fixtures, wall tile and paint all in good condition. A minor issue in the main restroom is that the paper towel dispenser is separating from the painted wall surface and the paint surface is cracking at separation.

Concrete flooring of Building C is cracked and stained in places. Acoustic ceiling tile of this same building contains many stains from leaking plumbing. Storage inside Building D is well-arranged. Building E is used for vehicle maintenance and is slightly undersized for the City of Tracy with some equipment beyond its useful service life. Restroom flooring inside Building E is stained with tiles in various states of deterioration.

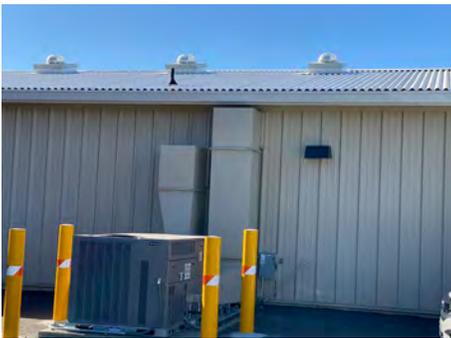
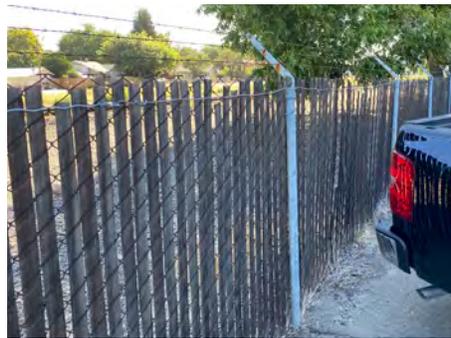
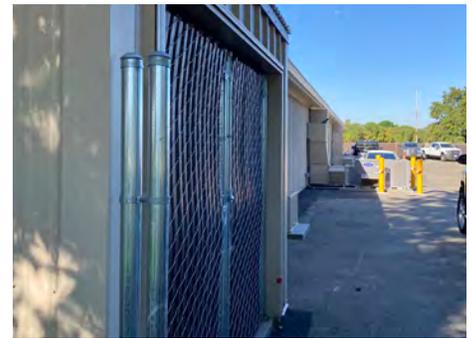
Asphalt paving for the Building B parking area is cracked in multiple places throughout. Heavier cracking is present closer to the building. Painted striping for parking stalls is generally faded throughout the parking area. Staining is apparent at parking stalls closest to brown gate on site. In the same area, there is a small accumulation of leaves and dirt. Landscaping is minimal but appropriate for the site. Fencing around the perimeter is nearing the end of its service life in some places.

The exterior envelope of Building B is in good condition overall. Siding throughout buildings is in good condition and is freshly painted.

No visible structural deficiencies were observed.

Site: It is recommended to repaint site striping and eventually repave site.

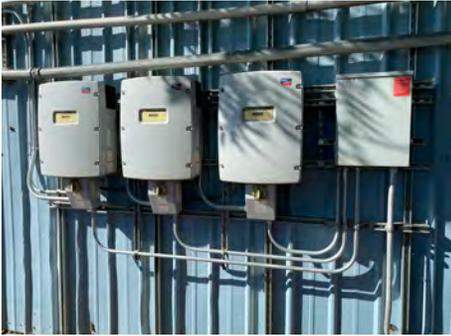
Building C - Maintenance Shops
Facility (unrenovated)

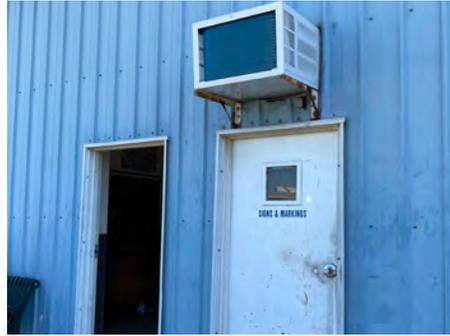
2.9</p> <p>Air vents and air conditioning units are located on the walls in the storage room, office space, and break room.</p> <p>ADA Compliance

MEP Systems: Investigate cause of leakage at acoustic ceiling tile at Building C interior. Remove items stored in front of fire alarm panels and circuit breakers.

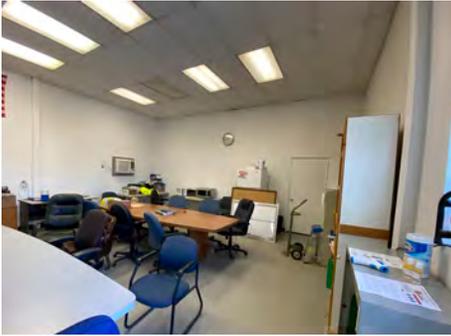
Interior

2.8</p> <p>Concrete flooring of Building C is cracked and stained in places. Acoustic ceiling tile of this same building contains many stains from leaking plumbing. Some acoustic ceiling tiles have minor cracks, visible in the corner tile by the garage door. Tube light fixtures provide an appropriate amount of light into the interior spaces.</p> <p>MEP Systems

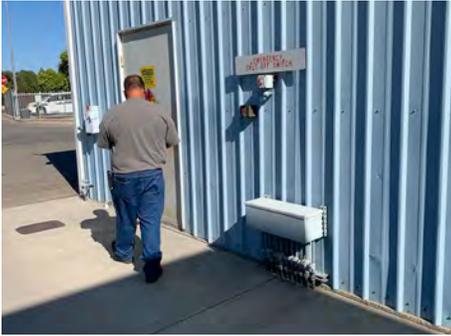
Exterior siding and doors at Building D contain faded paint and rusted screws. Roofing is in relatively good condition with no signs of rust but drainage would benefit from the addition of gutters and downspouts. Exterior lighting fixtures are present only above entrance to storage warehouse.
- Structure**

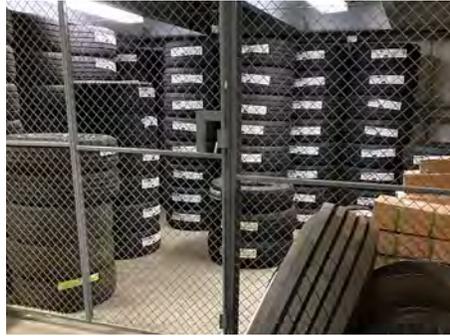
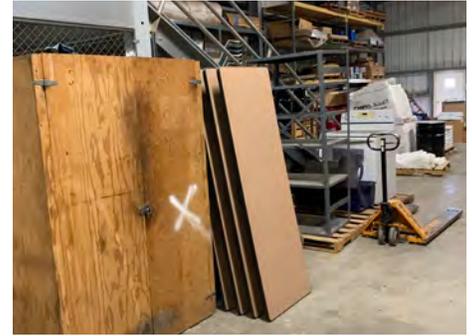
Interior

Entrance door at interior is very scuffed and dented especially at interior base. The remainder of the interior is generally well-organized and in fair condition.
- MEP Systems**

Interior: Replace entrance door.

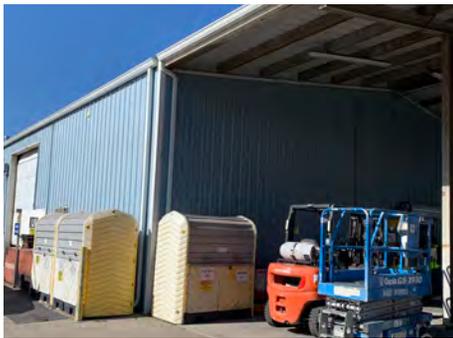
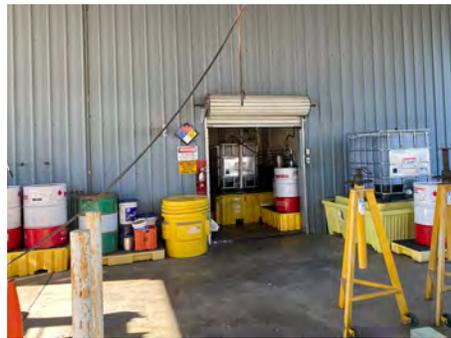
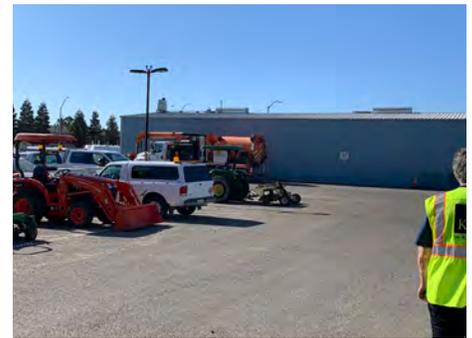
Building E - Fleet Shop

Asphalt paving around the Vehicle Fleet Shop is cracked in places. No landscaping exists around this building. Site lighting is lacking at this area.

The interior of Building E contains concrete flooring in fair condition with signs of wear and deterioration. Interior equipment related to vehicle maintenance is generally in good condition but undersized. Restroom flooring inside Building E is stained with tiles in various states of deterioration.
- Exterior Envelope** **3.5** **MEP Systems** **3.4**

Exterior siding of Building E contains faded paint and rusted bolts in areas. Overhead vehicle doors require replacement. Roofing is in fair condition. Exterior lighting is lacking

Exterior overhang area contains rusted structural elements.

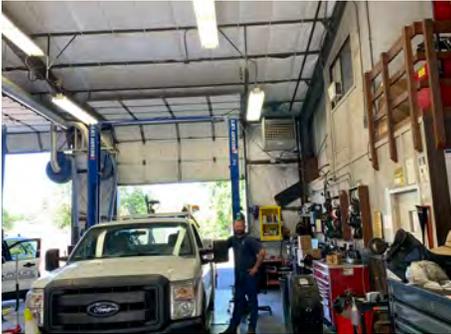
4.2.E: Concrete flooring at shop contains major cracking and faded striping.							
	4.3: Interior walls are covered in grease and grime with areas of chipping or faded paint.

Interior: Repair concrete flooring and replace interior stair system with ADA compliant second story access.

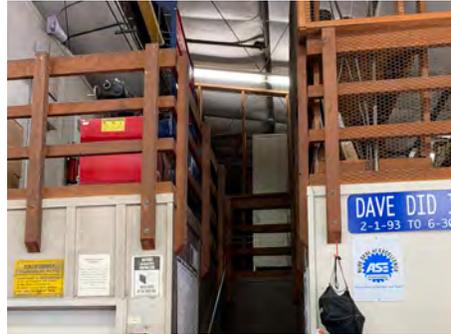
Loft

4.4: Interior doors are stuffed with fading paint.							
	4.5.A: Interior stairs are exposed wood with signs of rot and other deficiencies.							
	4.5.B: Interior stair handrails consist of an undersized metal pipe.

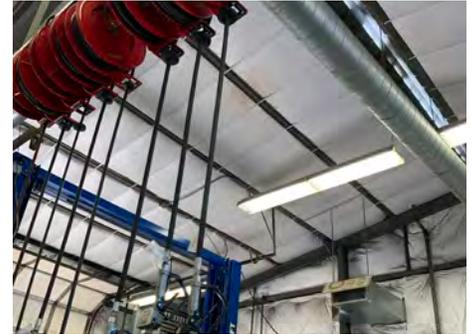
Ceiling

2.4.H: Roof vents including exhaust stacks are deteriorated and rusted.							
3 Structure								2.6
3.1	Foundation/ Footing							3.0
3.2	Columns							3.0

MEP Systems: Replace rooftop mounted exhaust vents. Design new exhaust and ventilation system for building.

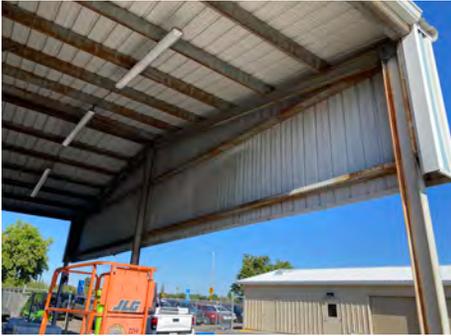
Overhang

3.3	Framing System							1.0
3.4	Walls							3.0
3.5	Lateral Force Resistance System							3.0
3.6	Covered Walkway/Canopy							N/A
3.7	Chimney							N/A
N O T E S	3.3: Large amount of surface rust is present at exposed framing system in covered equipment storage area.

Structure: Replace rusted structural components of exterior exposed bay.

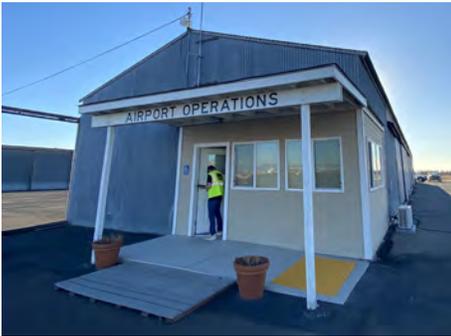
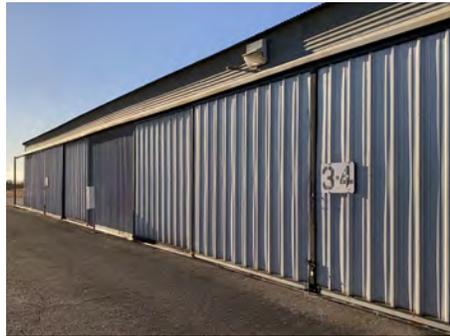
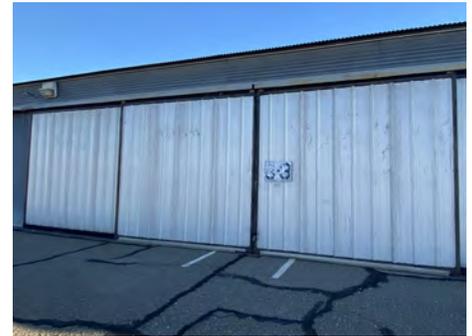
<p>Site 3.4</p> <p>The 3 series hangars are located on site at the Tracy Municipal Airport. The Airport Operations office is located adjacent to the 3 series hangars and houses three airport employees.</p>	<p>Interior 3.3</p> <p>Interior of the 3 series hangars largely consists of exposed redwood structure. Concrete flooring contains minimal cracking. Airport operations office has worn carpeting and contains an acoustic tile ceiling.</p>
<p>Exterior Envelope 3.1</p> <p>Light rusting is present a metal exterior panel edges. Gate tracks are rusted and often bent out of plumb. Waterproofing elements at bases of doors differ among hangars. Single pane windows are present at the Airport Operations office. The office paint is in good condition overall with no signs of chipping. Door frames are exposed wood with splitting and discoloration. Single plane window frames contain splitting wood frames and chipping paint throughout. Wood window sills are similarly deteriorating. Roof surface is rusted and out of plumb.</p>	<p>MEP Systems 3.9</p> <p>Lighting controls are present at hangars. Vents have been created in the ceiling of Airport Operations office to reduce the popping noises due to wind. Electrical junction boxes containing circuit breakers are mounted to hangar exterior with exposed conduit in fair condition. Minimal rusting and deterioration is present at exposed conduit joints.</p>

<p>Structure 3.3</p> <p>Exposed wood structure and trimming exists throughout with some signs of water damage. Foundation is in visibly sound condition. Some metal beams are slightly rusted and would benefit from a reapplication of protective coating.</p>	<p>ADA Compliance Needs Compliance</p> <p>The 3 series hangars are non-ADA compliant due to threshold concerns, locations of light switches and other elements. The Airport Operations office has non-compliant elements including furniture and counter items.</p>
