CITY OF TRACY

CITYWIDE PUBLIC FACILITIES MASTER PLAN UPDATE

December 2023

II. FACILITY CONDITION ASSESSMENTS

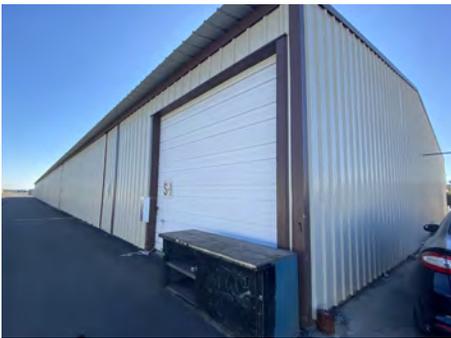
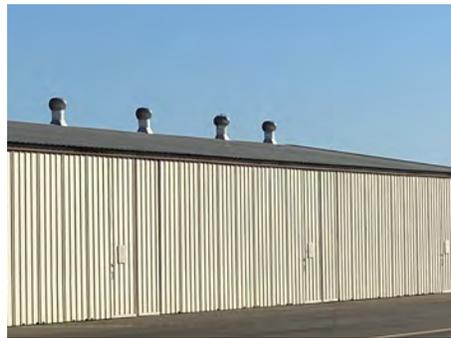
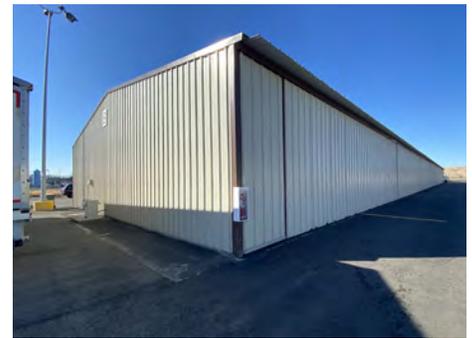
3.7</p> <p>Location of B-Series hangars is not ideal for airport maintenance staff as water drains toward the building that often causes tenants to construct makeshift elements to prevent water intrusion. The City must remove these elements at a later date.</p>	<p>Interior

4.0</p> <p>Staining from oil and other airplane engine fluids is present at interior concrete flooring.</p>
<p>Exterior Envelope

4.1</p> <p>Exterior walls are in good condition and appear recently painted. Roof and mounted exhaust fans contain much remaining service life with no visual deficiencies observed or maintenance problems reported.</p>	<p>MEP Systems

3.1</p> <p>Housing for exterior ground-mounted 3-Ph transformer is rusted.</p>
<p>Structure

3.8</p> <p>Steel framing and other interior structural elements appear to be structurally sound with much remaining service life. Some structural wood contains elements of rot, especially in shop area.</p>	<p>ADA Compliance

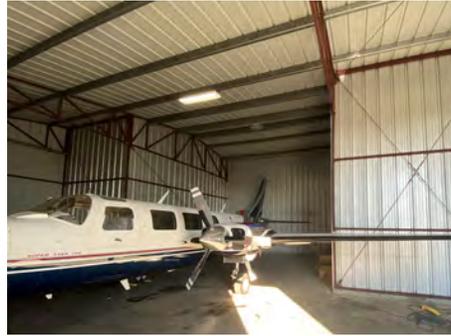
Hangar

Needs Compliance</p> <p>Interior clear floor space is not present at many portions of the interior. Thresholds are present at sliding floor bottoms at entrances to individual hangars.</p>

Structure: It is recommended to remove rot and replace structural elements in shop area.

ADA Compliance: Impact of recommendations will result in increased accessibility within hangars and will require one week to clear out floor space.

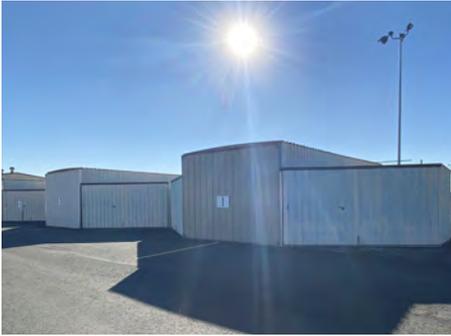
2.7</p> <p>Steel exterior of F-Series hangars is rusted in places especially at entrance thresholds and door components. Paint has chipped which has allowed rusting. Paint is faded and hangars are not uniform in color. Flat roofs are discolored and rusting at edges. Tow hitches used for transport of hangars appear rusted and should be further investigated prior to transport. Door latching system is worn and had to utilize at many doors.</p>	<p>MEP Systems

Exterior Envelope: Recommended actions include cleaning rusted areas of the hangar include entrance thresholds and door components, repainting the facade and making sure all hangars are painted in the same color, cleaning and painting flat roofs, potentially replacing tow hitches and replacing rusted door latching system.

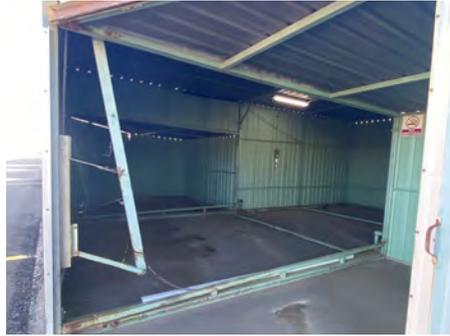
3.0</p> <p>Some staining is present at interior asphalt floors. Minimal cracking is present in flooring. Interior lighting lenses are discolored.</p>
<p>Exterior Envelope

Interior: Recommendations include cleaning interior asphalt floors and interior lighting lenses.

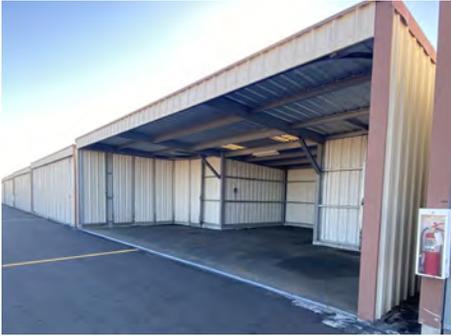
3.8</p> <p>Exterior structure is visibly worn and maintenance staff and tenants report many problems with door operation which alludes to structural deterioration.</p>	<p>ADA Compliance

Exterior Envelope: Recommendations include repairing mechanical issues within exterior sliding door tracks, reinforcing sheet metal, and repairing weatherproofing at door base to be in plumb.

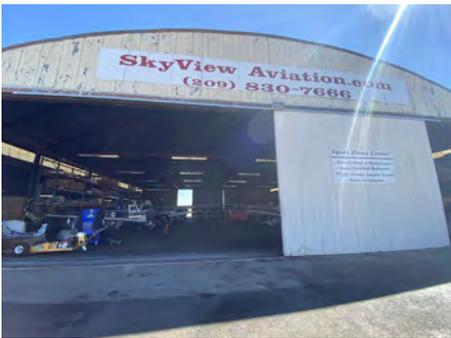
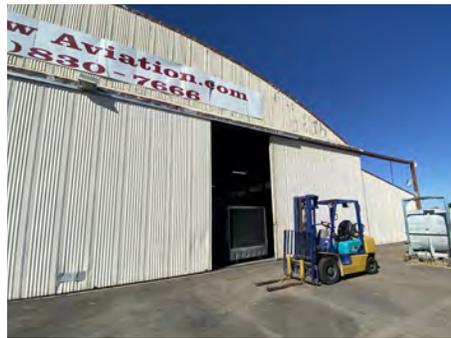
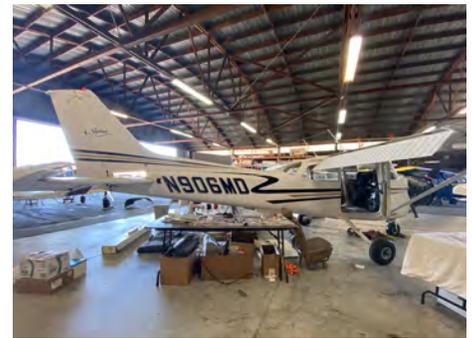
<p>Site 3.3</p> <p>A drain located adjacent to the main aircraft entrance to the hangar attempts to lessen water intrusion to the interior. Site drainage is reported to be less than ideal. Lettering is flaking off from exterior signage. An exterior transformer dedicated to fuel monitoring is located on site. Parking lot striping is faded throughout.</p> <p>Exterior Envelope 2.6</p> <p>The exterior metal siding is in fair condition with some areas rusted through with paint required. The roof has had reports of leaks over the last decade. Skylight panels are discolored and worn. The large sliding doors allowing aircrafts access to the hangar are on overly sized tracks that require excessive force to open and utilize.</p> <p>Structure 3.3</p> <p>Structural connections are in visibly fair condition, as they are rusty but contain intact protective coatings. Straps holding arch of structure at exterior must be tightened occasionally. Wood framing system contains rot in places due to water intrusion from leaking roof.</p>	<p>Interior 3.6</p> <p>Some evidence of wood rot is present at hangar structure. Interior lighting is just adequate and could be modernized. Current tubes are fluorescent with some units out of discolored. Asphalt flooring is pitted in areas but generally works well for the operations of the facility. Flooring in administration and office areas differs throughout but is largely rolled carpeting in fair condition. Green carpet is original to the building. Previous mold issues present at interior asphalt has led to mildew prevention efforts. Windows are in good condition as double-paned glass has recently been installed. Ceilings are plaster in office areas and painted white. Hangar area has exposed wood and metal roof structure as ceiling.</p> <p>MEP Systems 3.7</p> <p>Heating and air conditioning equipment is largely located adjacent to the building in the parking lot. These units were intended to serve the office and administration areas but systems are no longer operational. Portable evaporative coolers are used in summer months.</p> <p>ADA Compliance Needs Compliance</p> <p>Interior restrooms are not ADA compliant due to a multitude of violations related to dimensions and other items. Accessible parking space requires re-striping.</p>

Site: Recommendations include eventually altering site drainage so water flows away from the building and repainting parking lot stalls.

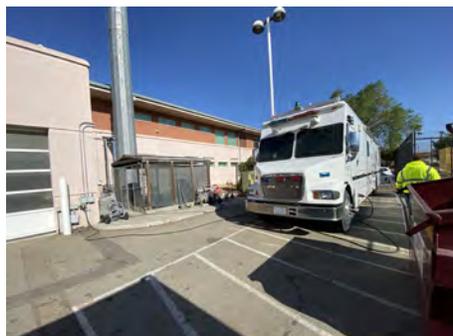
Exterior

Site elements include multiple parking lots, landscaping, HVAC system components and cellular communications antennae. Curbing and walkways around entrance contain tire markings and other stains and require cleaning. Parking pavement is in fair condition with striping deterioration and cracking in places. Solar panels in gated south police parking lot are in good condition with minimal wear. Gate to access south lot contains rust and worn track and motor housing. Site lighting poles are contain discolored lenses and require paint. Vegetation is mostly healthy but some areas of open dirt remain. Lawn is well-kept and appears healthy and green. Building signage is present but faded and undersized especially at parking lots and adjacent building areas.

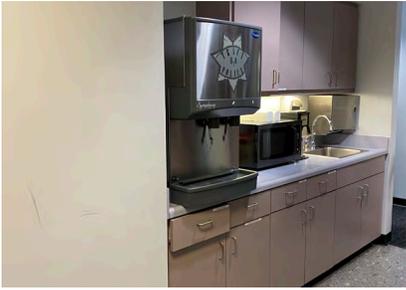
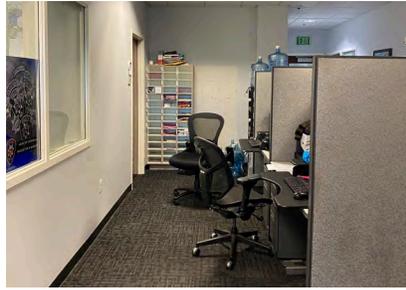
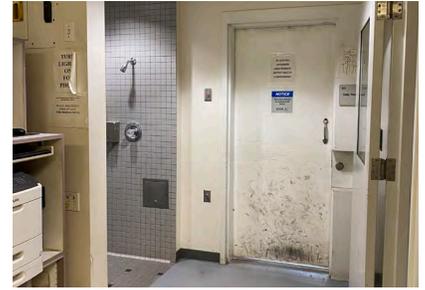
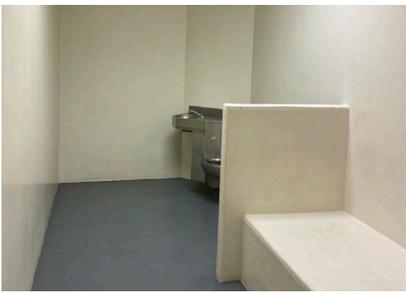
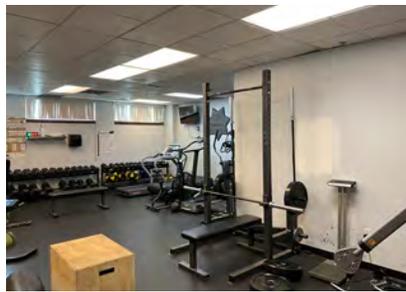
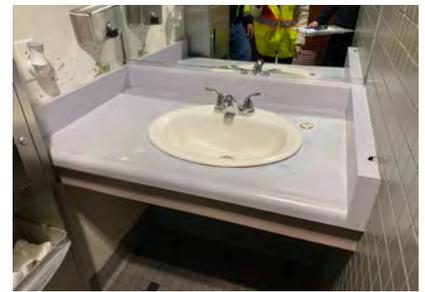
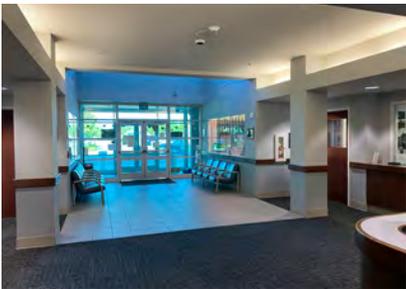
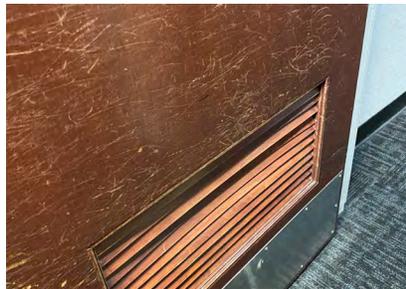
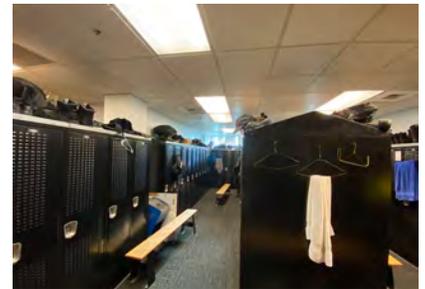
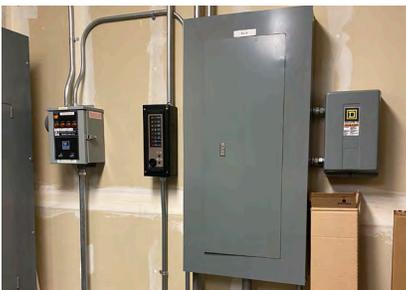
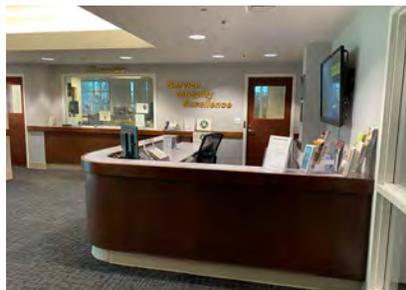
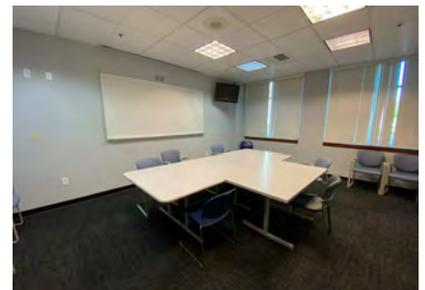
Photo Documentation | Interior Blow Ups

D. Urinals		4					
	E. Lavatorie /Sinks			3				
	F. Counter			3				
	G. Shower Compartments				2			
4.7	Hazmat							N/A
4.8	Room Capacity							N/A
N O T E S	4.1.A: A selection of suspended ceiling tiles contain signs of ceiling leakage.

4.2.B: Vinyl flooring throughout the facility is scuffed, scratched and misaligned in areas.							
	4.2.E: Concrete floors are cracked and deteriorating especially in jail area.

Interior: Provide door seals at bottoms of exterior doors that lack them, including in jail area. Paint interior walls throughout building. Replace stained ceiling tiles and investigate cause of staining.
